January 15, 2016

390/265831

**Subject: 2015 Annual (Initial) USEPA CCR Landfill Inspection Report  
Brunner Island Ash Disposal Area No. 8**

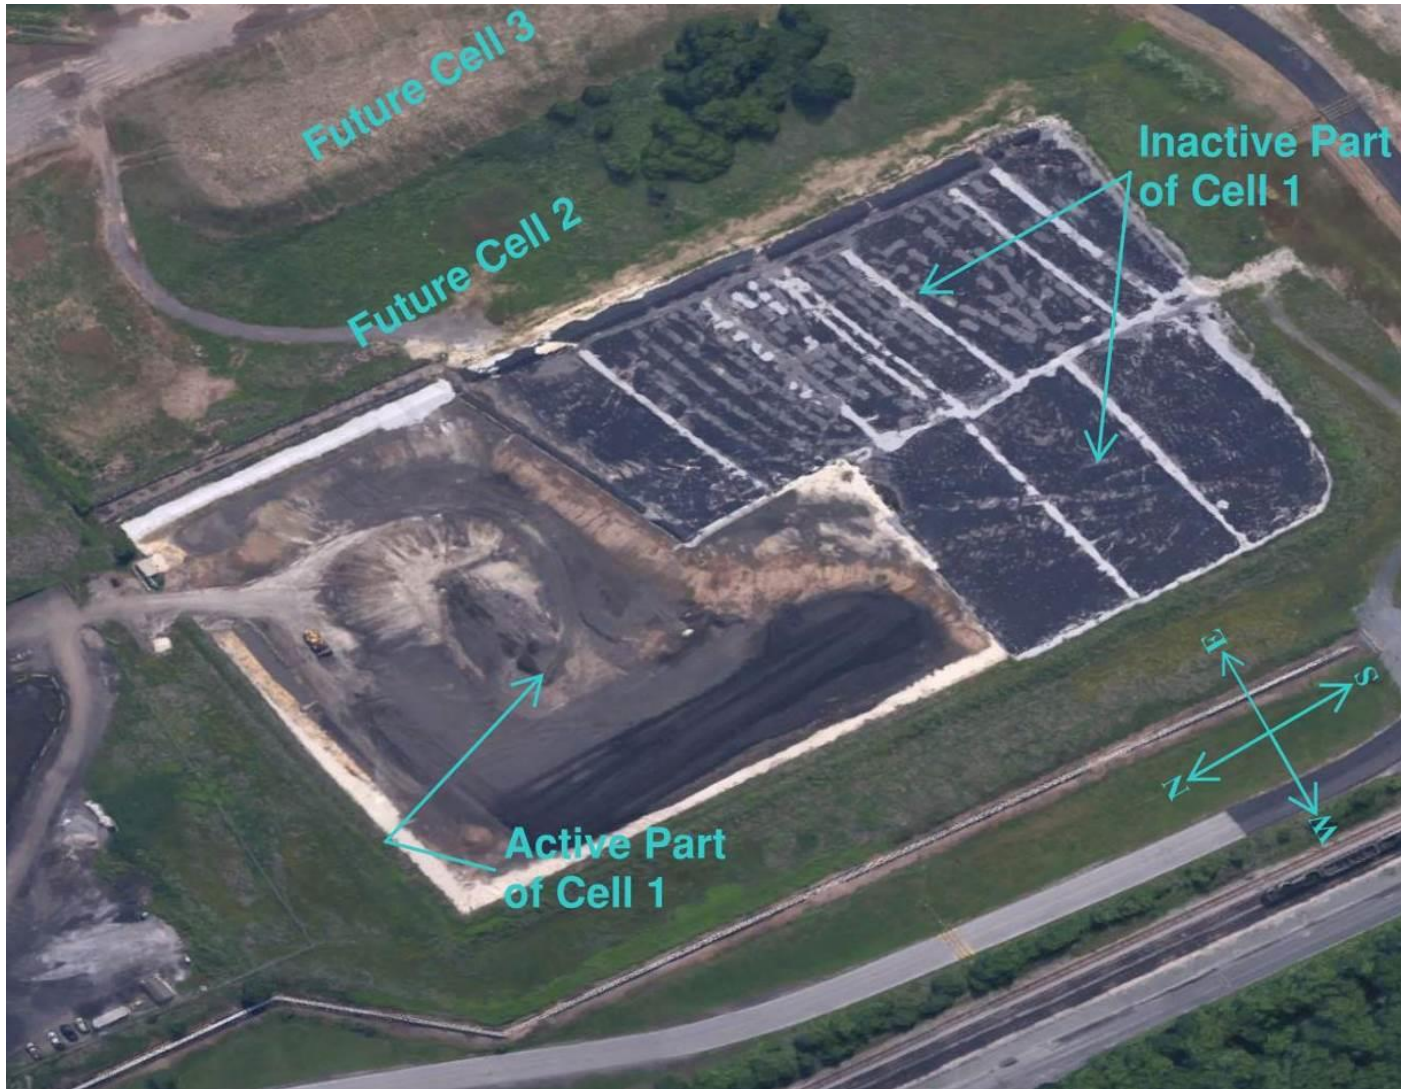
Photo 1 - Aerial view of Brunner Island Ash Area No. 8. The active part of Cell 1 is seen to the left (north). The right (southern) part of Cell 1 has had the liner system installed, but has not been filled. Temporary plastic tarps can be seen covering the liner system over the inactive part of Cell 1. Construction of Cells 2 and 3 has not yet started.

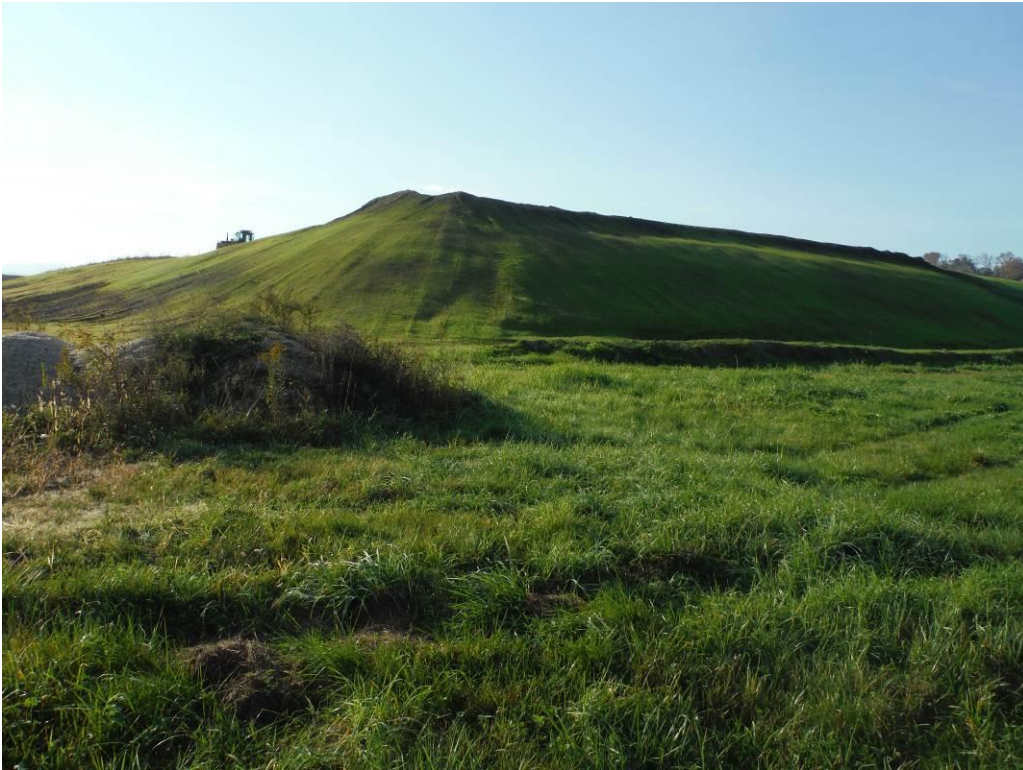
Photo 2 – North and east slopes of the active part of Cell 1. The final build out of the slopes has not taken place and the vegetative cover is temporary, providing erosion and dust control.

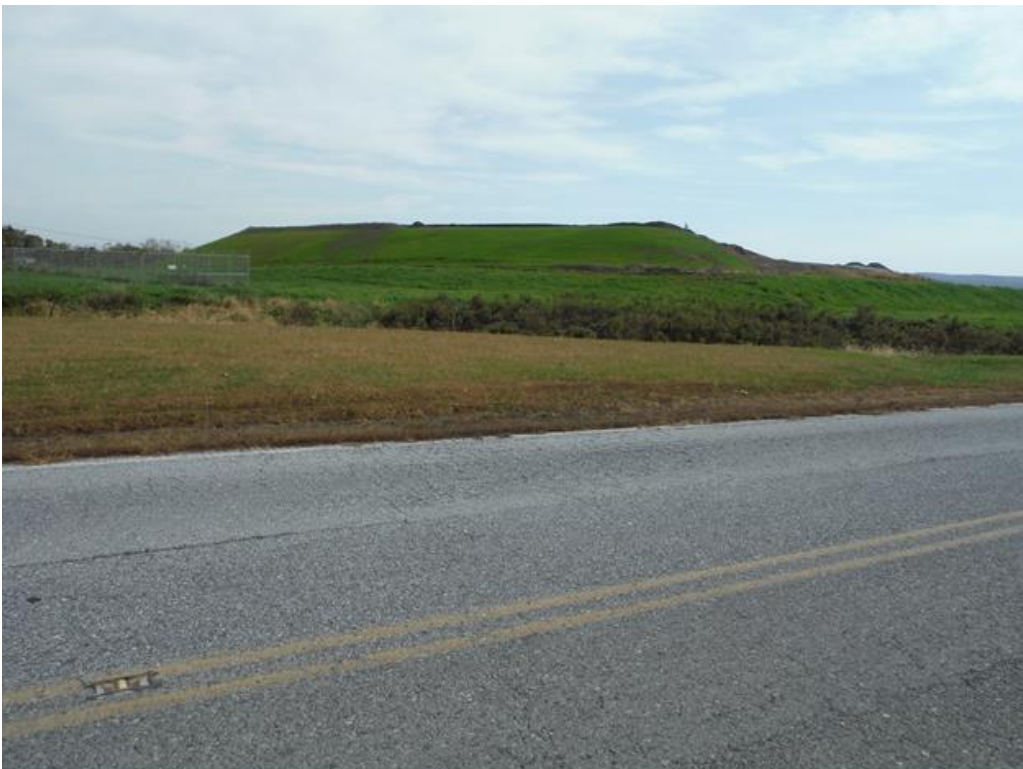
Photo 3 - North and west slopes of the active part of Cell 1.

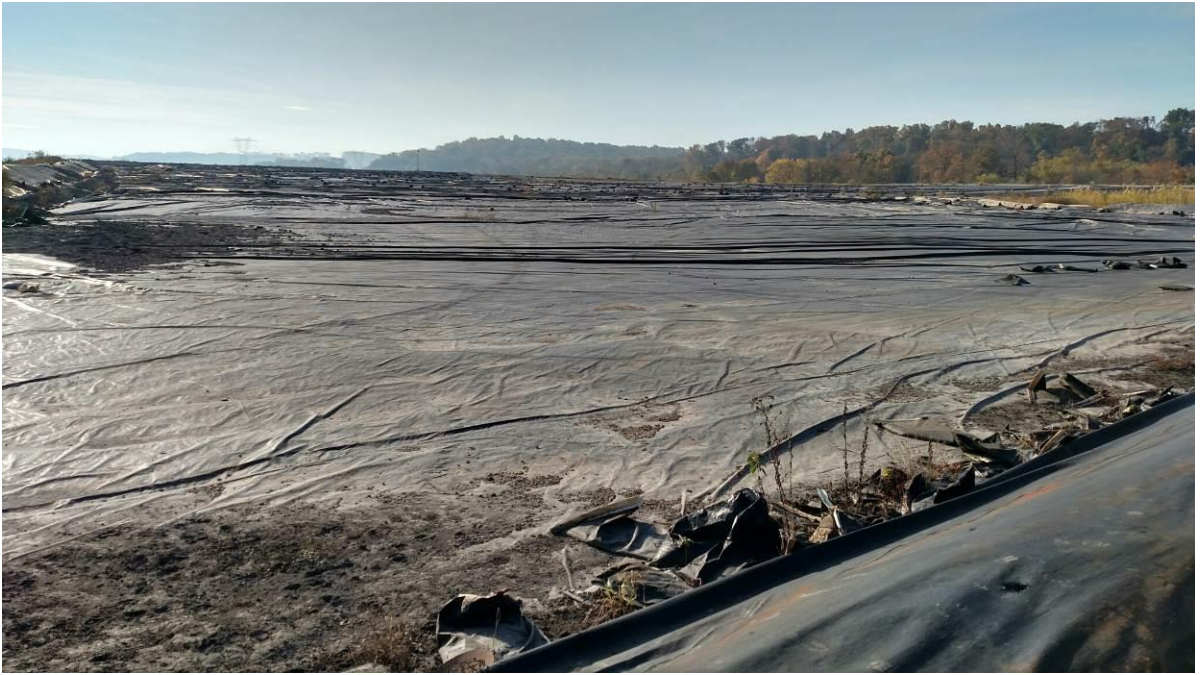
Photo 4 – Unfilled (inactive) section of Cell 1. Note the temporary plastic tarps covering the liner system.

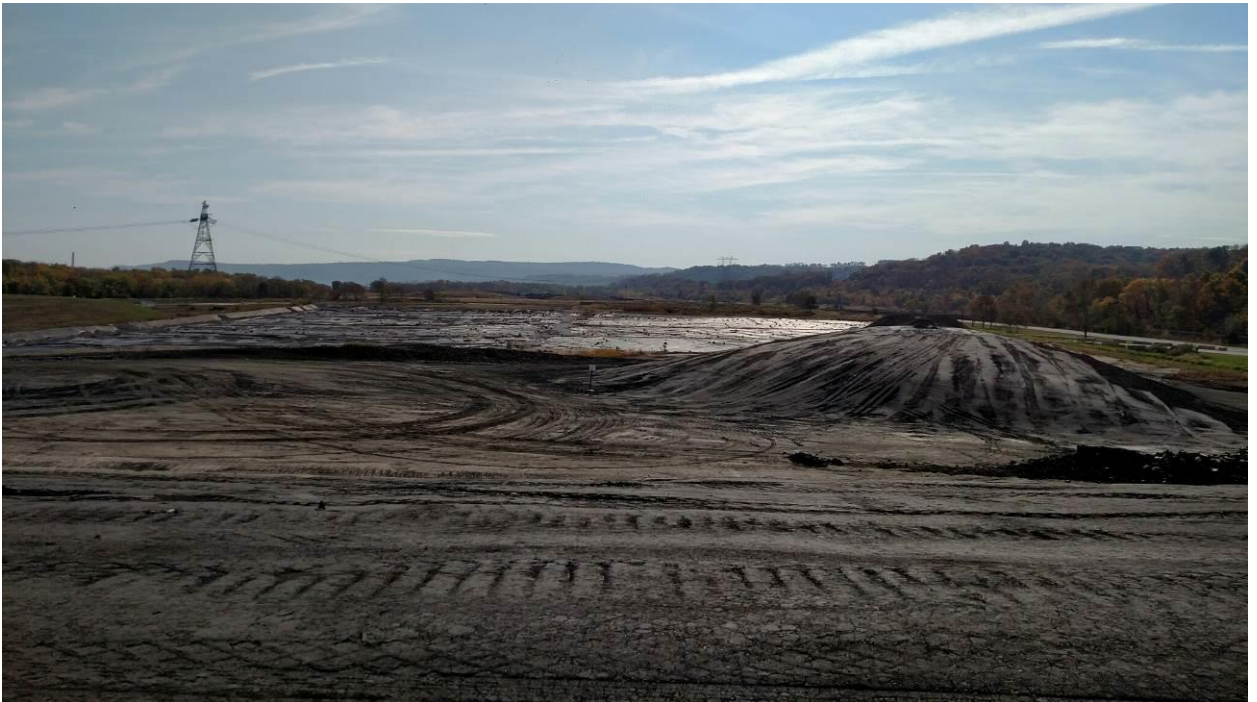
Photo 5 – Working surface of Cell 1, with the inactive part of Cell 1 in the background.

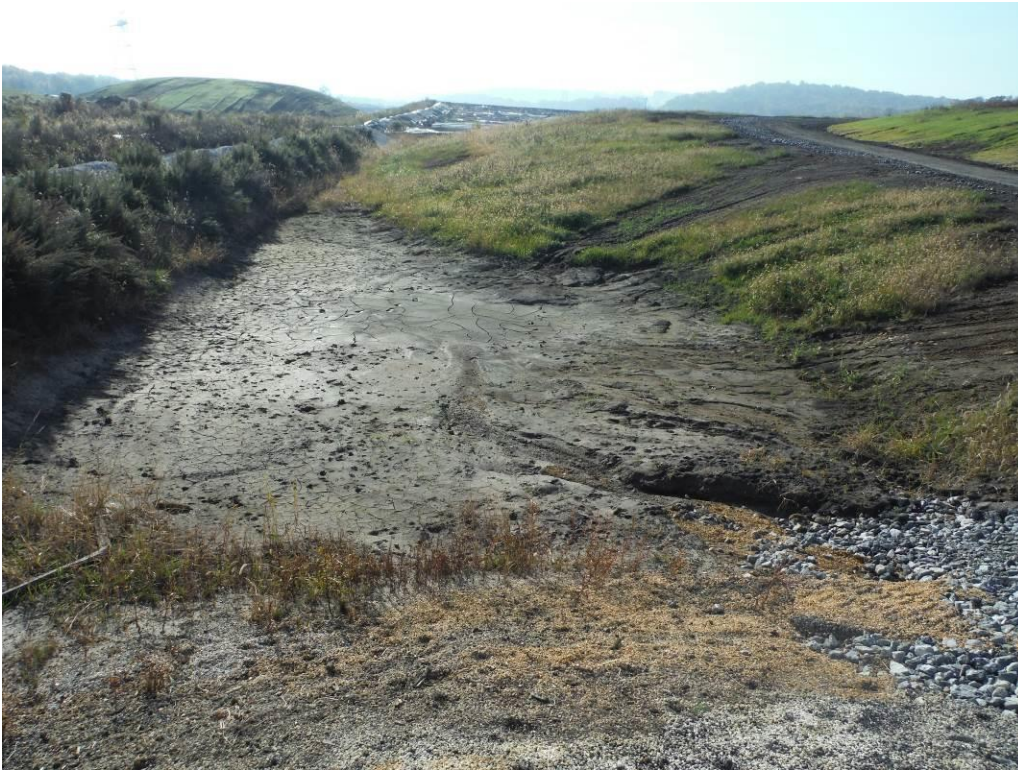
Talen noted that the lagoon at the east side of the active part of Landfill Cell 1 adjacent to the pump house, shown in Photo 6, is temporary and is scheduled to be filled in the near future. The perimeter swale around the active part of the Landfill currently directs contaminated run off to this basin, which is totally contained within the lined landfill. Before this lagoon is filled, Talen should verify that contaminated run off resulting from the design rainfall will be completely contained within the lined section of the Landfill, in accordance with the Run-on

Photo 6 – Ditch separating Cell 1 from future Cell 2. The swale surrounding the active part of Cell 1 drains to the temporary stormwater detention basin shown in the foreground. Captured stormwater percolates to the sump and is pumped to the Plant Flue Gas Desulfurization (FGD) waste water treatment plant. The clean water channel shown in Photo 7 is to the left.

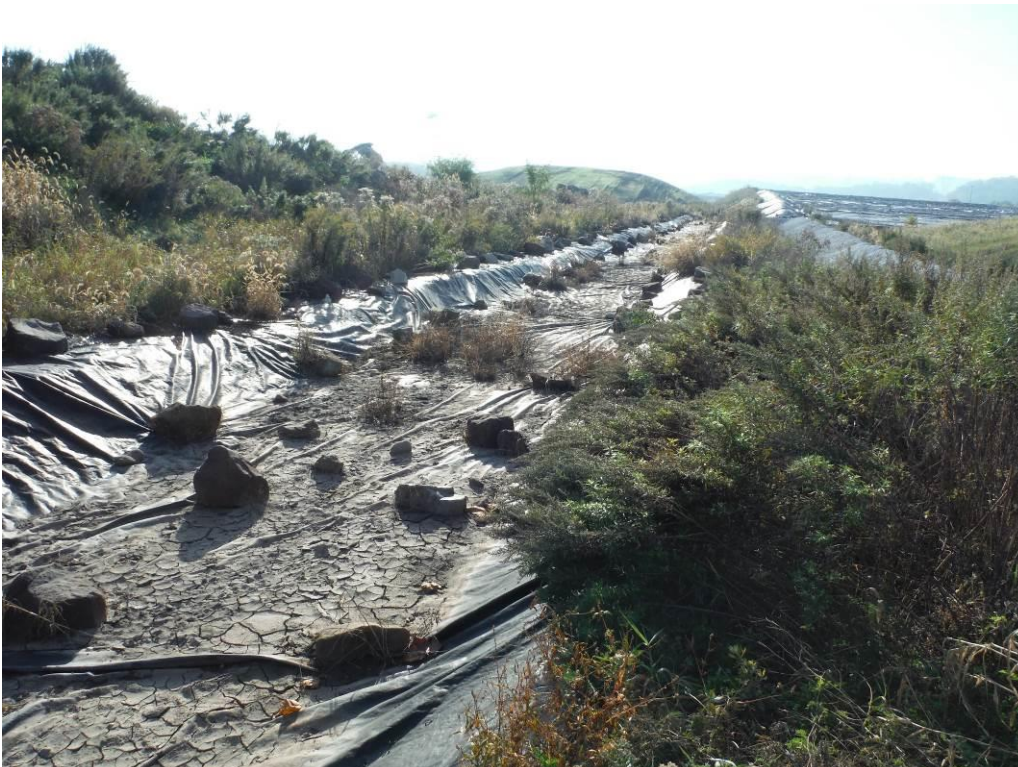
Run-off Control Plan. The clean water channel draining the inactive part of Cell 1 is shown in Photo 7.

Photo 7 – Clean water discharge channel draining the unfilled part of Cell 1. This discharges to a ditch leading to the Susquehanna River.

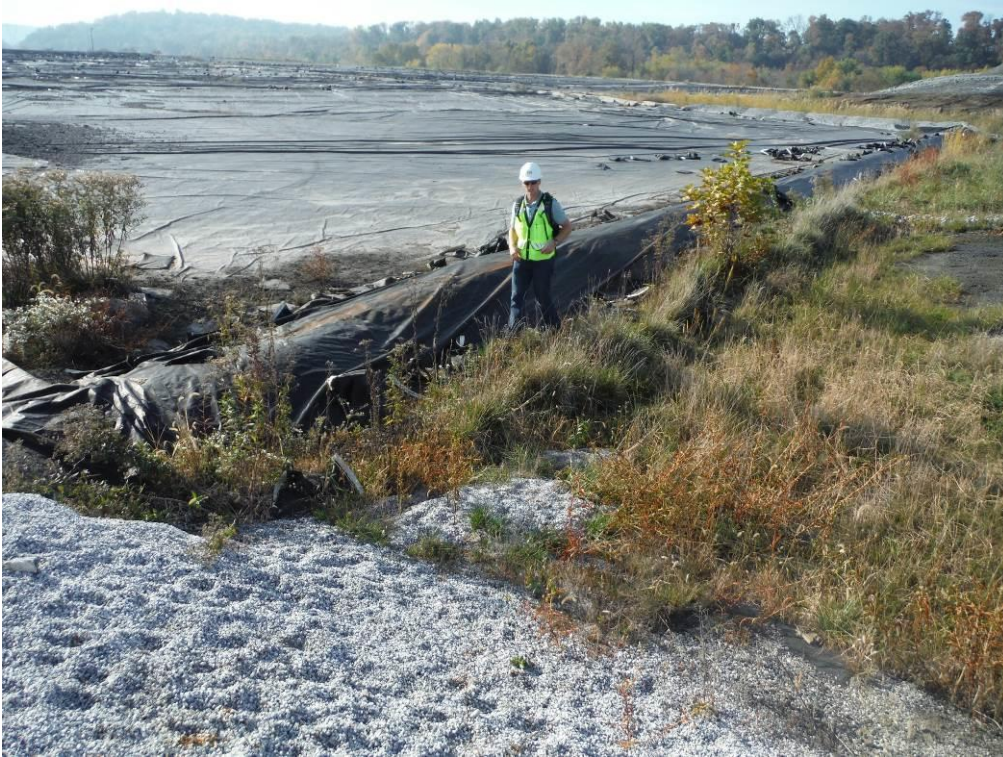
Photo 8 – Separation dike between the active and inactive parts of Cell 1, looking southwest. This section, at the southeast corner of the active part of Cell 1, is well formed, though it appeared to be less than the 4 foot height shown on the project drawings.

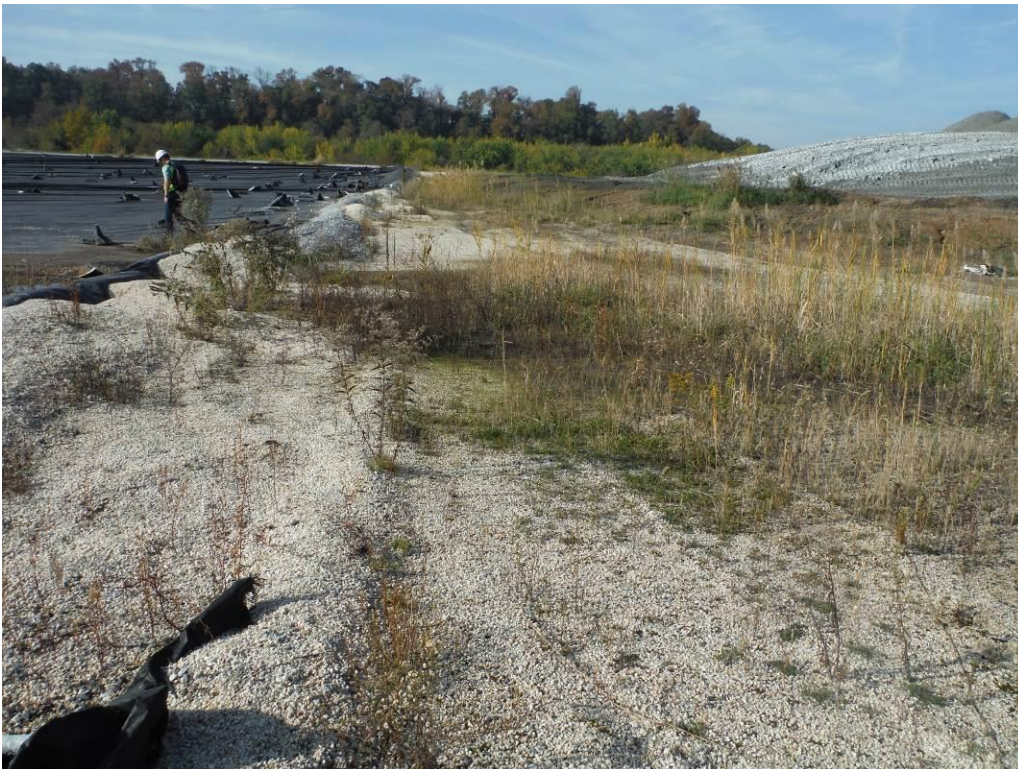
Photo 9 – Irregularly formed section of the separation dike between the active and inactive parts of Cell 1. This section of the dike should be reformed with a minimum height of 4 feet, as shown on the Project drawings.

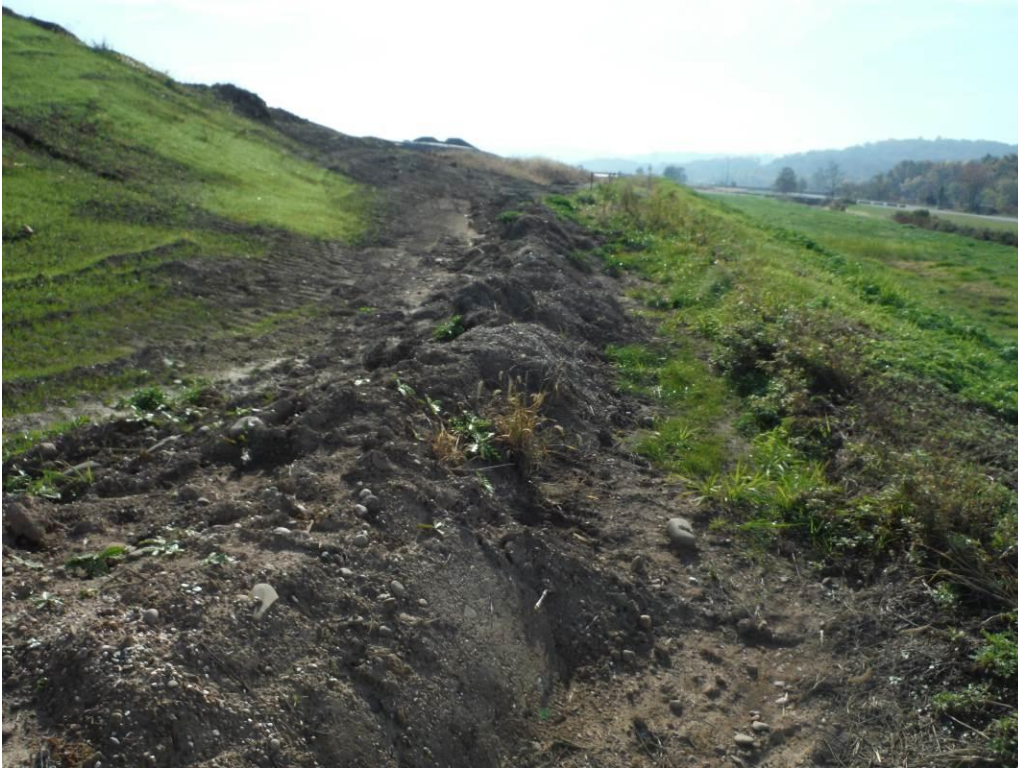
Photo 10 – Ditch at the northwest corner of Cell 1, under construction. The section to the left will convey contaminated stormwater run off to the south, and the ditch to the right conveys clean stormwater run off to the north.

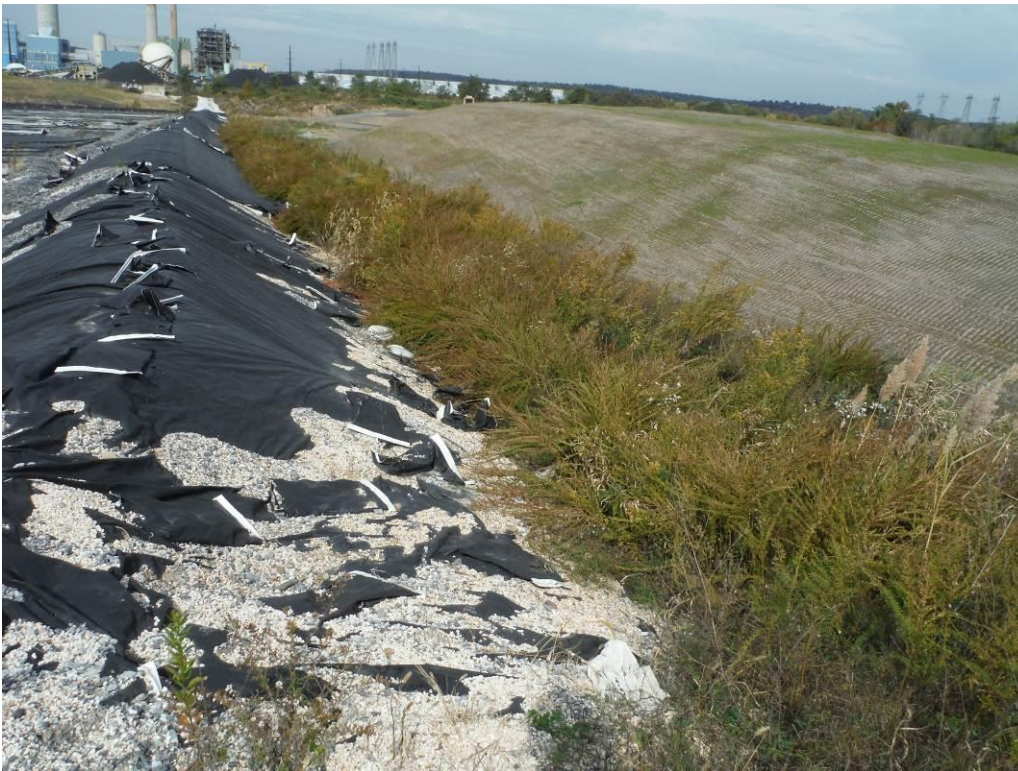
Photo 11 – Overgrown ditch along the east edge of the inactive section of Cell 1.

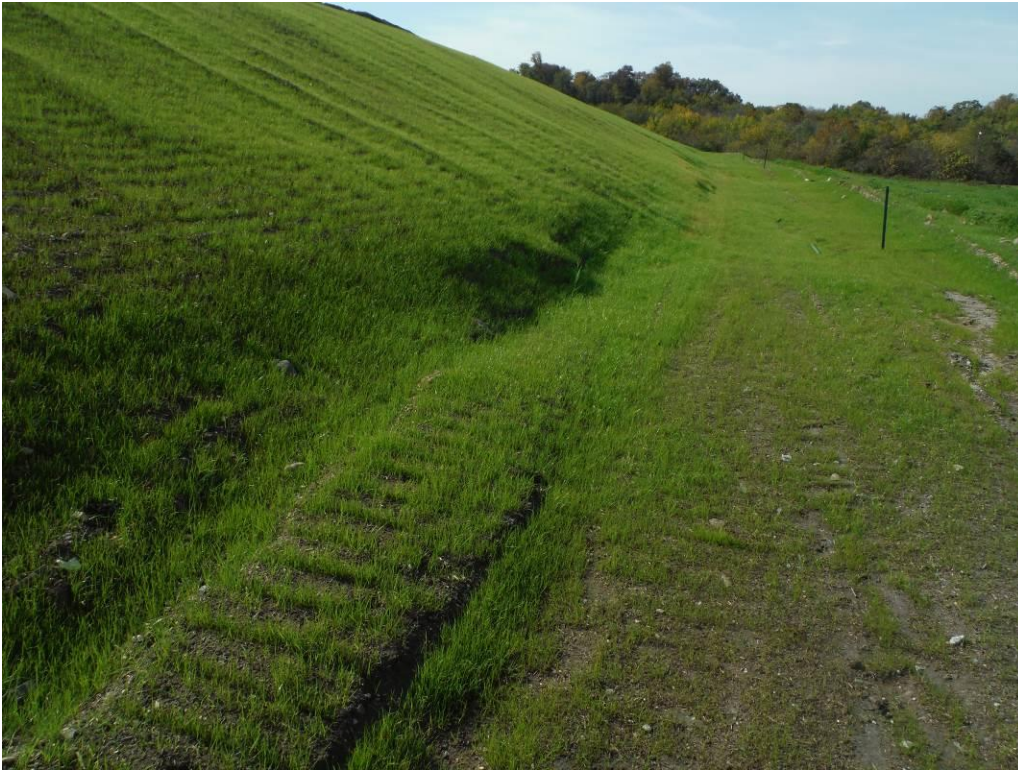
The filled area of Cell 1 was well formed and maintained. Locally steep areas were observed along the north and south slopes of Cell 1, seen in Photos 12 and 13. Talen noted that the north edge had been temporarily filled and stabilized and would be built out shortly to the design limits and design slope of 3H:1V. Stabilizing the south slope would reduce erosion and the sediment load in the stormwater run off.

Photo 12 – Locally steep, irregular slope along the north edge of the Cell 1. Talen noted that this fill was temporary and final filling and grading would take place in the near future.

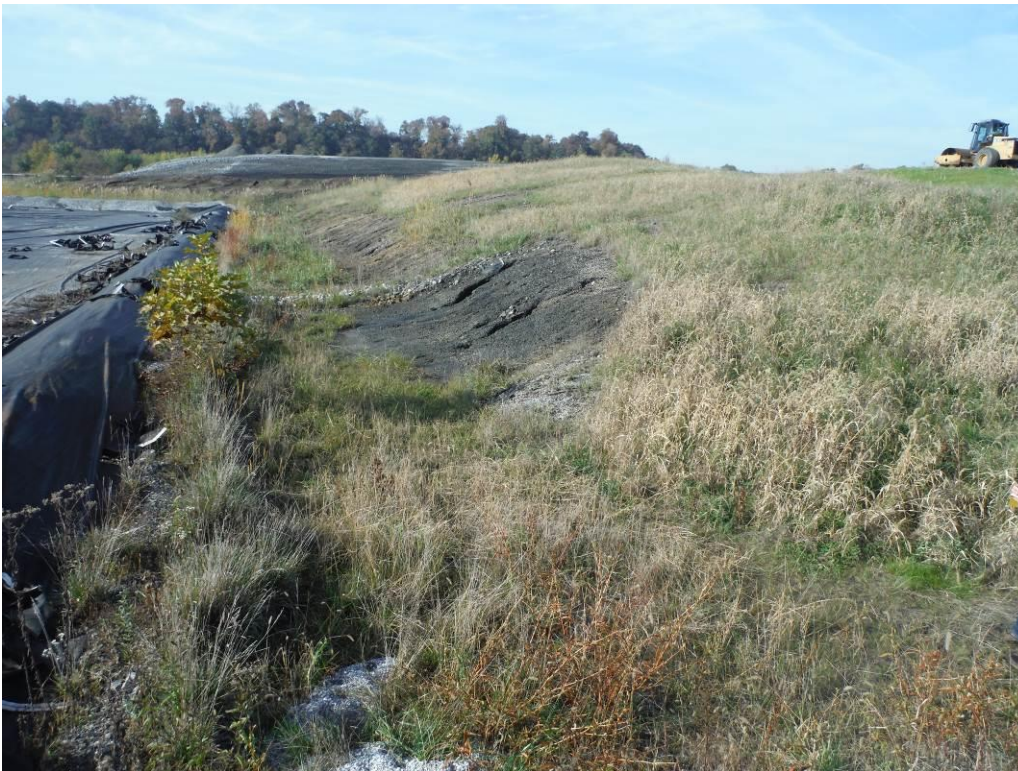
Photo 13 – South edge of the active part of Cell 1, showing temporary vegetation used for erosion control and a locally steep area subject to erosion.

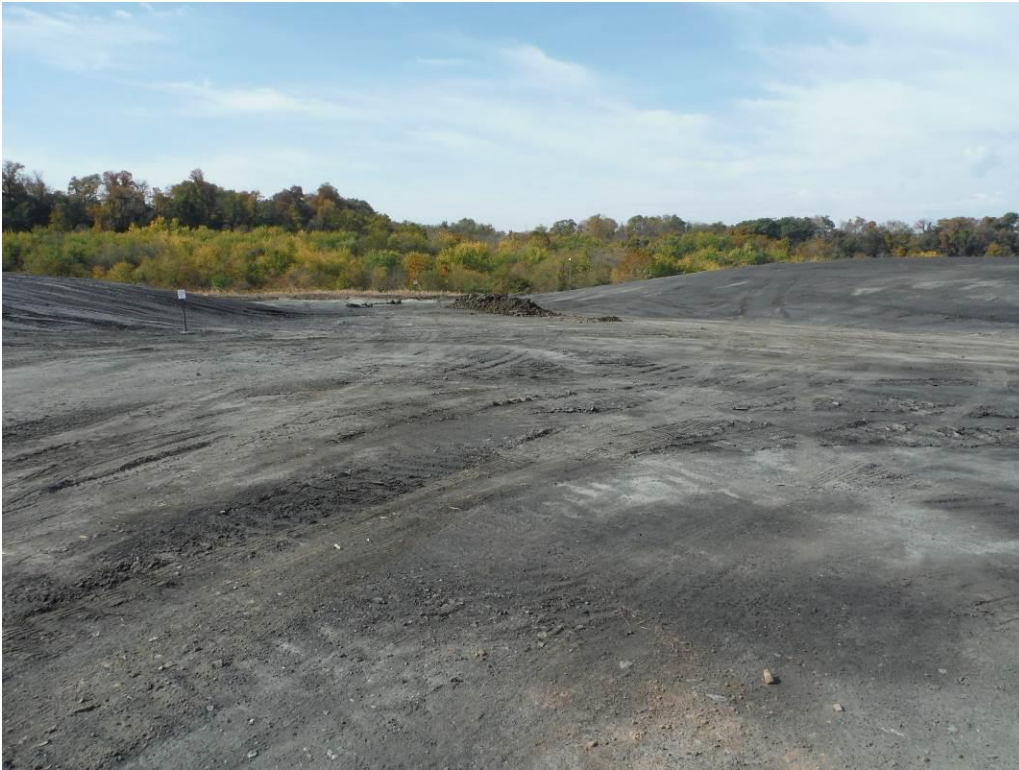
The active surface of the landfill can be seen in Photos 14 and 15. Run off and dust control measures were appropriate, except where grading was underway, as seen in Photo 15, to establish final grades and containment measures.

Photo 14 – Landfill surface, showing grading and finishing of the working surface. A recently dumped load can be seen in the photo center.

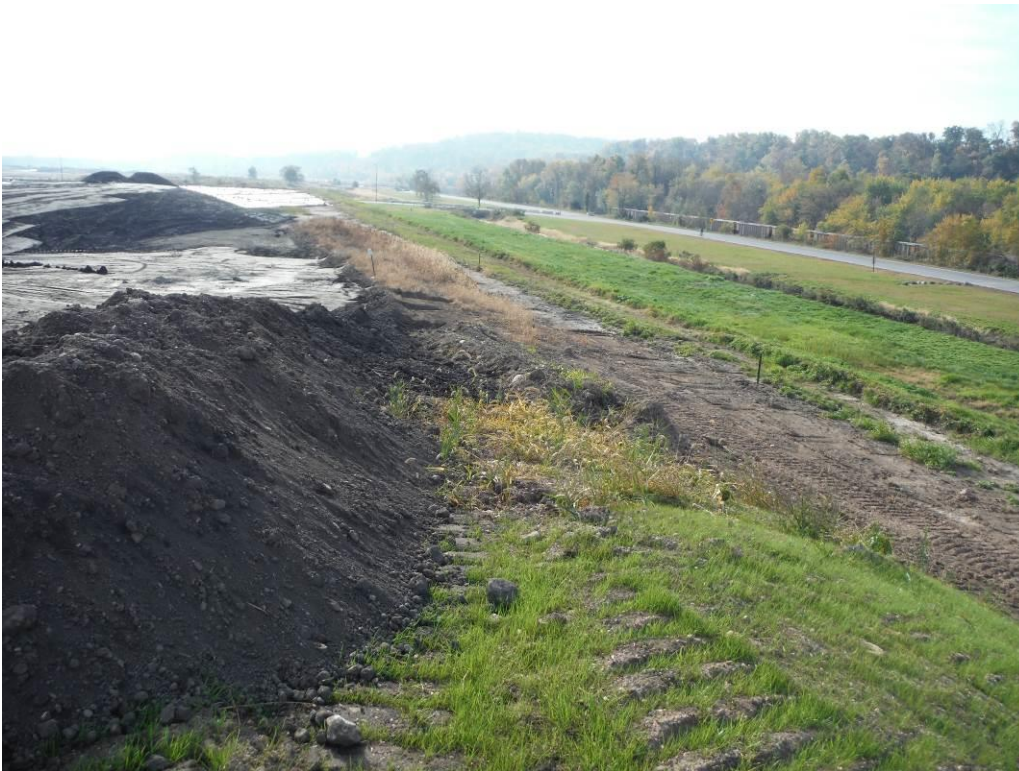
Photo 15 – West edge of Cell 1 showing containment measures under construction. .

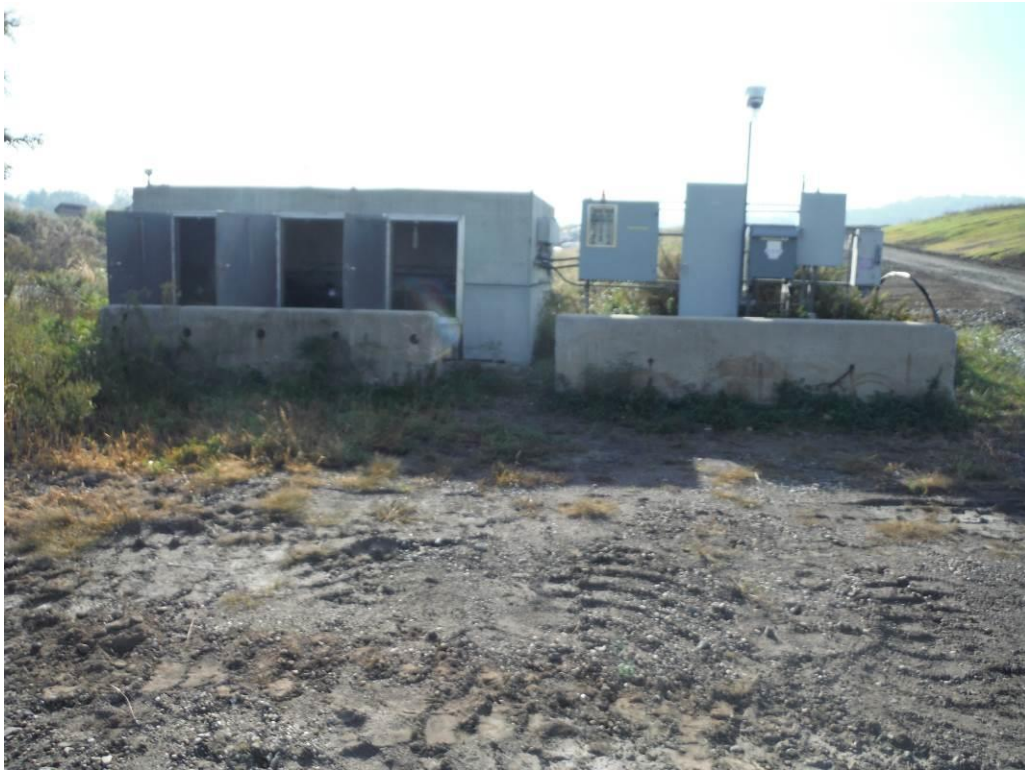
Photo 16 – Mechanical building housing the leachate collection and leakage detection sump pumps.

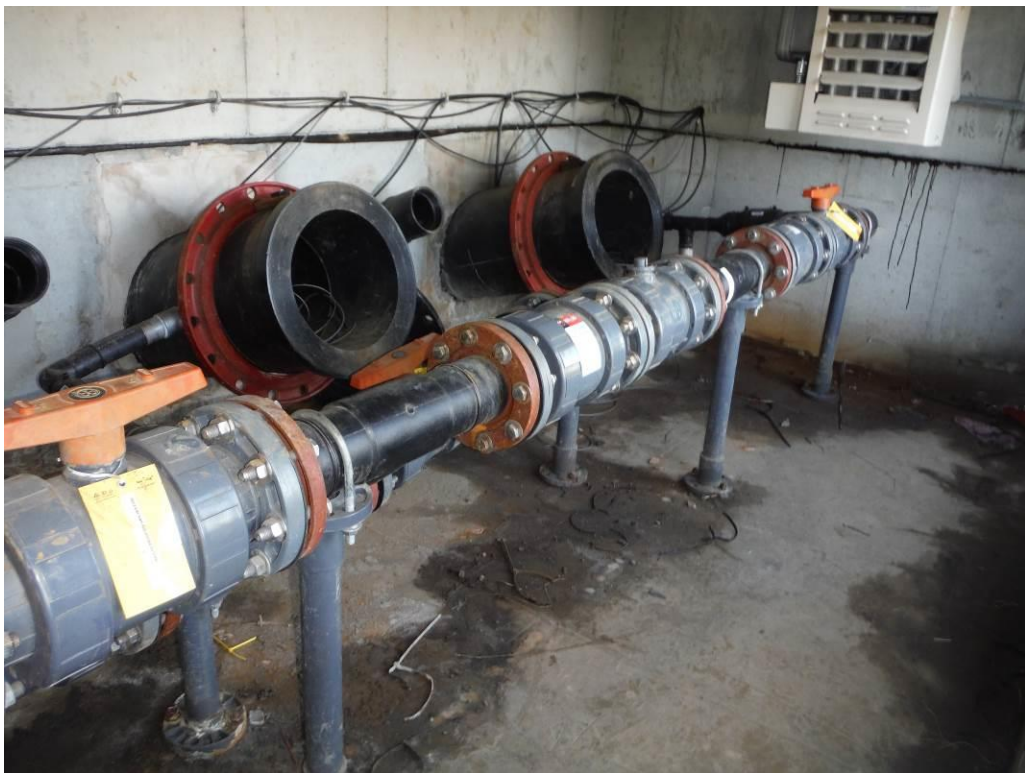
The leachate and leakage detection sumps are located at the north end of Cell 1. The mechanical building, seen in Photo 16, was in good condition. The pumps located in the two leachate collection sumps and one leakage detection sump all discharge into a common header, seen in Photo 17. The mechanical system and structures appeared to be in good condition. As noted previously, Talen encountered problems measuring and evaluating liner leakage. Talen replaced the level sensor and noted that significant liner leakage flow was no longer being observed. Talen records the overall pump run times and cycles daily. Calculating and plotting the run time and cycles on a regular basis would facilitate evaluation of leachate and leakage flows. Adding redundant sump level sensors, in-line flow measurement, separation of the headers into three separate lines, or a combination of these measures should be considered, particularly if abnormal flows are encountered. Talen calibrated the pump discharge at 33.5 gallons per minute shortly after the inspection. The pumps should be periodically checked to account for pump wear, and abnormal discharge readings should be checked.

Photo 17 – Sump pumping system.
