December 11, 2015

390/265831

**Subject: 2015 Annual USEPA CCR Surface Impoundment  
Initial Annual Inspection Report for Brunner Island Ash Basin No. 6**

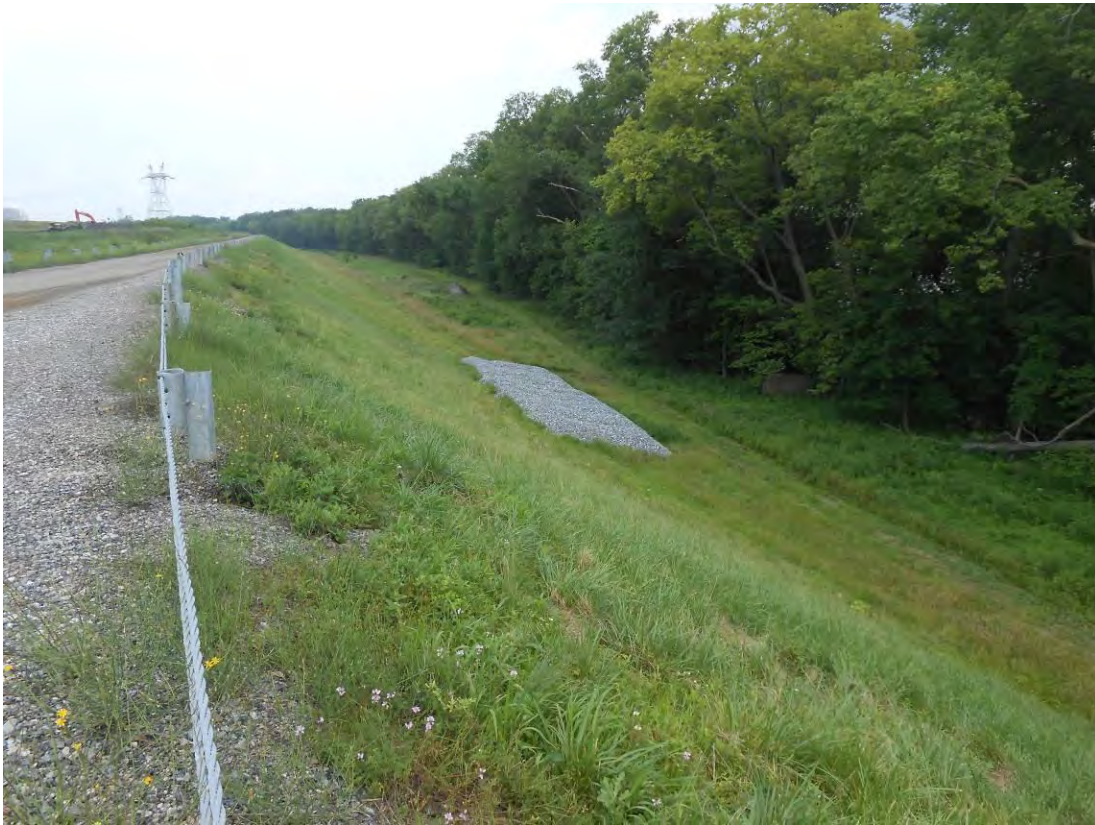
The slough repair areas on the downstream embankment mentioned in prior reports were re-vegetated. These were located at Stations 0+20 to 0+50 (such as that seen in Photo 2), 21+70 to 22+10, 22+20 to 24+00 (seen in Photos 7 and 8), 25+20, and 26+00. The sloughs were previously estimated to be less than 3 feet deep and extended to within 6 feet of the crest. There was no evidence of recent movement of these sloughs.

Photo 2 – Downstream slope of the east embankment, looking north from the south end, south of Station 0+00. A seepage blanket, shown in the middle of the photo, has been installed at the toe of the slope, which has historically been wet.

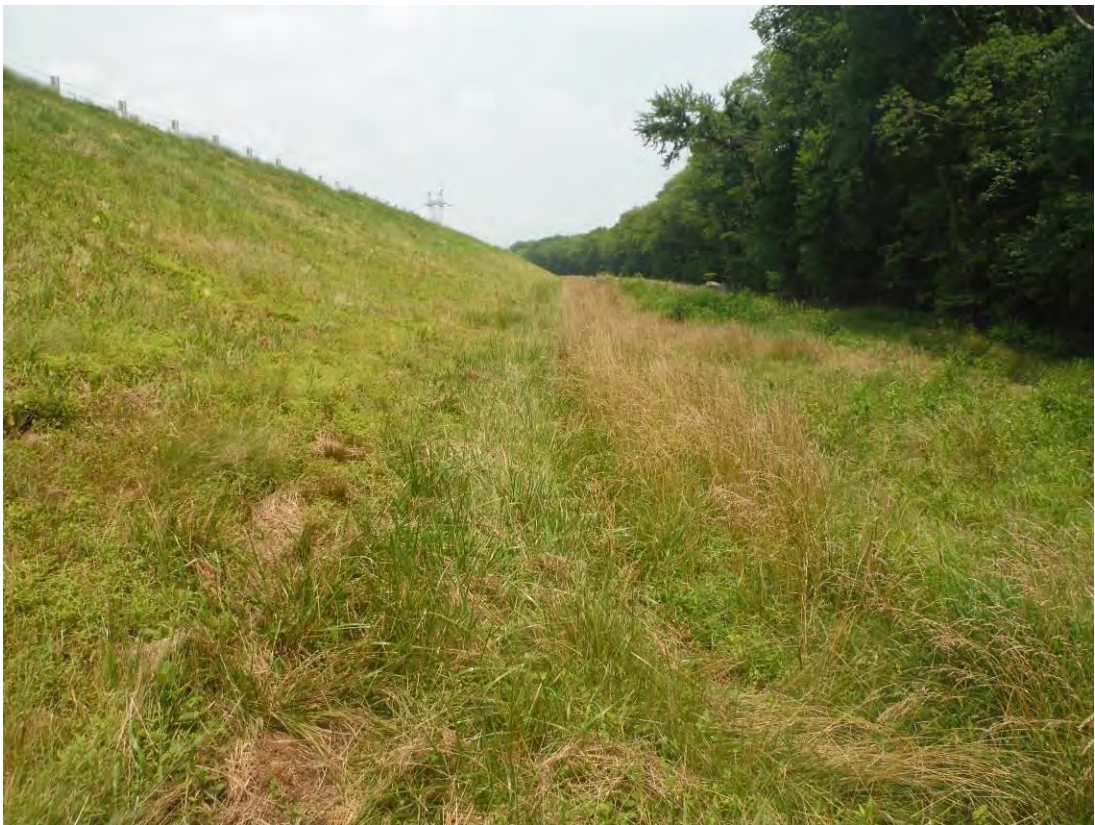
Much of the toe of the embankment was wet. Standing water was observed in ruts and depressions intermittently along the toe of the embankment. Wet soil, extending 3 to 8 feet vertically up the slope, was observed at Sta. 1+50 and between Sta. 16+80 and 17+60, such

as that seen in Photo 4. No flow or evidence of piping was observed at any of these locations. A new stone filter blanket was installed between Stations 0+75 and 1+50 to address the wet area observed at the south end of the east embankment. The filter blanket extends about 20 feet upslope and is about 3 feet thick.

Photo 3 – Looking north at a wet area at the toe of the east embankment at about Station 1+50. Wet soils extended about 3 feet vertically up the slope.

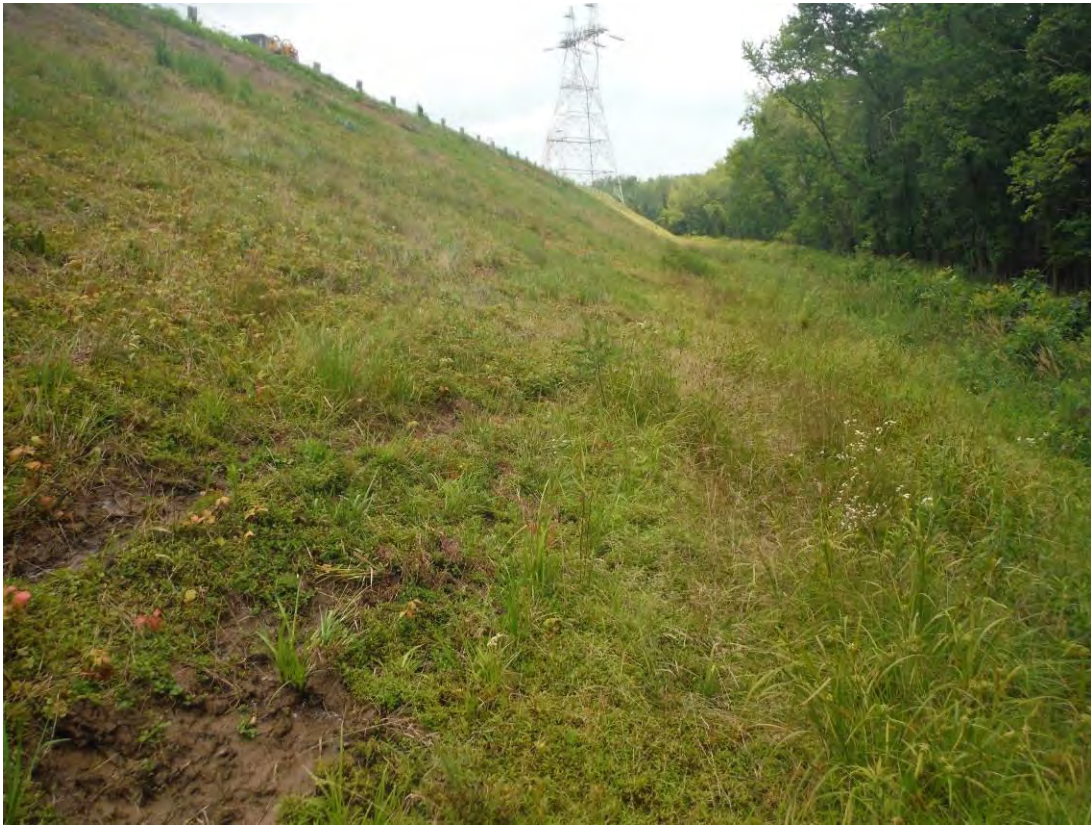
Photo 4 – Toe of the east embankment at about Station 16+00. Wet soil extended up to 8 feet vertically up the slope between Stations 16+80 and 17+60.

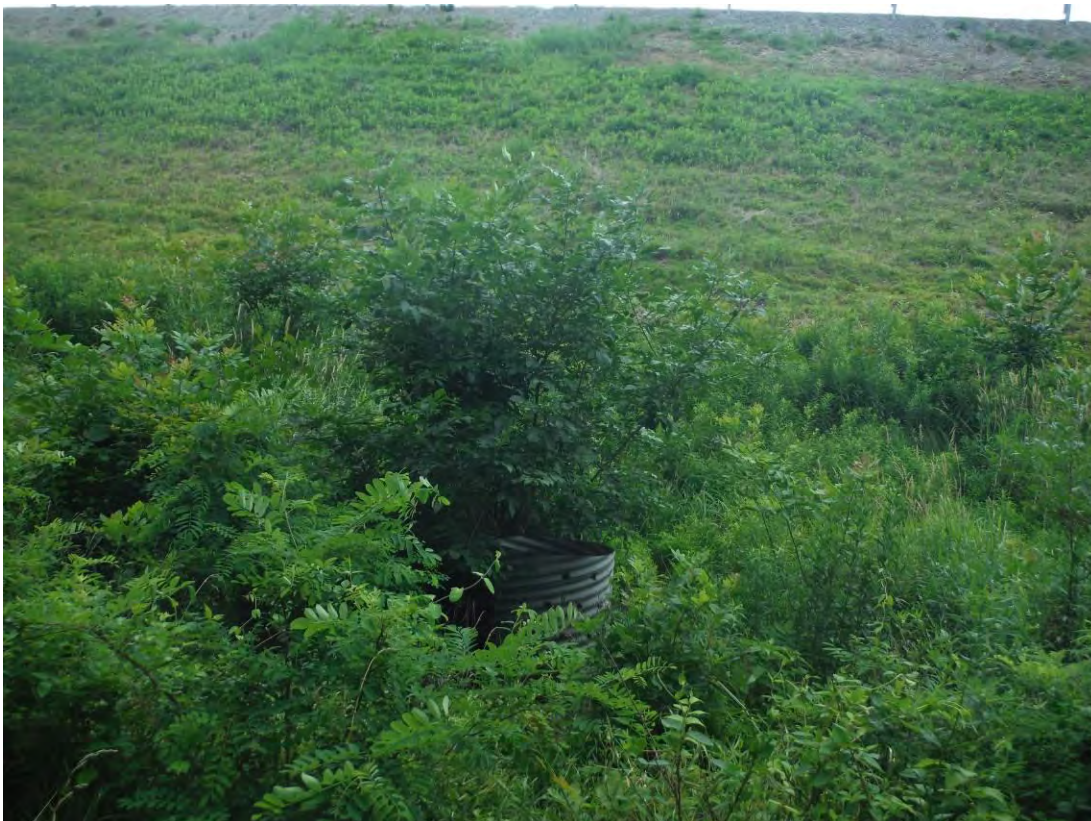
Photo 5 – Abandoned drainage structure in the ditch at the toe of the east embankment at about Station 16+00.

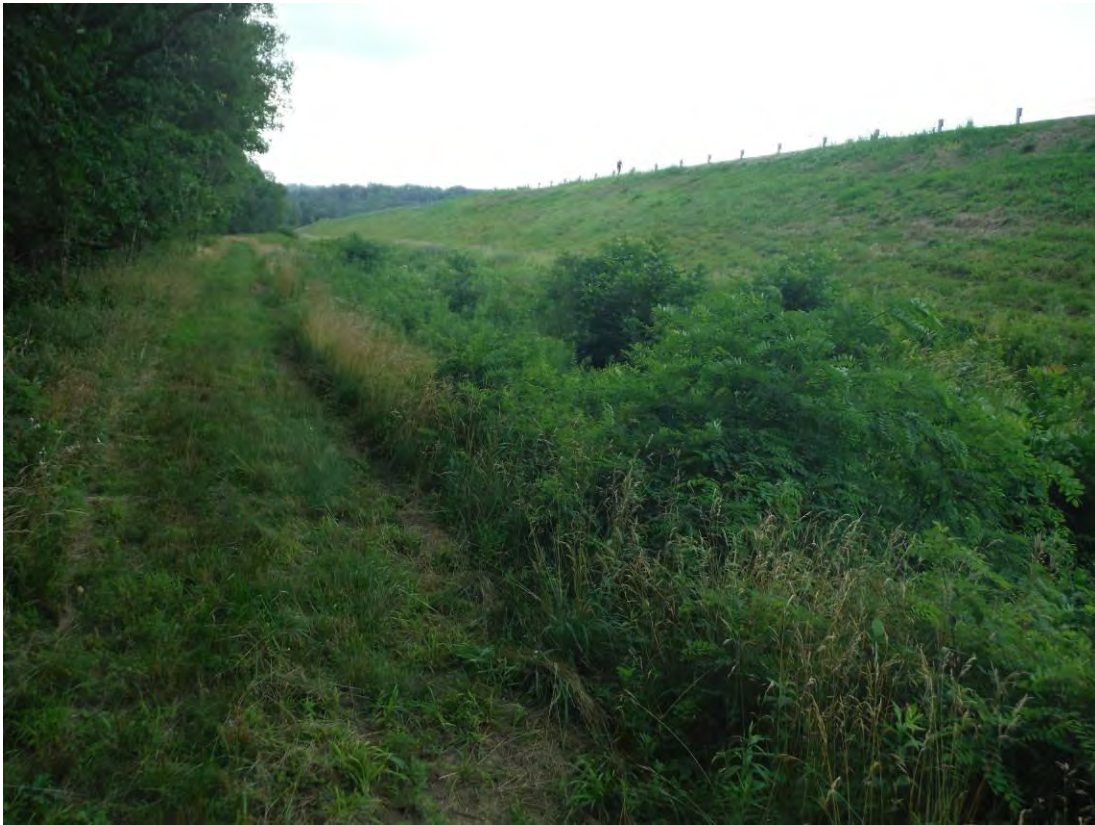
Photo 6 – East embankment looking south near Station 16+00. Heavy vegetation at toe indicates a wet area where equipment could not operate.

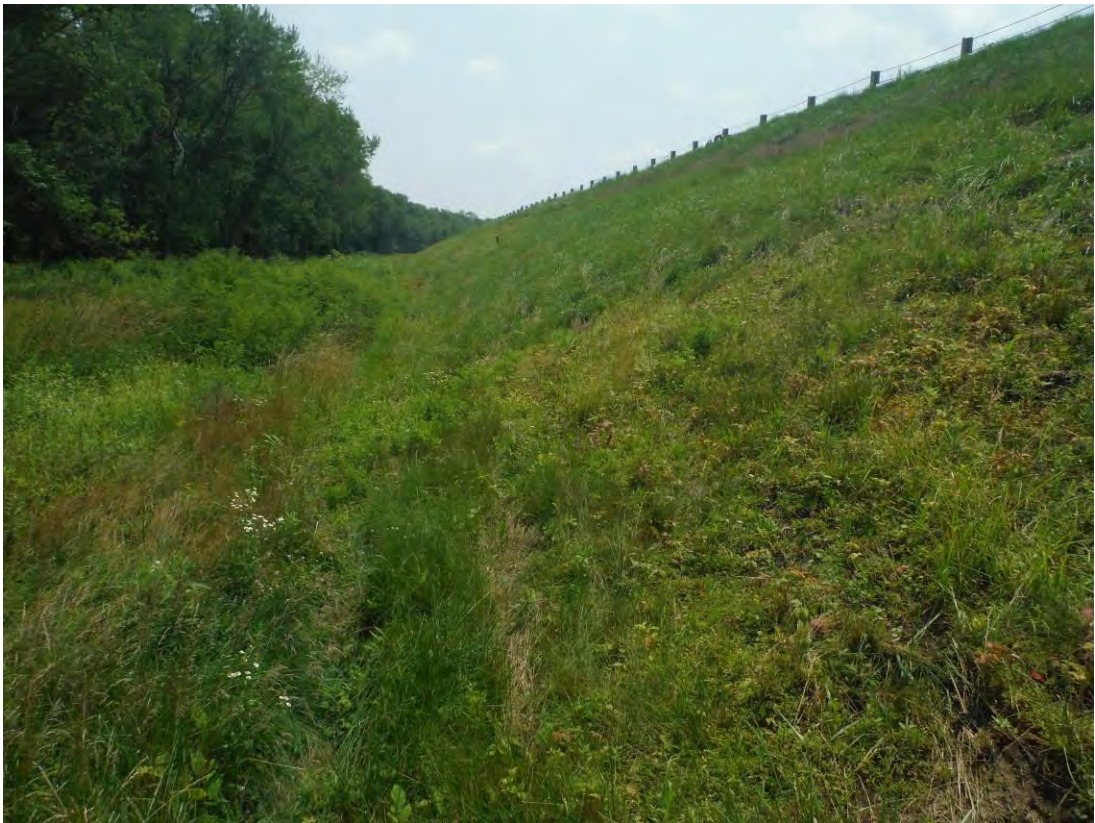
Photo 7 – East embankment looking south from about Station 24+00 at an area where previous sloughs had been repaired and re-vegetated.

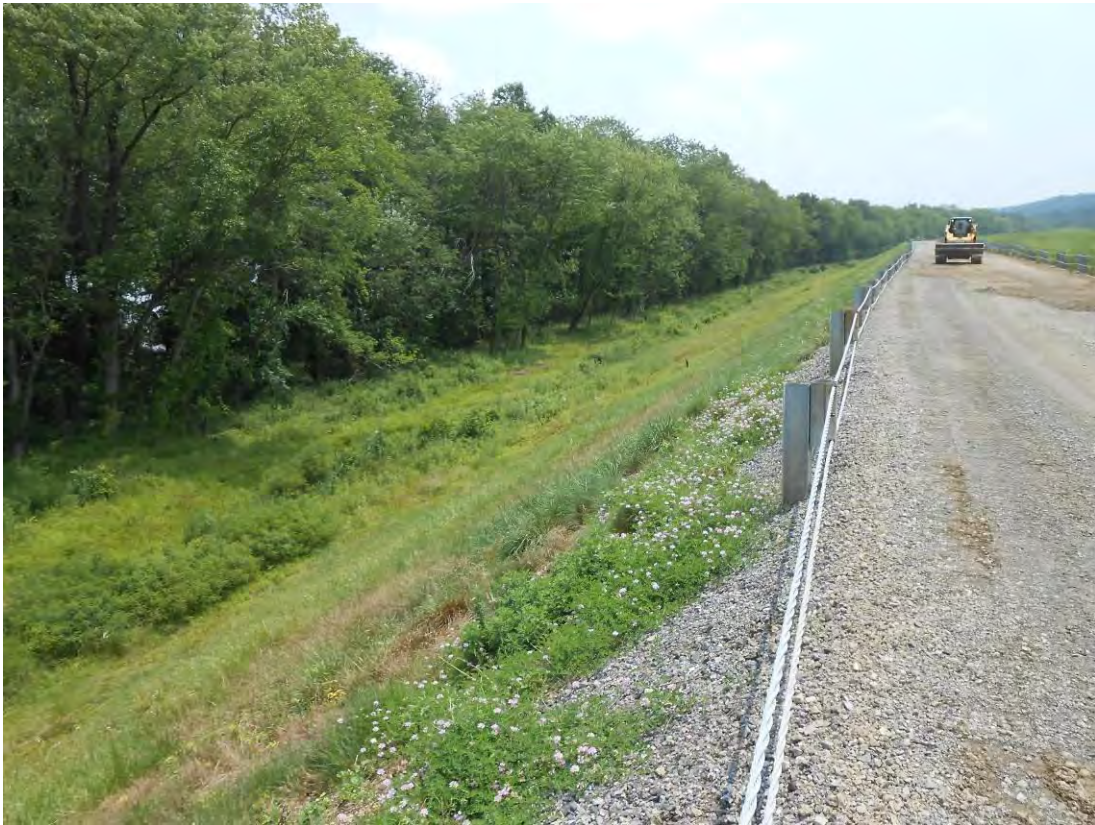
Photo 8 – East embankment looking south from about Station 23+50, showing repairs of previous sloughing on the downstream slope and the recently raised gravel crest.

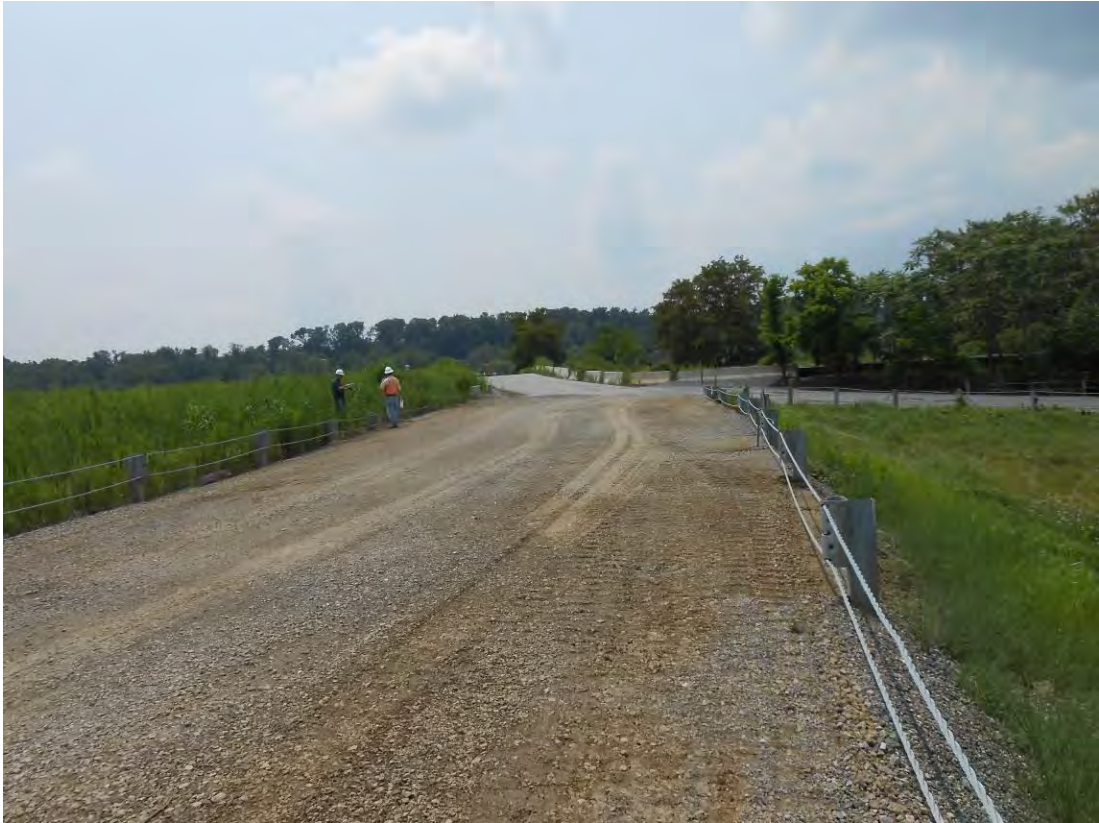
The crest of the embankment, which was recently raised to the nominal design elevation of 290 feet, consisted of a gravelly surface and can be seen in Photos 2, 8, and 10. No evidence of movement, settlement, cracking, or other distress was observed. Minor erosion rills were observed along the downstream edge of the crest as seen in Photo 36. The condition of the roadway crest was consistent around the entire ash basin. Talen periodically regrades the access road and repairs the erosion rills.

Photo 10 – Crest of the north embankment at the northeast corner of the basin. The crest was raised to the design elevation of 290 feet in 2014.

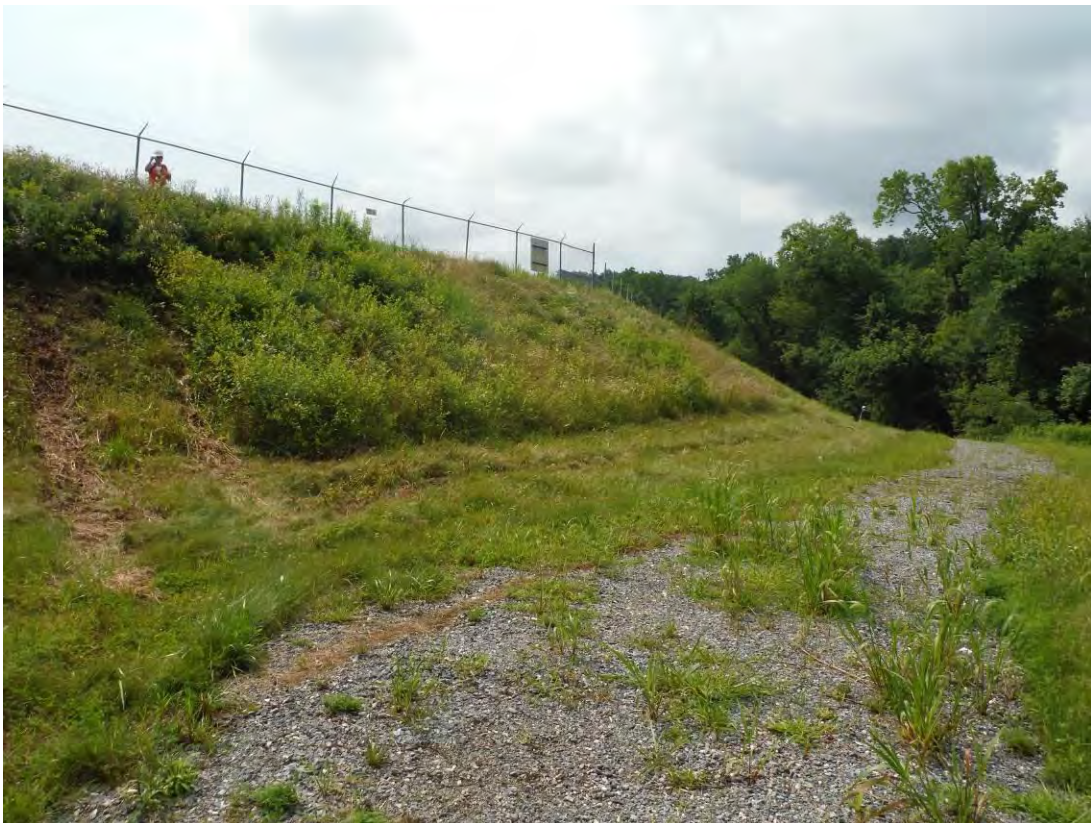
Photo 11 – Downstream slope of the north embankment near the northwest corner, showing a section of the slope where vegetation was not recently cut.

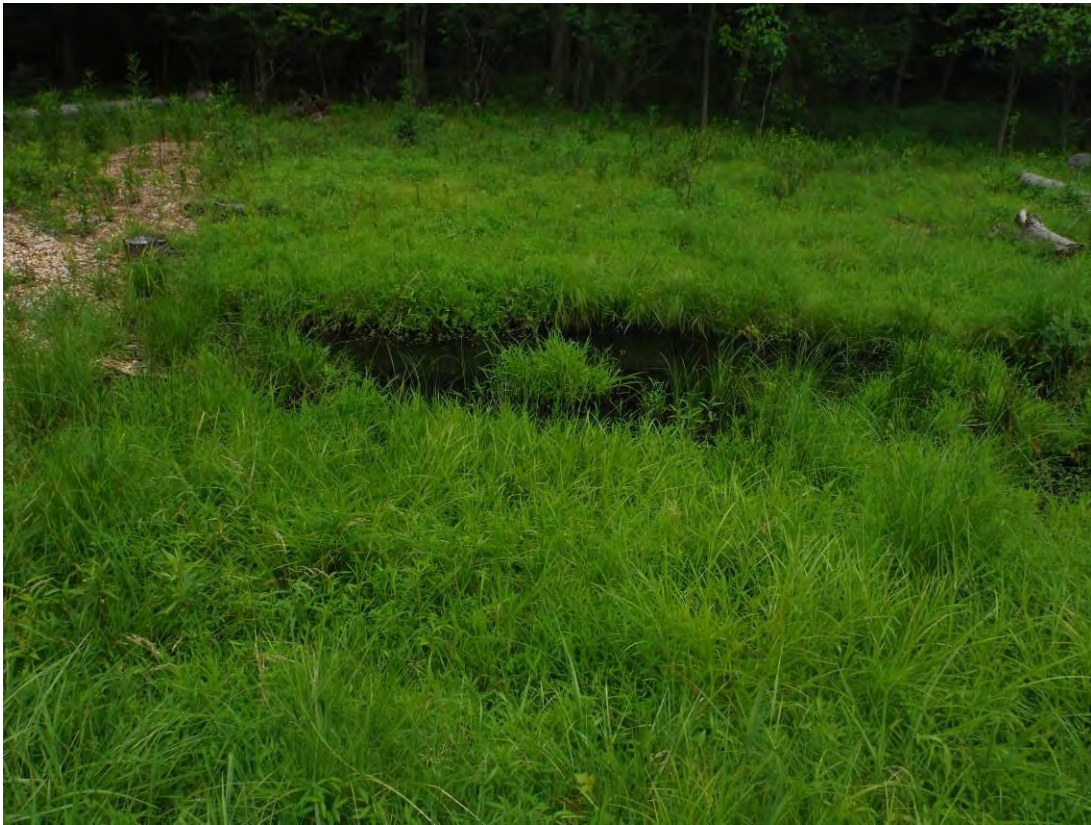
Photo 14 – Pool of stagnant standing water at the toe of the downstream slope of the polishing pond.

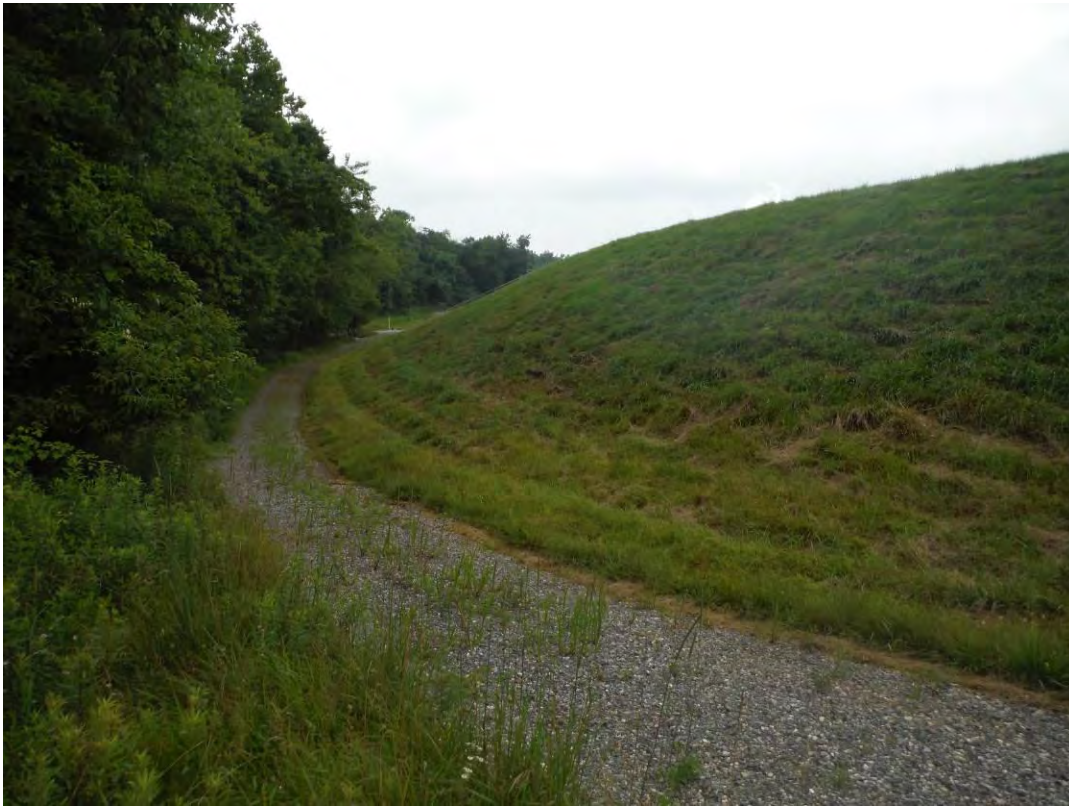
Photo 20 – Toe of the west embankment where significant disturbance was observed in 2011. The area has been regraded and reseeded. Wet soils and rutting were observed previously. A new gravel access road was installed along the toe in 2015.

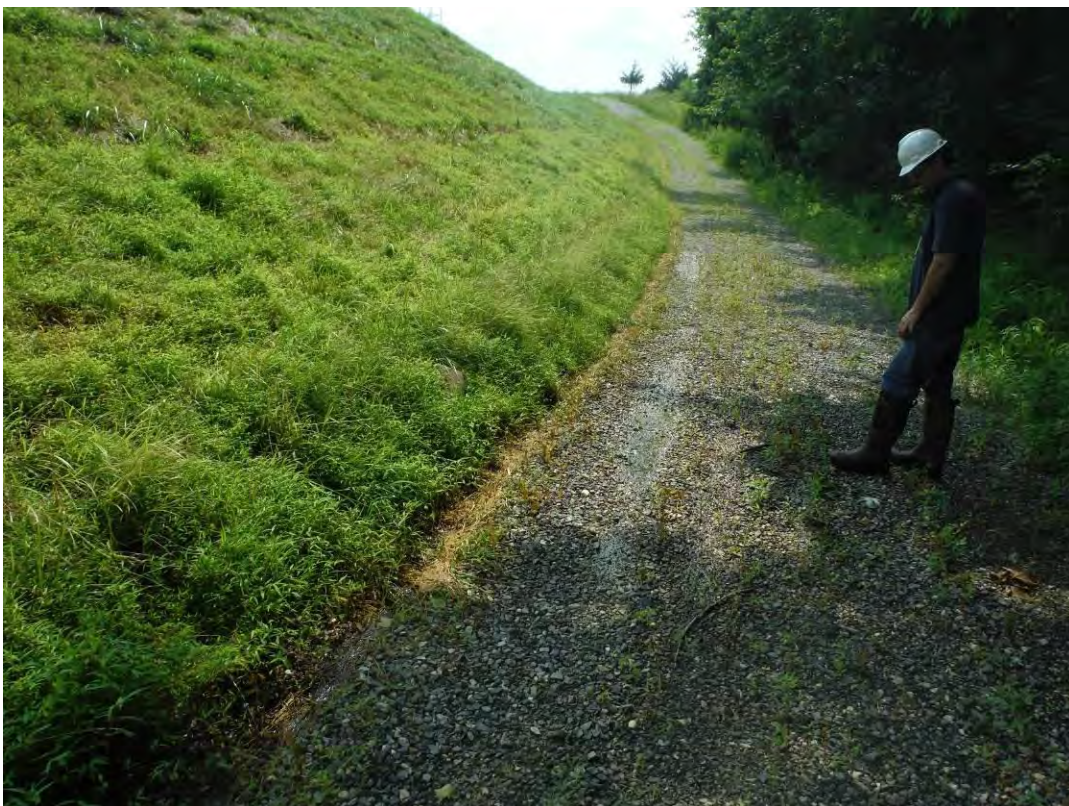
Photo 21 – Wet area with standing water at the north end of the west embankment in a previously disturbed area that had been restored.

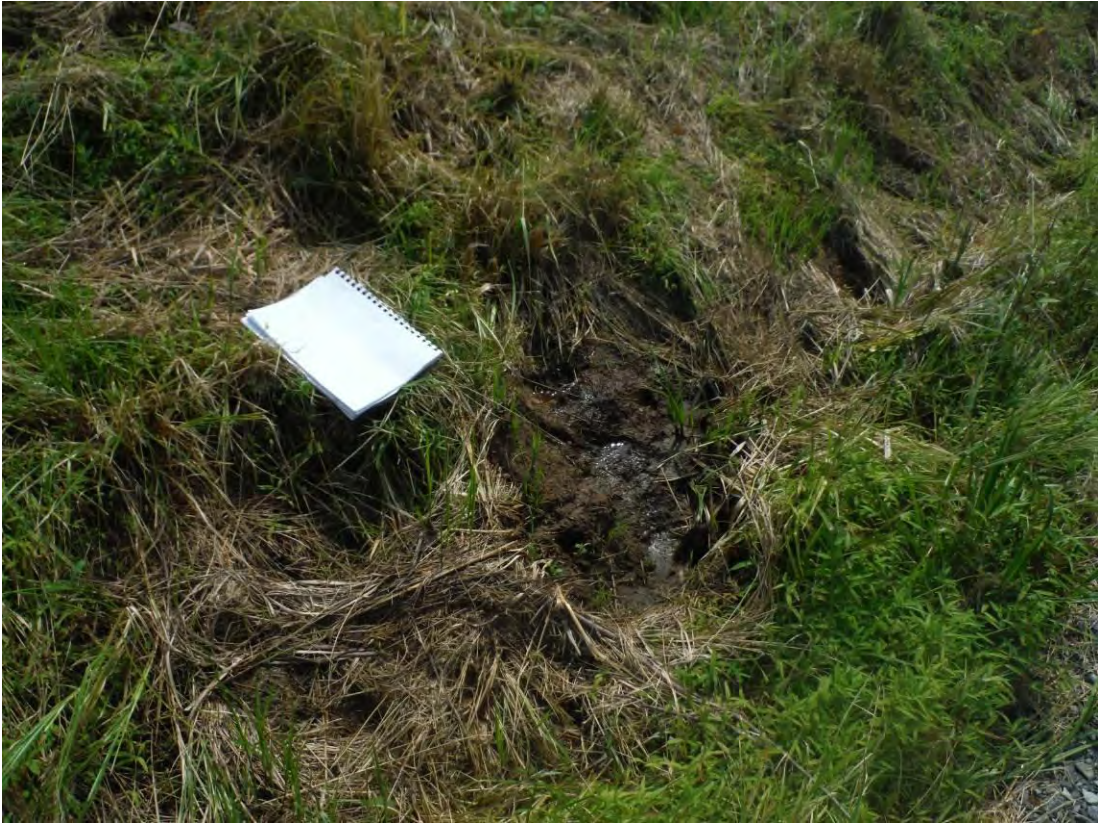
Photo 22 – Standing water in ruts at the toe of the slope at the north end of the west embankment.

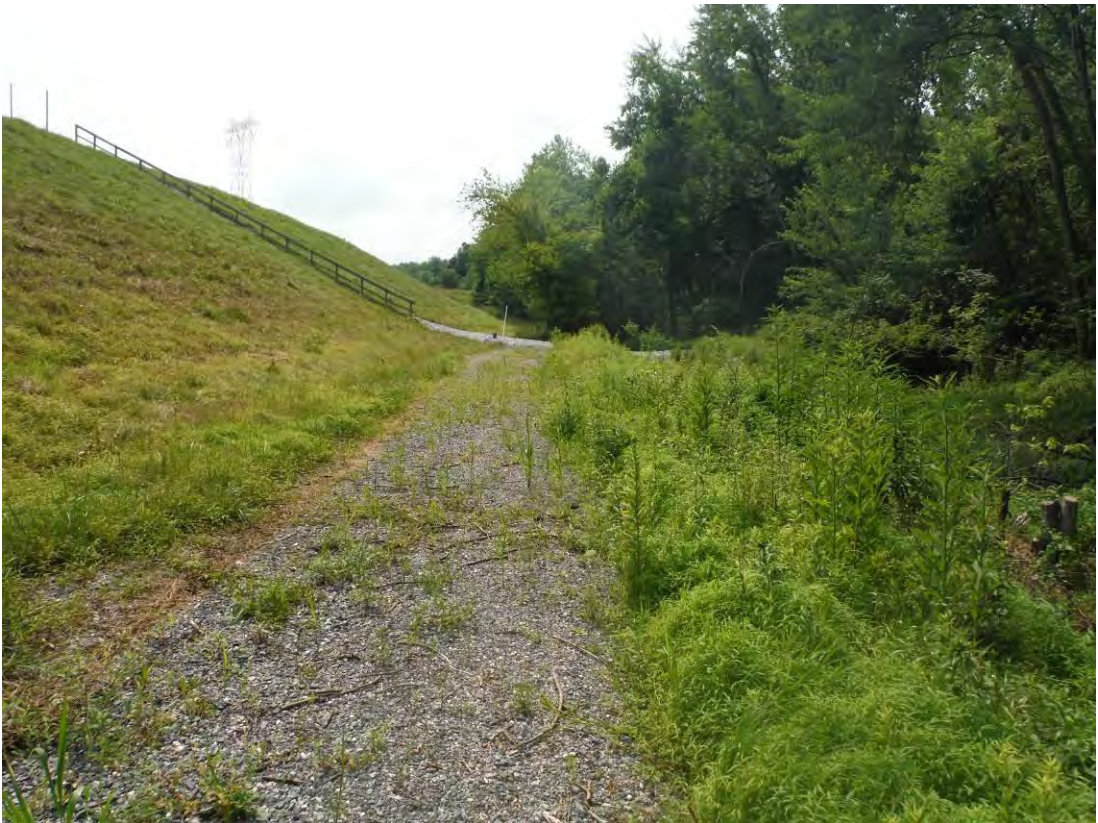
Photo 23 – Access road and grading for Monitoring Well No. 6 at the toe of the west embankment near the north end, showing irregular ground, thick vegetation and stumps.

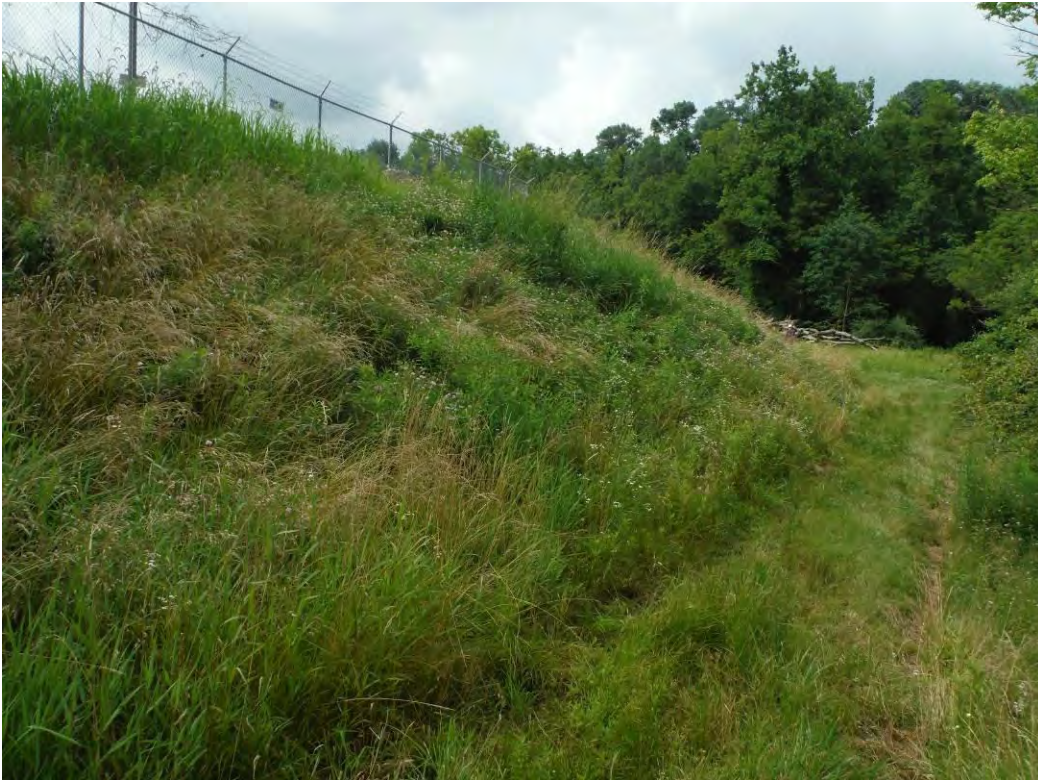
Photo 24 – Downstream slope of the west embankment near the north end, where an old slough was repaired. Grass on slope was chest high and downed trees had not been cleared.

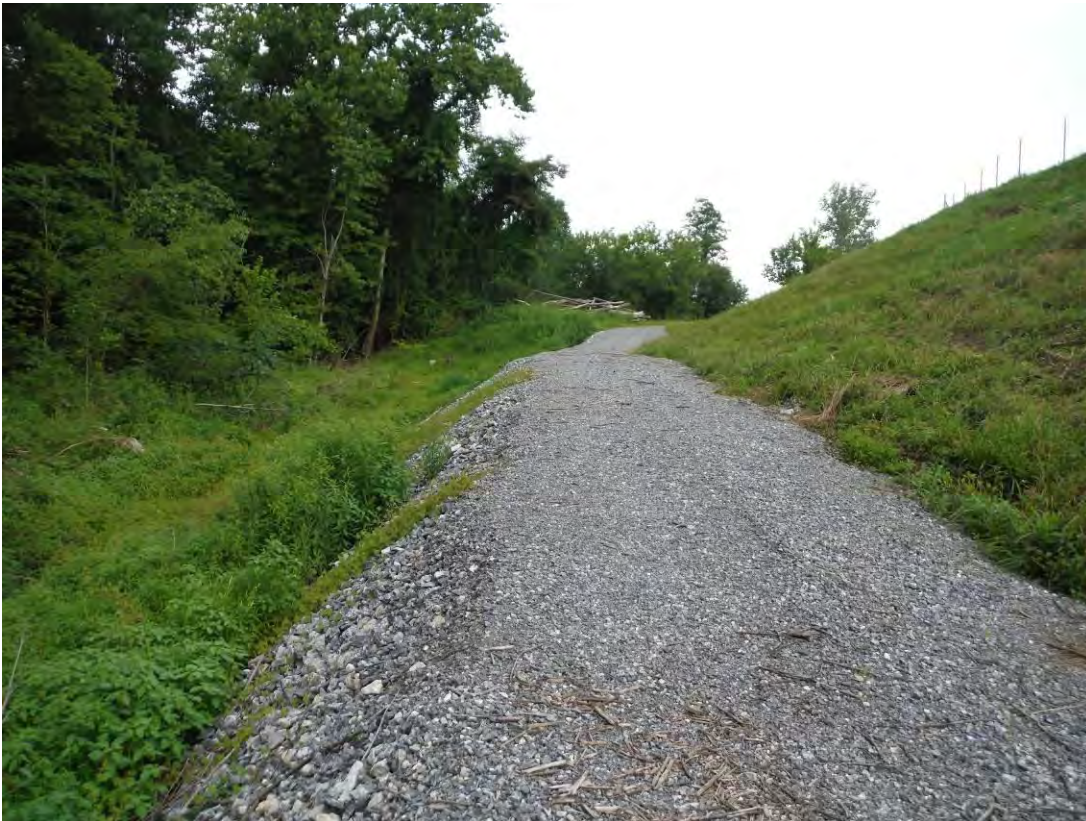
Photo 25 – Area of historic slough at the north end of the west embankment which was recently repaired. An access road with a stone berm was recently constructed. Note vegetation at toe.

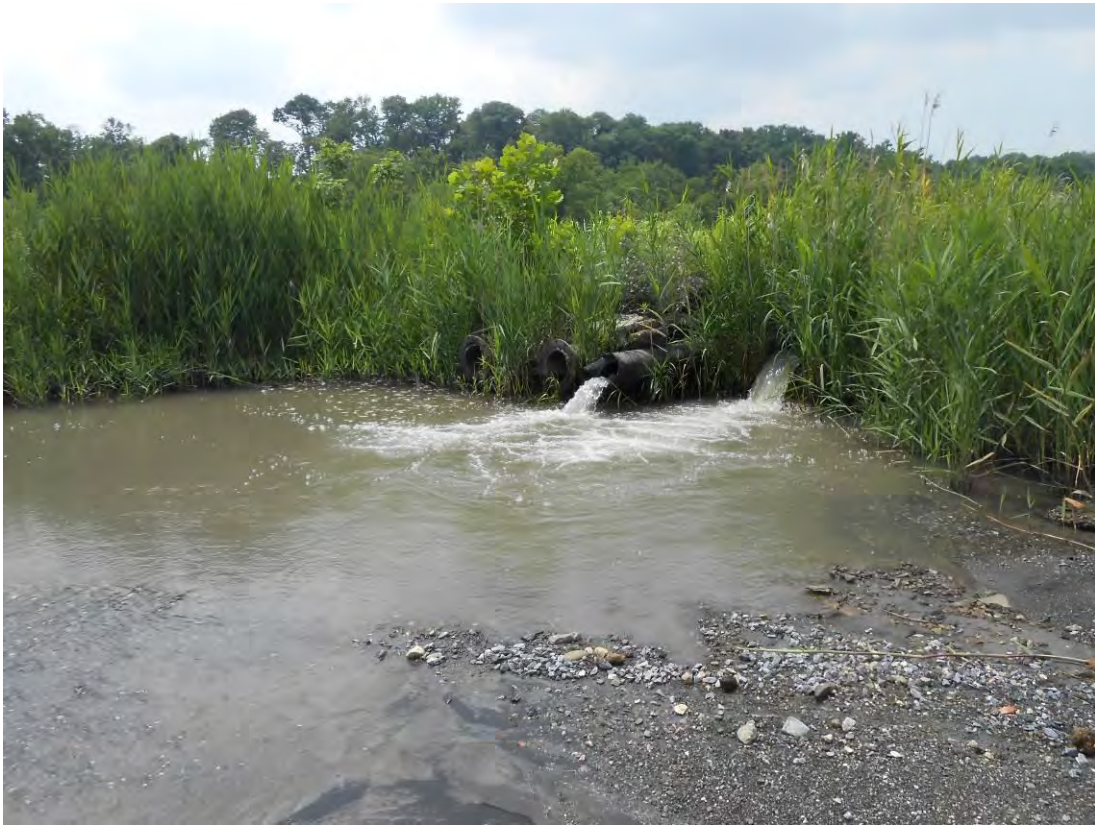
The former ash discharge sluices are located near the northwest corner of the basin. The discharges consist of three pipes that currently discharge process water into an open pool, seen in Photo 28. Although ash sluicing has been discontinued, the discharge sluices are still used to discharge process water from the steam plant dewatering troughs, and the discharge pool was still full of water. As noted previously, a separate discharge pipe for equalization pond process water is located near the northeast end of the basin, which is also still in service. The discharge channel for this pipe was cleared. Talen reportedly monitors the discharge area daily for evidence of flow backing up. An old 12-inch floating fly ash pipeline was observed along the east slope, extending to the basin. Talen confirmed this pipeline is abandoned. An emergency swale was installed which would convey the equalization pond discharge to open water if the normal swale becomes blocked.

Photo 28 – Former ash slurry discharge location near the northwest corner of the basin. The discharge pipes in the center of the photo are still being used to discharge process water.

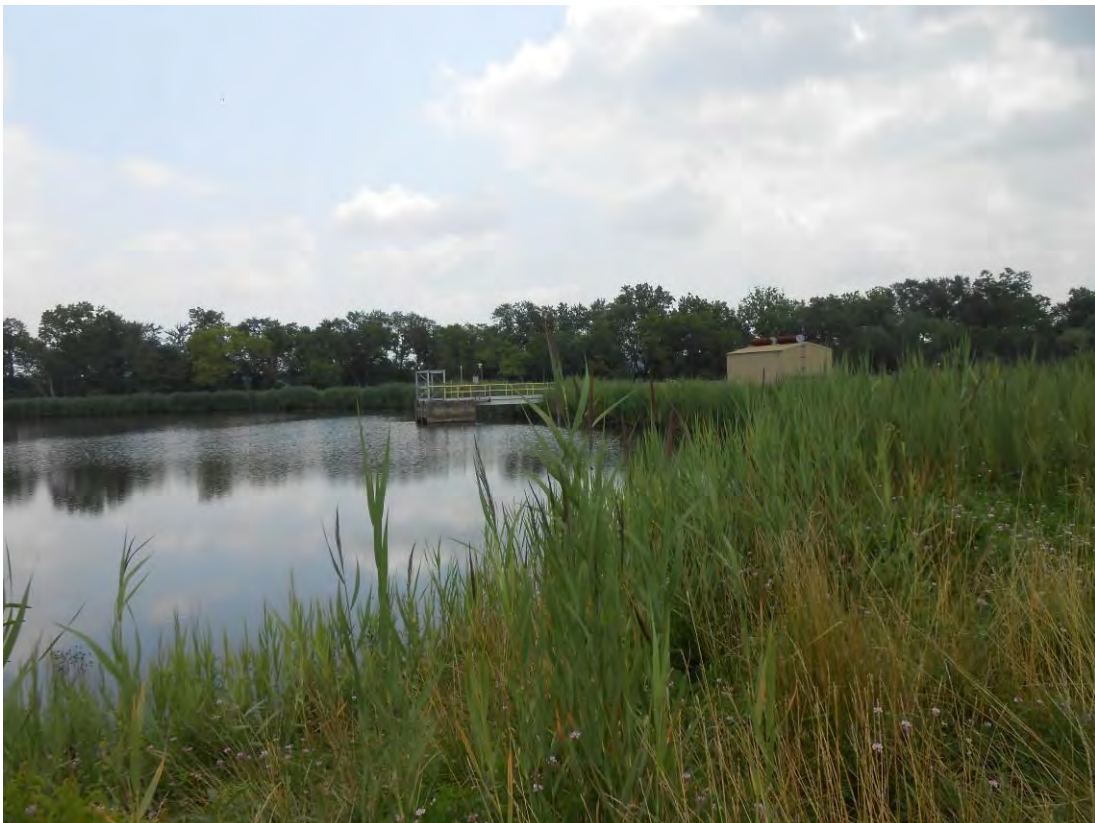
The outlet structure located between the main basin and the polishing pond was in good condition and can be seen in Photo 29. The splitter dike between the main basin and the polishing pond can be seen in Photos 30, 31, and 32. The concrete appeared to be in good condition, and the skimmer gate appeared to be new. The walkway paint showed some signs of deterioration, although the walkway itself was sound. New winches with stainless cable were installed within the last 5 years to suspend the skimmer gates at the outlet structure. Two 9-inch-high stoplogs had been removed since the previous inspection, lowering the impoundment level by 18 inches. The top of stoplog elevation was 284.25 feet at the time of the inspection, and the impoundment water surface elevation was 284.75 feet. Talen reported that an additional stoplog was removed in the fall of 2015, after the 2015 inspection, with the top of stoplog elevation now 283.5 feet and the normal reservoir surface elevation at 284.2 feet. The skimmer gates were out of the water at the time of inspection.

Photo 29 – Outlet structure between basin and polishing pond.

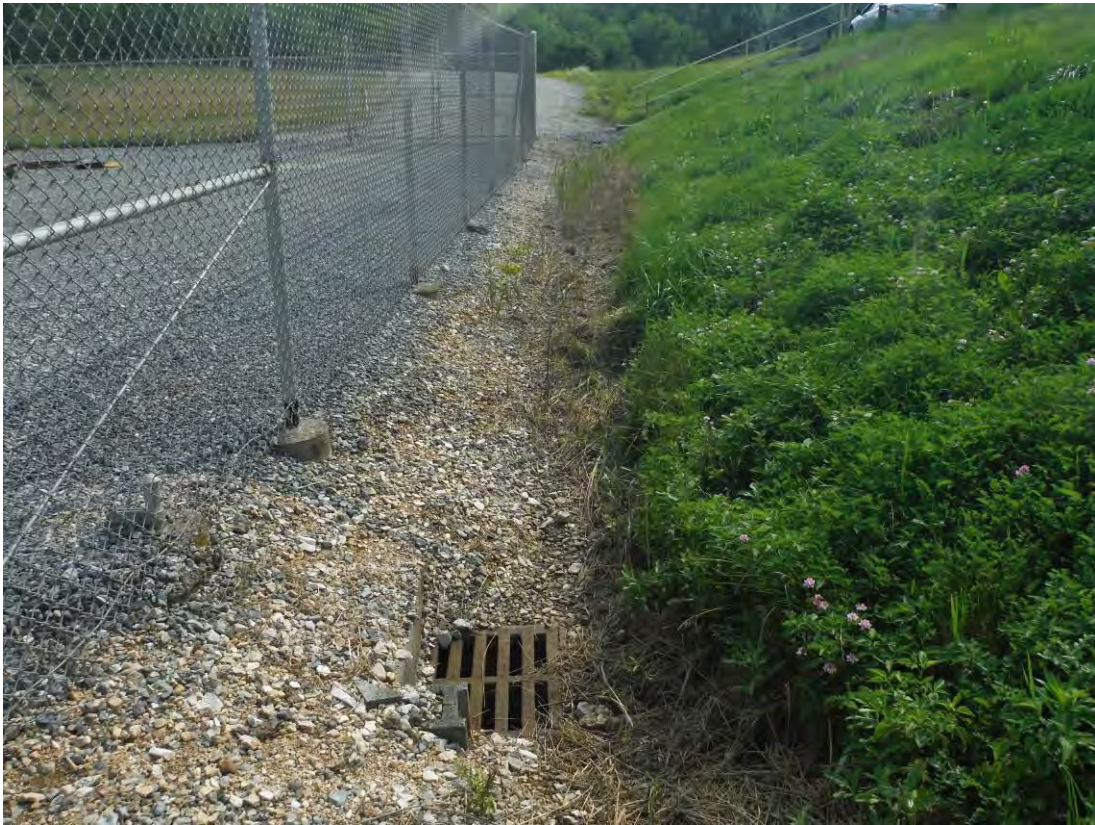
Photo 32 – Catch basin and ditch at the median dike, which has grown in and should be maintained.

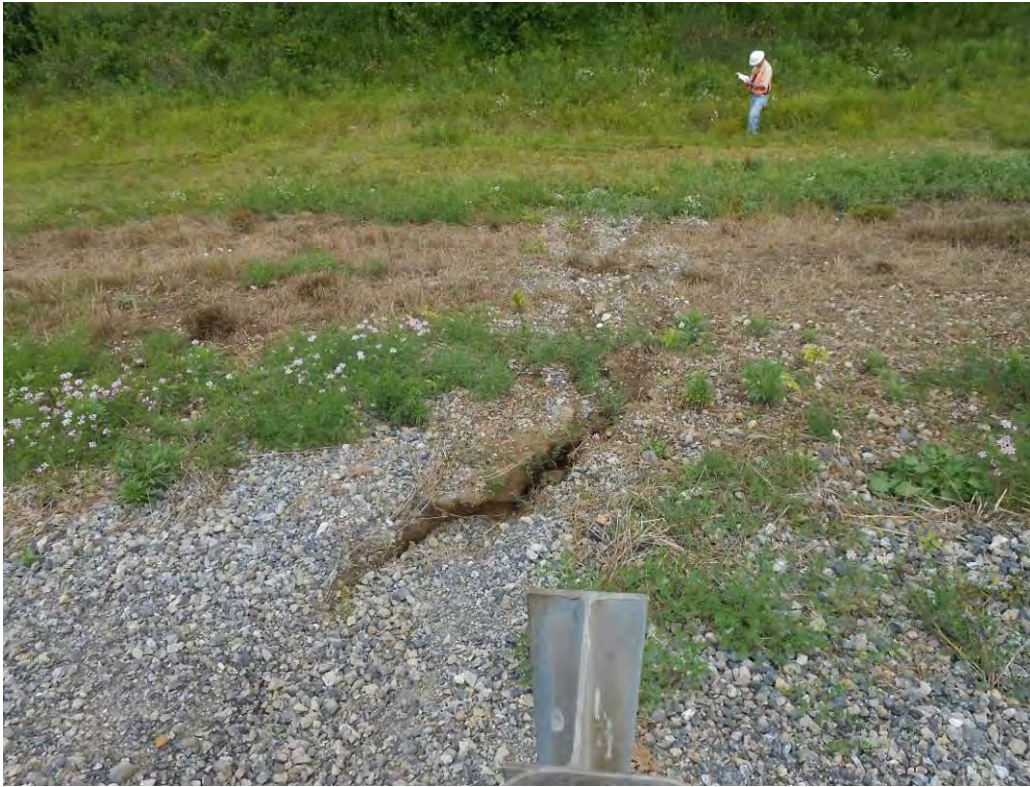
Photo 36 – Typical erosion rills observed at the top of the east and south embankments, where the crest was recently raised. This erosion rill is approximately located at STA. 18+40 on the east embankment.

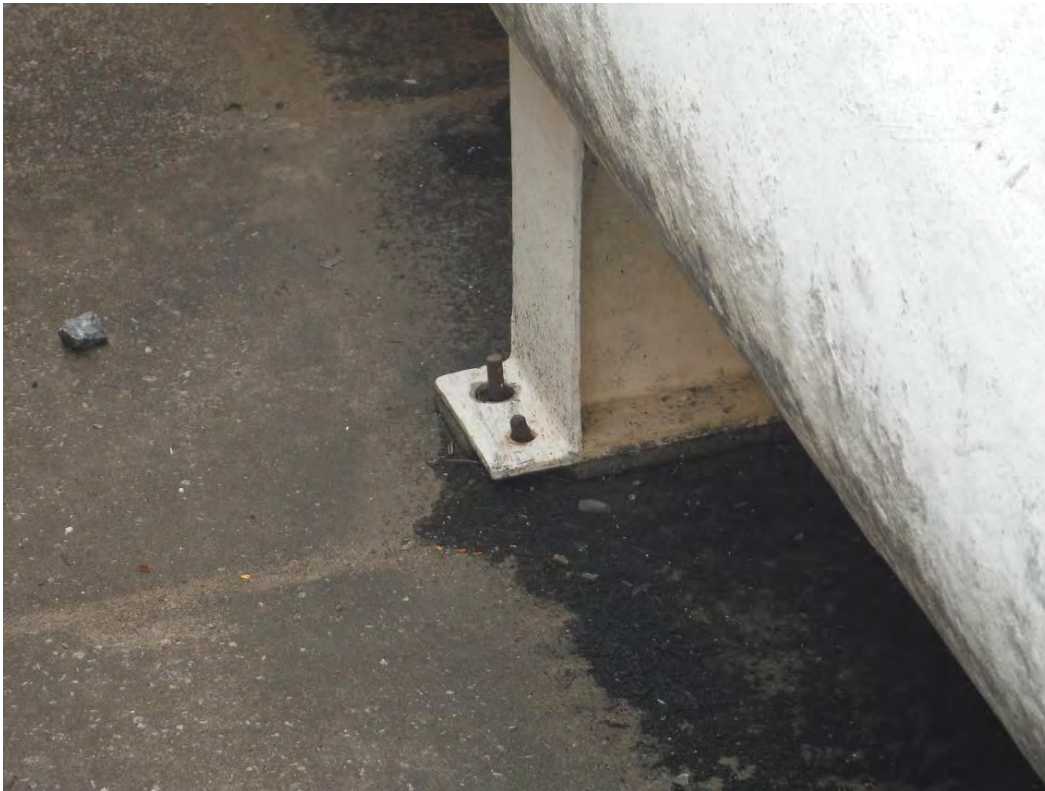
Missing nuts were observed on the bolts on the saddles of the discharge pipeline through the splitter dike, from the main basin to the polishing pond as seen in Photo 38. This is not typically a concern under normal or flood conditions but could result in movement or damage to the outlet pipe during earthquakes.

Photo 38 – Missing nuts observed on most of the bolts on the saddles of the discharge pipeline to the polishing pond.

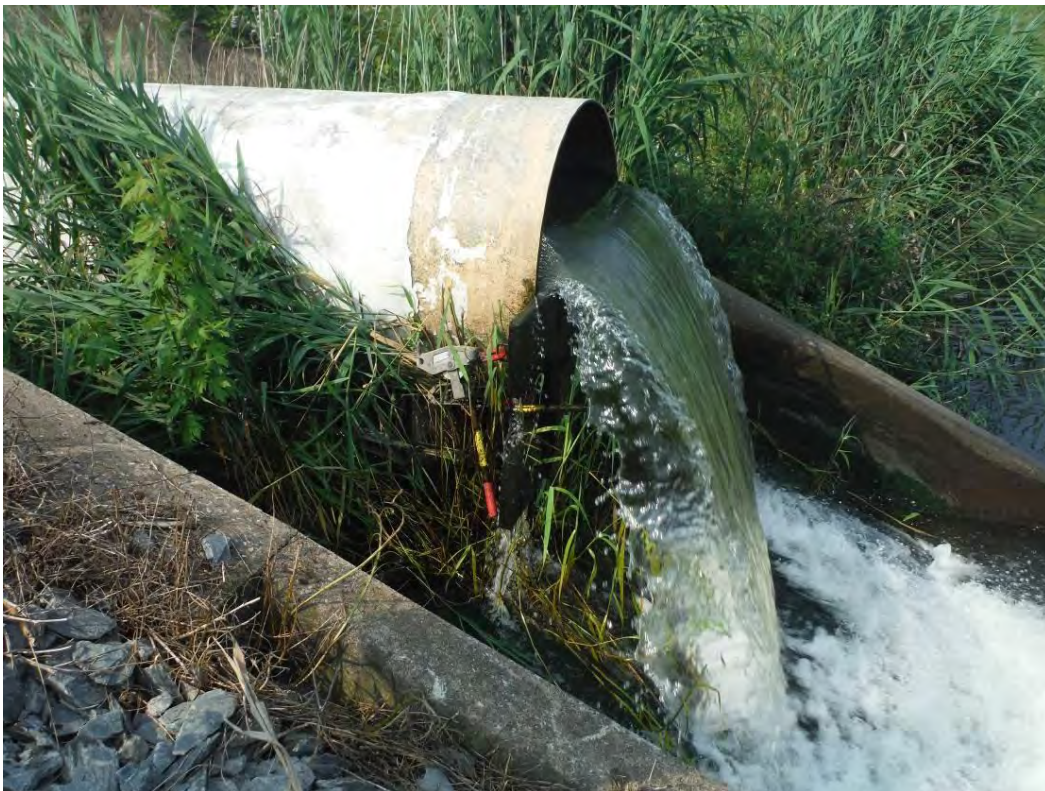
The discharge pipe through the splitter dike was observed to be 2/3 blocked with a timber exit weir as shown in Photo 39. Talen reported that this weir is in place to raise the water level in the pipe to allow chemistry and water quality testing but that it can be removed in the event of a flood to achieve full capacity.

Photo 39 – Discharge pipe through the median dike observed to be 2/3 blocked with a timber exit weir. The spillway adequacy analysis assumed this discharge structure to be at full capacity. Maintenance staff were aware that the weir needs to be removed during a flood.
