January 15, 2016

390/265831

Mr. Benjamin Wilburn, P.E.  
Senior Engineer  
Fossil and Hydro Support  
Talen Generation, LLC  
835 Hamilton Street, Suite 150  
Allentown, PA 18101

**Subject: 2015 Annual (Initial) USEPA CCR Landfill Inspection Report  
Montour Ash Disposal Area No. 3**

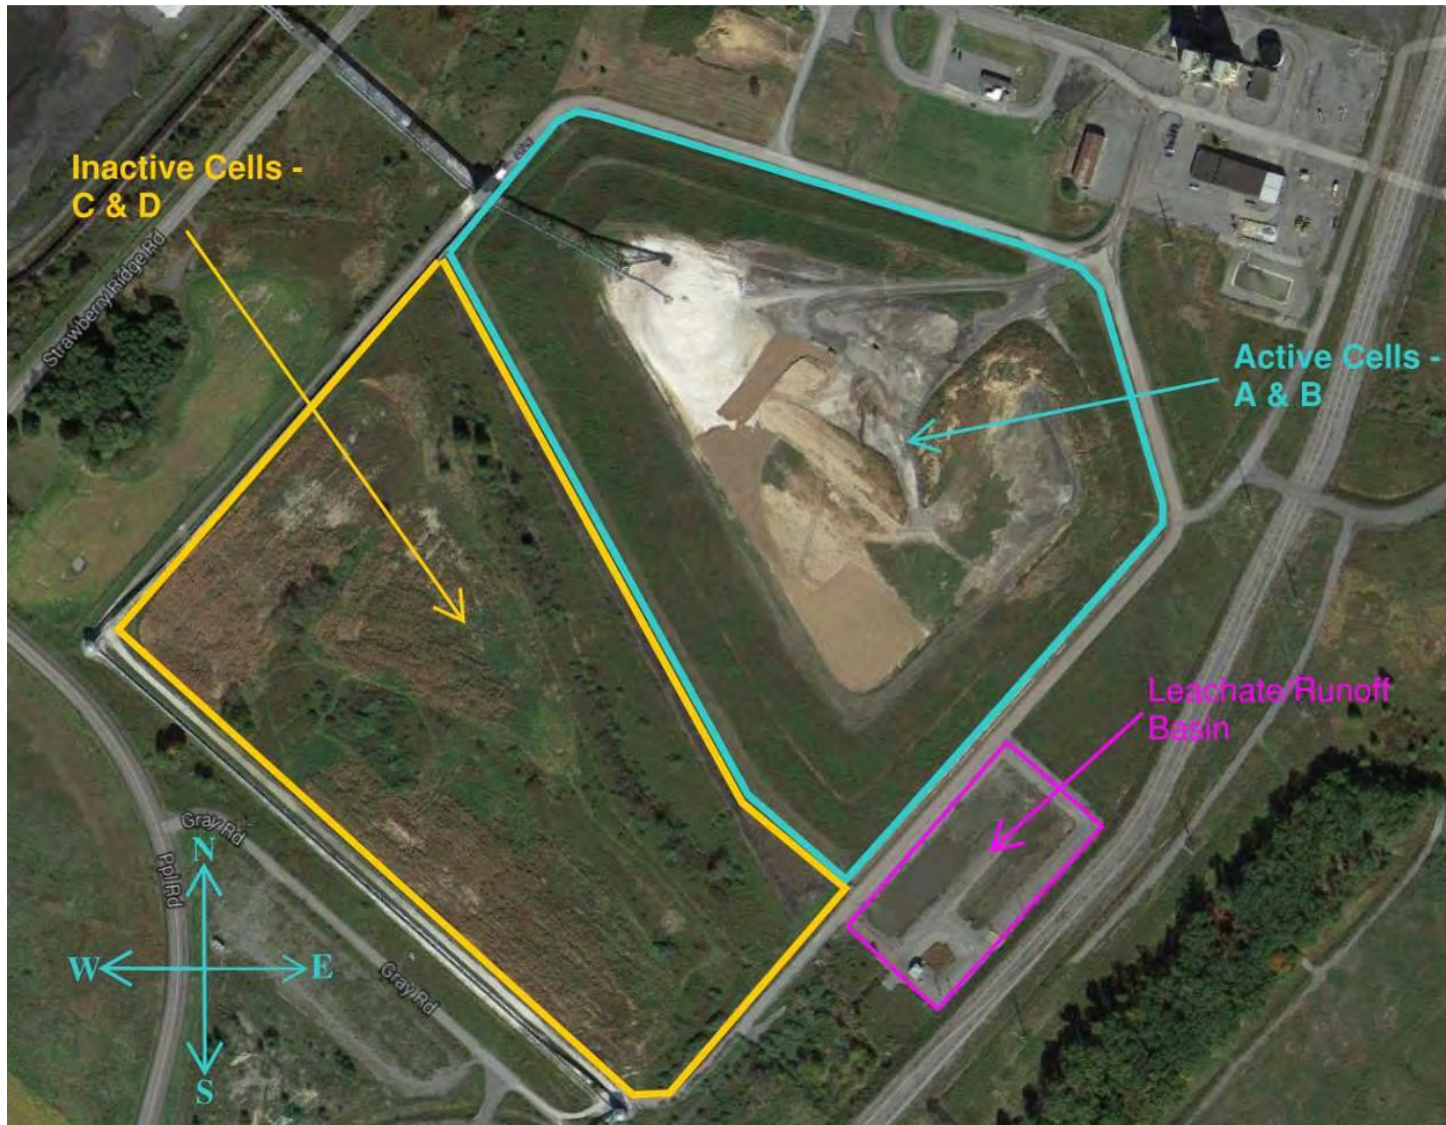
Photo 1 - Aerial view of Montour Ash Area No. 3. Cells A and B, which are actively being filled, can be seen in the center. Construction of Cells C and D has not yet started.

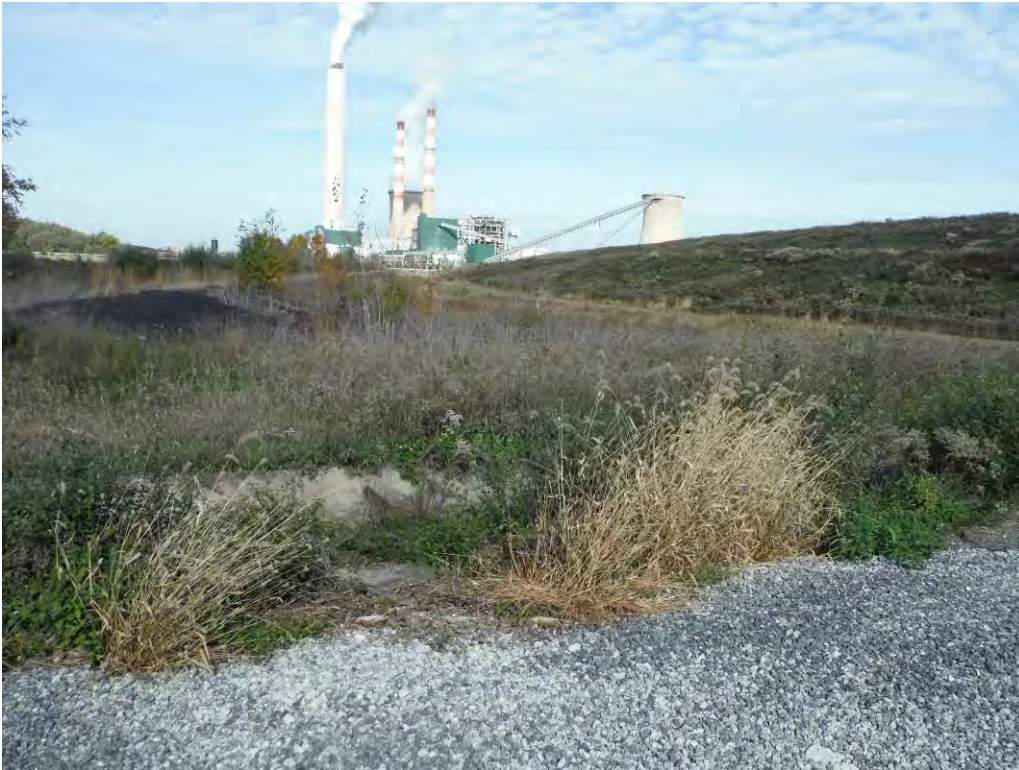
A perimeter swale extends around the entire Landfill and drains to the leachate/run off basin. Thick vegetation along the west, east, and north perimeter swales, seen in Photos 2, 4, and 5, as well as along the entire bench at approximate elevation 539 feet, will likely retard flow and reduce the hydraulic capacity of the system with respect to the design calculations. The effect of the vegetation currently growing in the swales should be checked with respect to the assumptions in the calculations and what was shown on the drawings, and cut as necessary. Debris and irregularities within the swales, particularly along the east and north swales, should be cleared. This includes a number of erosion rills along both banks of the east perimeter swale.

Photo 2 – West edge of Active Cells A and B. The berm to the left of the photo separates active Cells A-B from Cells C-D, which have not yet been constructed. The berm overlies the two 48-inch pipes that divert an existing stream through the Landfill footprint.

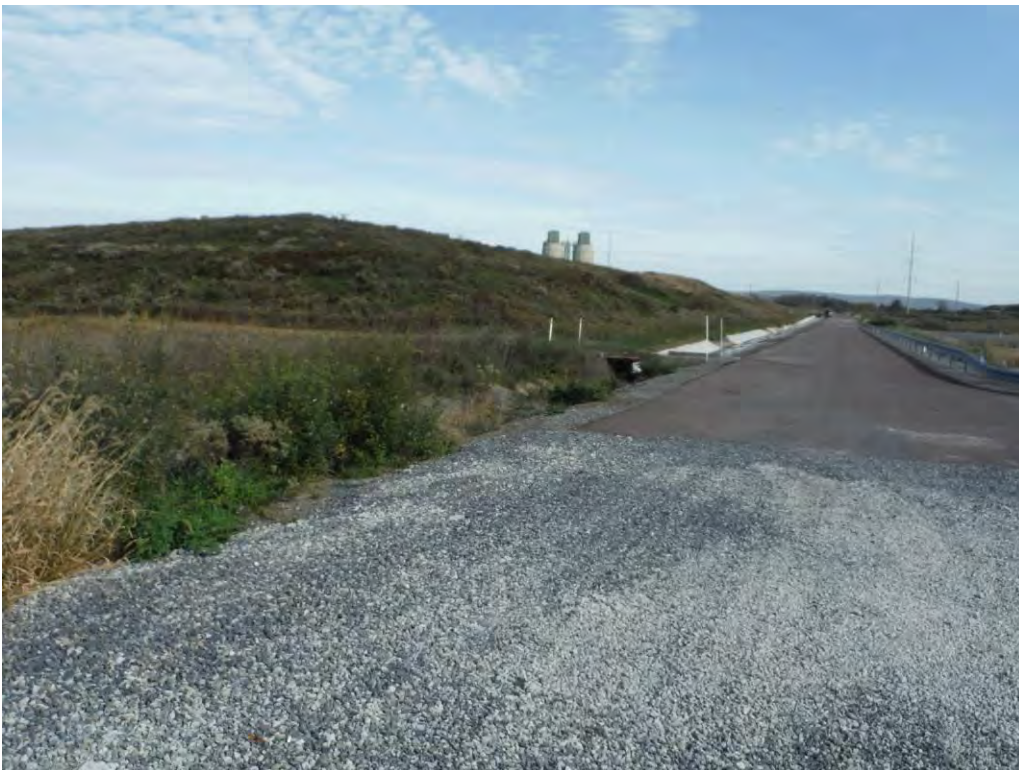
Photo 3 – Southwest corner of Cell A.

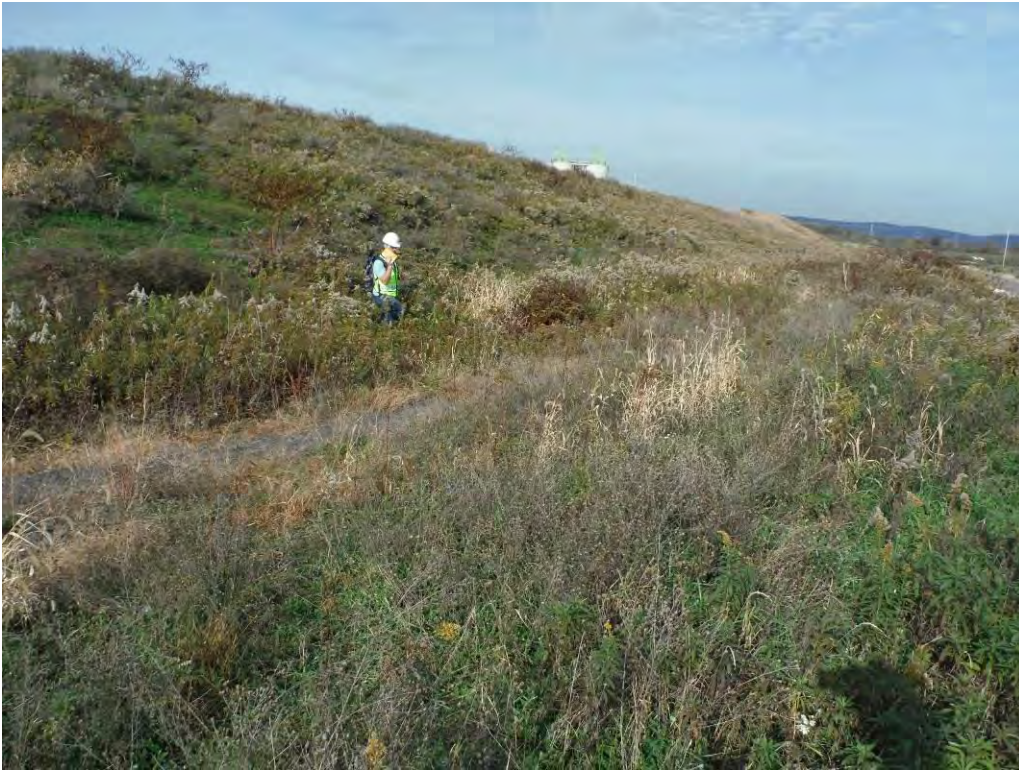
Photo 4 – East side of Cells A and B, showing heavy vegetation.

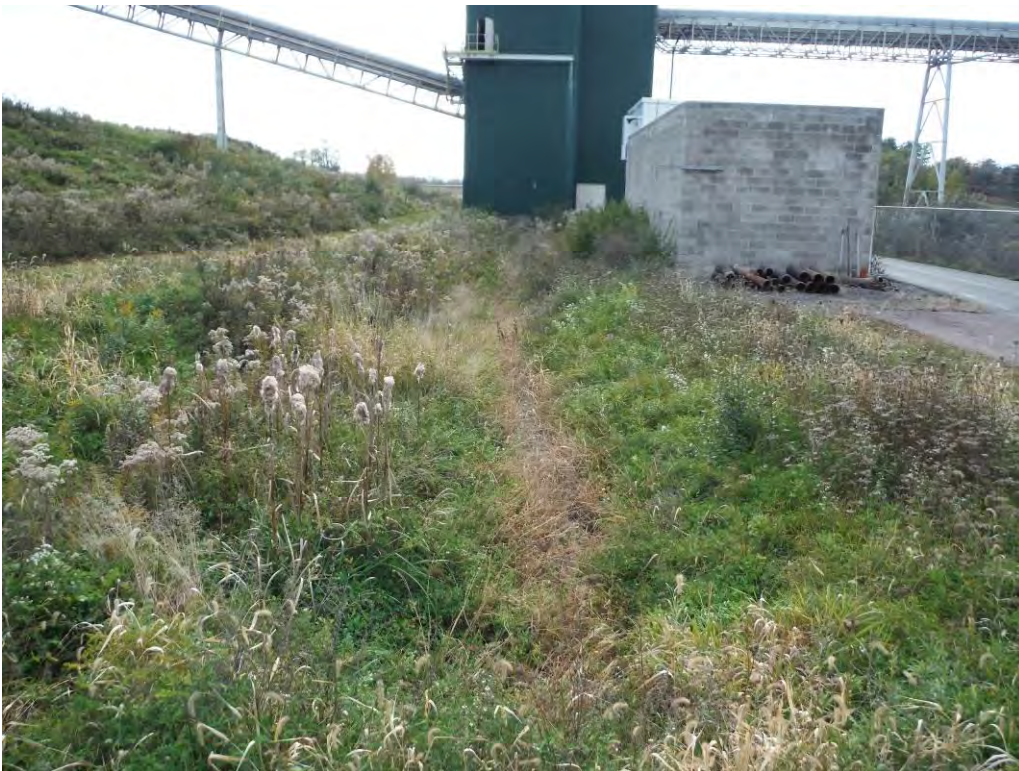
Photo 5 – North end of Cell B. The conveyor building, constructed after the Landfill, straddles the north dirty water perimeter swale.

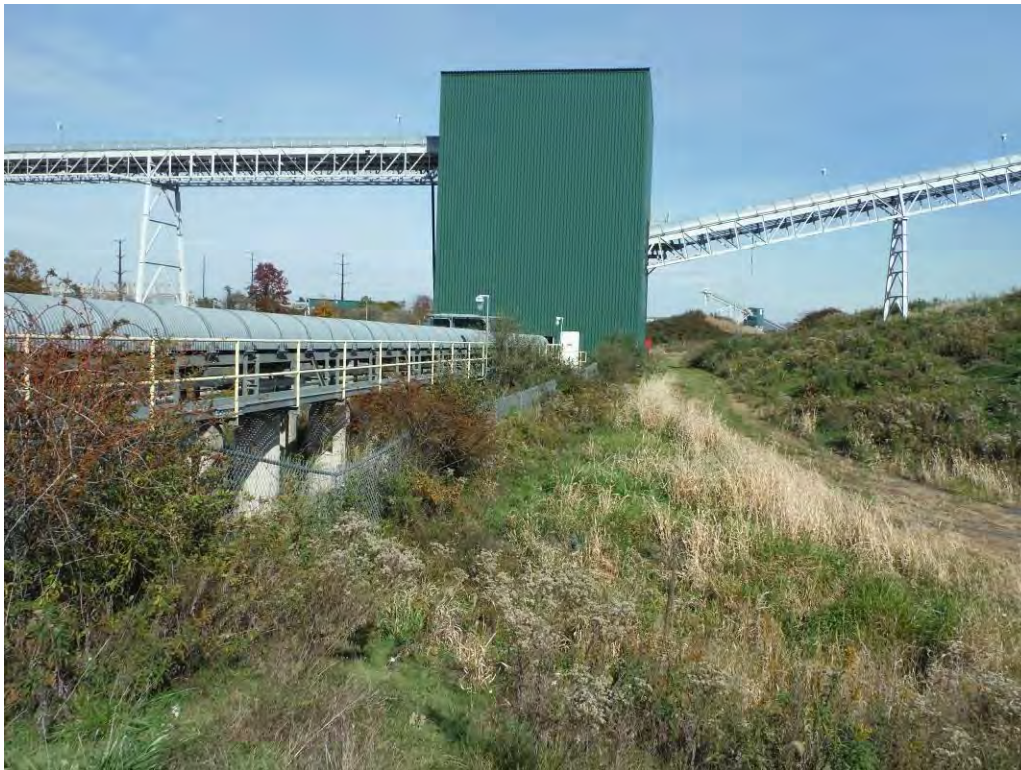
A number of woodchuck burrows were observed at the northwest toe of the Landfill, adjacent to the chain link fence, seen in Photos 6 and 7. These burrows appear to go both over and either under or through, the Landfill liner. Although this could not be confirmed, it appeared that the edge of the liner was exposed and that the swale along the north end of the landfill, which conveys contaminated run off, referred to as "dirty run off" on the drawings, was located

Photo 6 – Toe of the Landfill at the northwest corner, looking east. Several woodchuck holes were observed in the tall grass adjacent to the chainlink fence, which appeared to have exposed the edge of the liner. The dirty water swale at the north end is located to the left (north) of the chain link fence and may be beyond the limits of the liner.

outside of the limits of the liner. There were no visible markers showing the location of the edge of liner in this area. The location of the perimeter of the liner should be verified and marked, and the location of the liner with respect to the swale verified. Vegetation should be cut to remove cover for burrowing animals. The liner should be exposed, its condition assessed, repaired if necessary, and covered. The liner should be extended under the north perimeter swale, if it does not already.

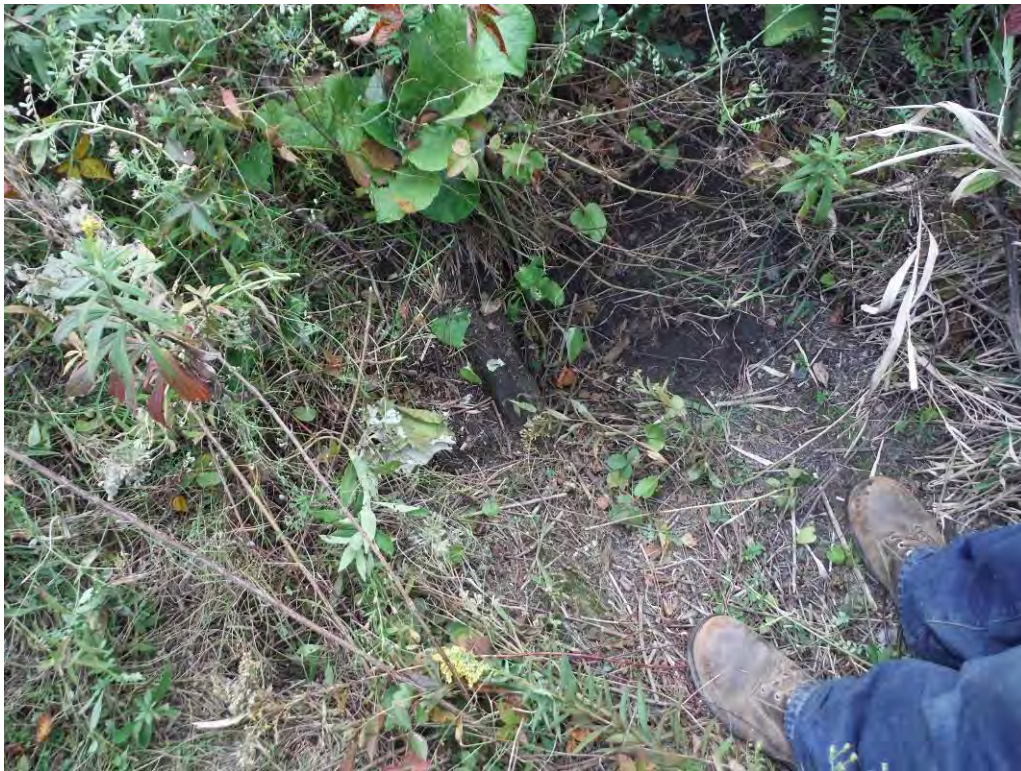
Photo 7 – Exposed geotextile and liner at woodchuck burrows near the northwest toe of the Landfill.

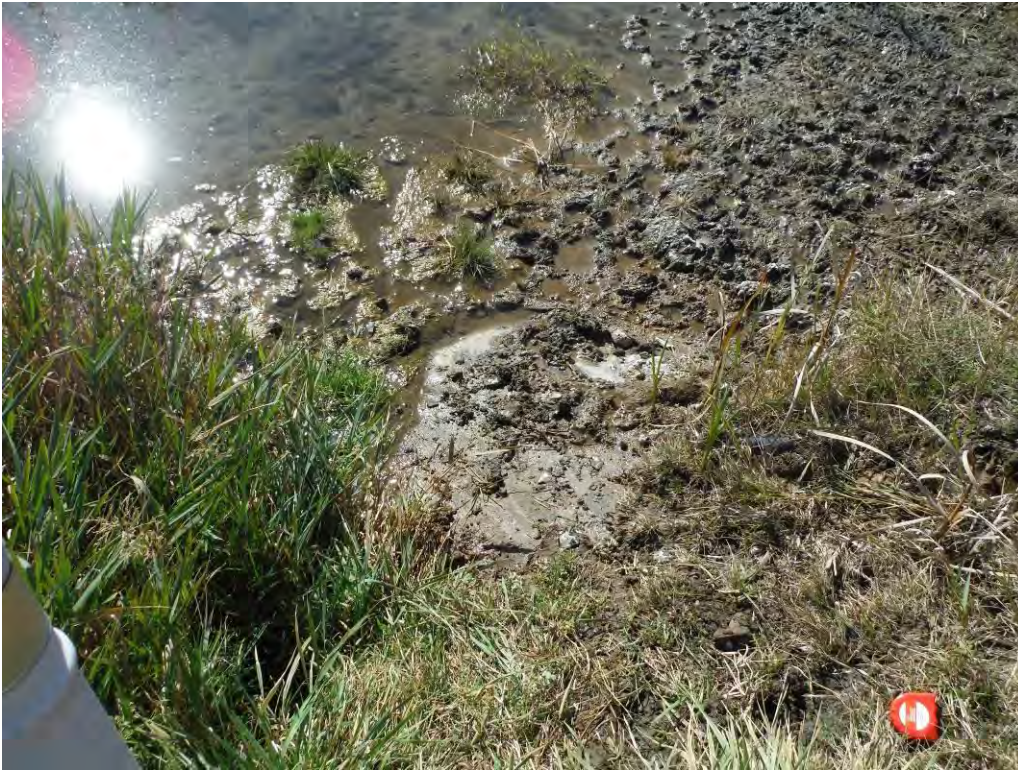
The liner was exposed at the south end of the west perimeter swale, adjacent to the first leachate drain outfall, as seen in Photo 8. There was evidence of heavy deer traffic at this location, with the potential to damage the liner. The liner should be inspected, repaired if necessary, and covered to protect it.

Photo 8 – Exposed liner at the south end of the west perimeter swale, adjacent to the first leachate drain outfall. Heavy deer traffic in this area could potentially penetrate the liner.

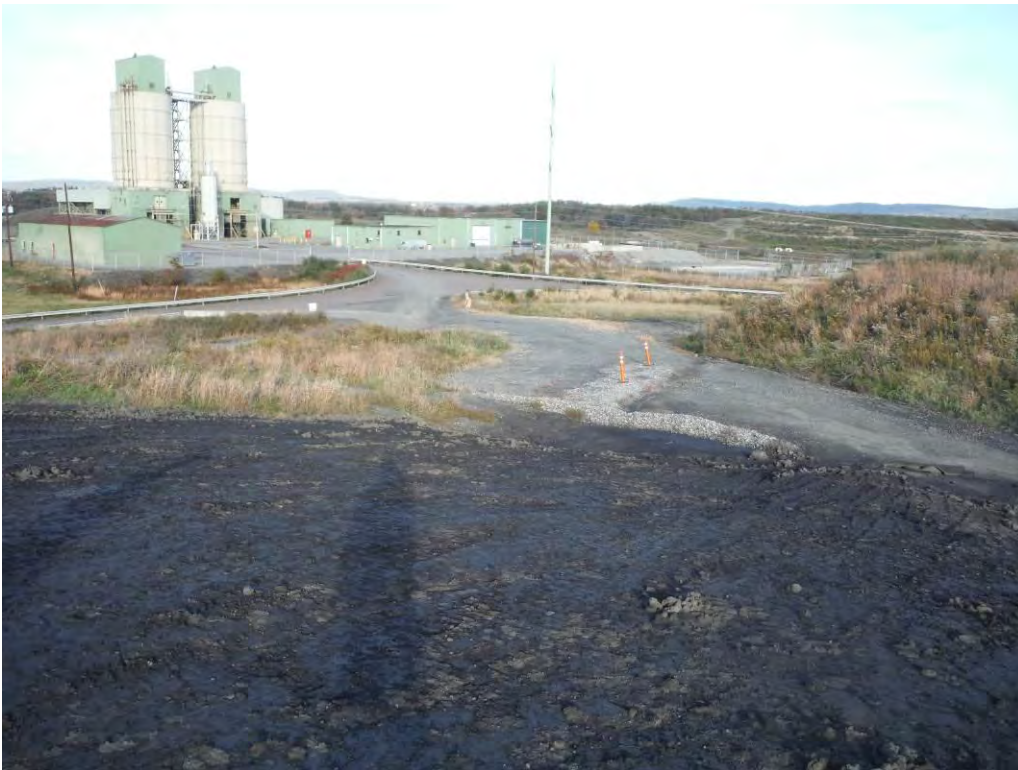
The access road to the active fill area can be seen in Photo 9. It appeared that contaminated stormwater run off from a heavy rainstorm could flow down the access road, across the entrance ramp at the east end of Cells 1 and 2, across the adjacent paved road, and into an existing clean water swale. The area draining to the access road is fairly large, the road is steep, and the rock check dams along the road did not appear to have adequate capacity to check flow from a heavy rain. The potential for run off to exit the landfill should be checked and the road access ramp and perimeter swale re-graded as necessary inside the landfill, so that discharge will be fully contained.

Photo 9 – Access road, looking east. Erosion control measures did not appear to be capable of preventing stormwater runoff from flowing down the road and out of the Landfill.

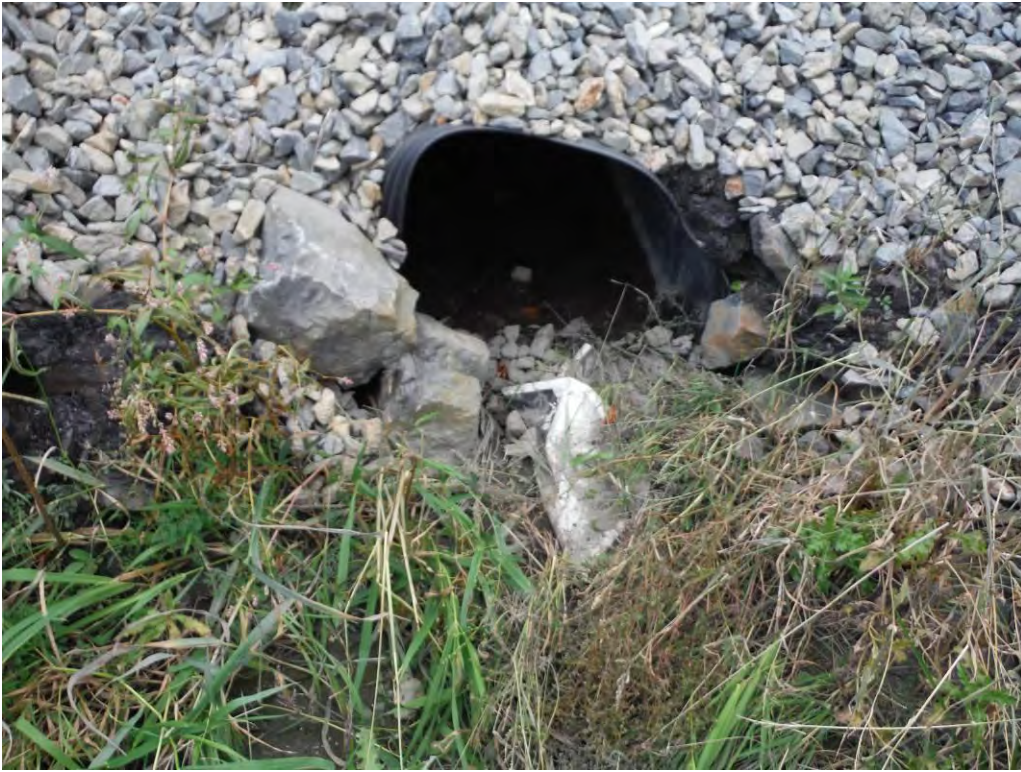
Culverts for the perimeter swale are located at the southeast corner of the Landfill, under the access road ramp, at the northeast corner of the Landfill and extending under the conveyor building, seen in Photo 10. Each of these culverts was partially obstructed with vegetation or riprap, or was damaged. These should be cleared, repaired, and maintained. The size of all of the culverts should be checked. The culverts are not shown on the drawings and may have been installed without consideration of the required hydraulic capacity. The 12-inch-diameter culvert at the northeast corner appears to be significantly undersized.

Photo 10 – Obstructed culvert passing under the conveyor building.

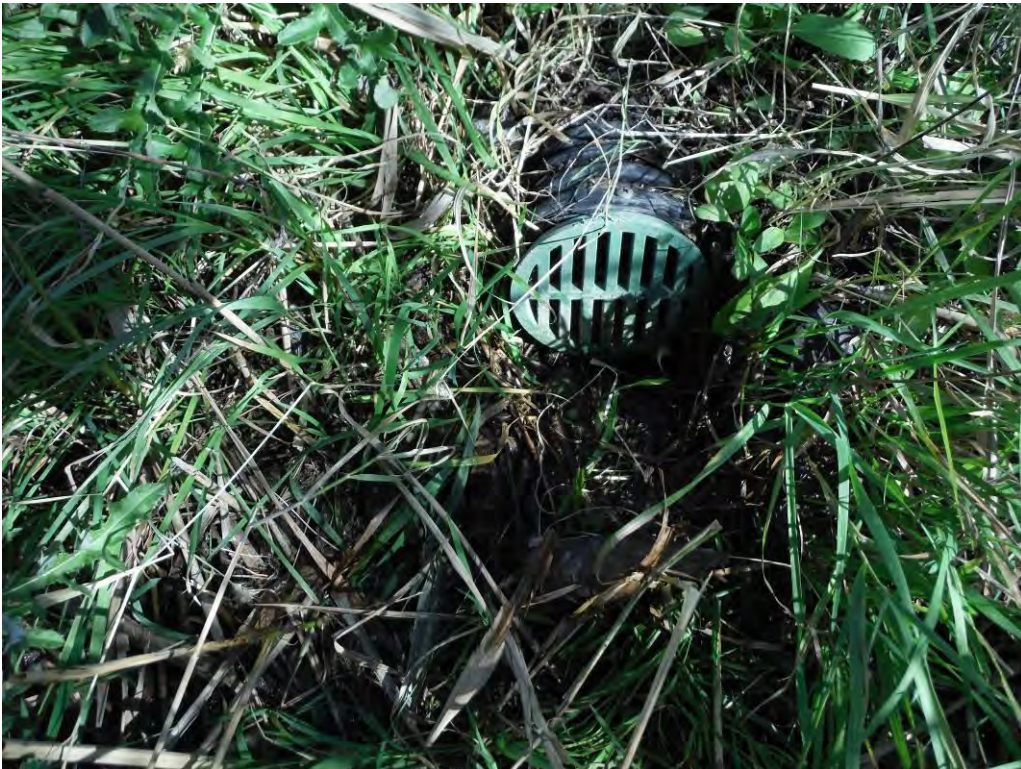
The leachate collection system under Cells A and B consists of 4-inch-diameter, perforated HDPE pipe with 8 separate outfalls, an example of which can be seen in Photo 11. The leachate drain pipes discharge to a swale leading to the leachate/run off basin. The 6-inch-diameter leachate collection header pipe shown on the Drawings has not yet been constructed, since filling of Cells C and D has not yet started. Trans Ash reportedly checks each available outfall for evidence of drainage weekly, though no documentation was available for review. The following observations were made with respect to the leachate collection pipe outfalls. In this report, the pipe outfalls, referred to as drains below, start with the southernmost outfall referred to as Drain 1.

Photo 11 – Leachate Drain No. 7 outfall with animal guard.

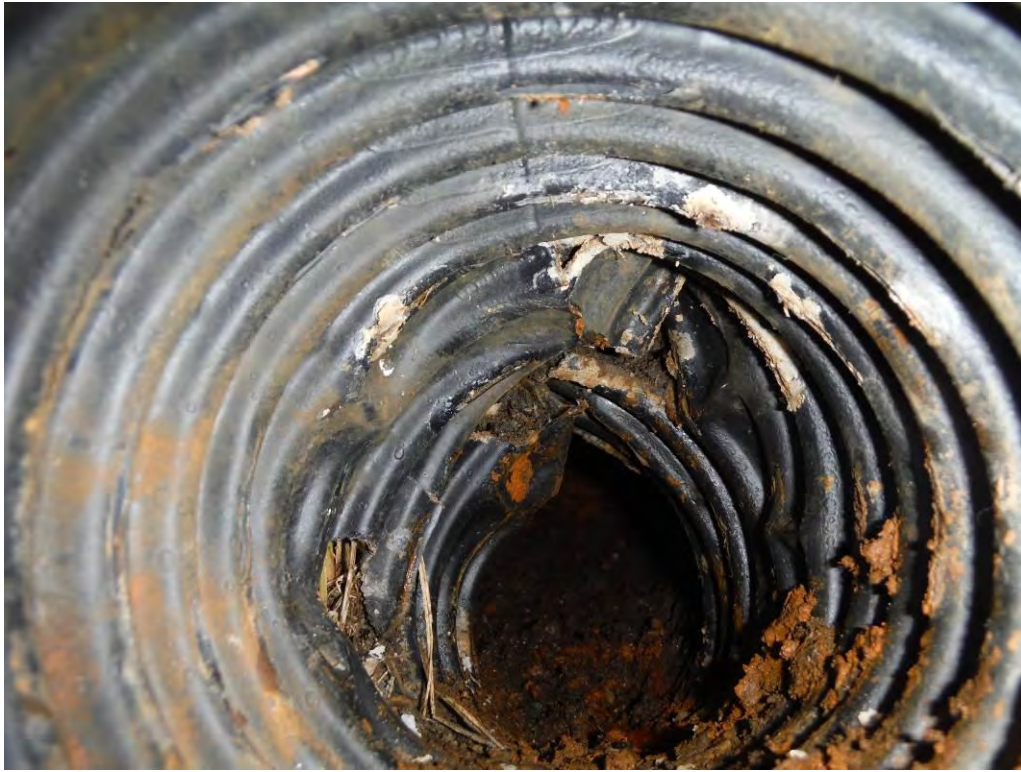
- Drain 4 had no flow, the animal guard was missing, the pipe interior appeared to be damaged and appeared to be plugged, as seen in Photo 12. The outfall should be inspected, cleaned, and repaired.

Photo 12 – Damage and plugging of the outfall of Leachate Drain No. 4.

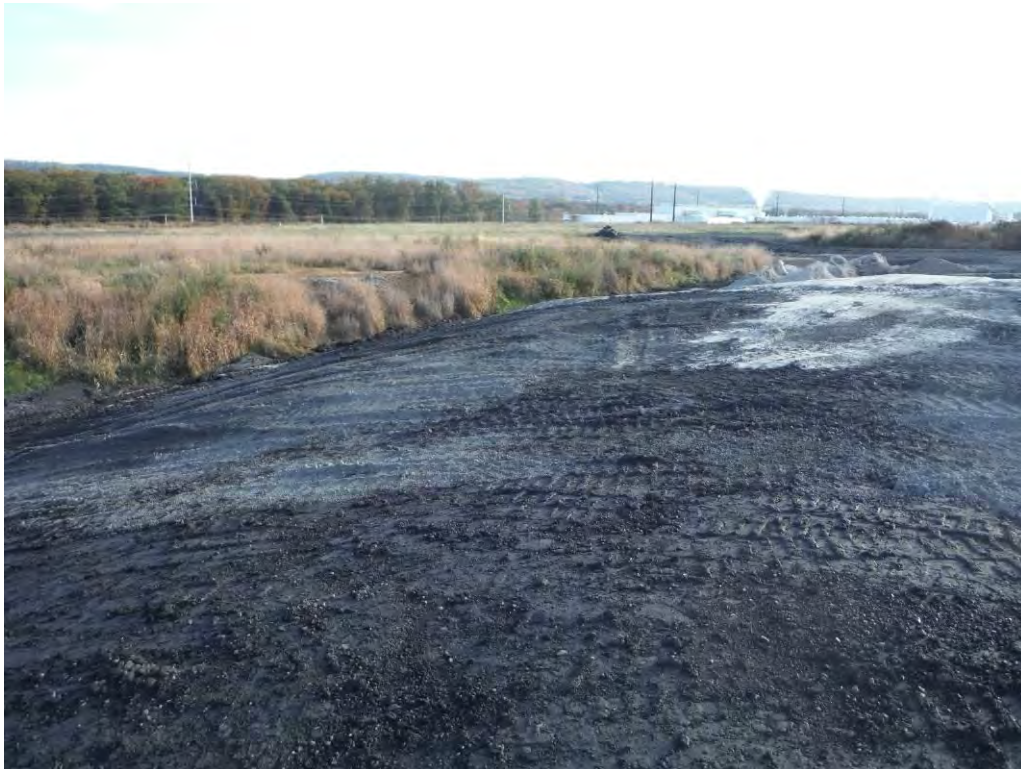
The active surface of Cells A and B was well maintained, with fill shaped and compacted to provide drainage and reduce infiltration, as seen in Photo 13. A caking agent had been applied in areas to prevent dusting.

Photo 13 – Working Landfill surface showing shaped, compacted fill, dust-protection caking agent, and temporary grass cover beyond.

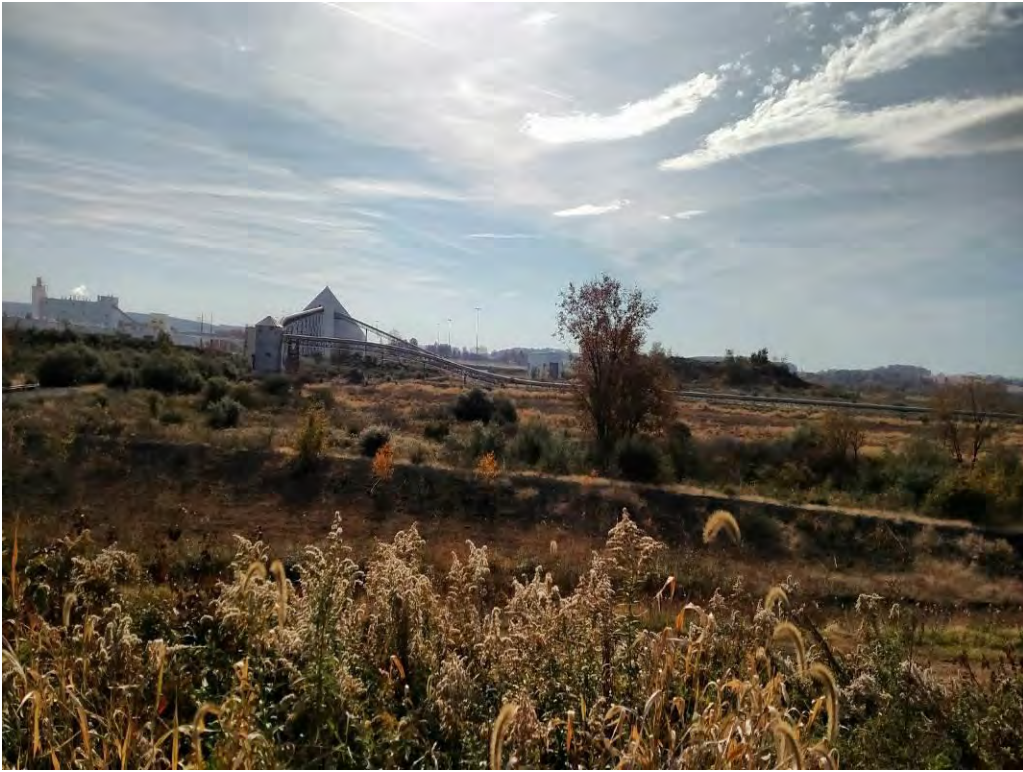
The liners have not been constructed at Cells C and D, and this area is overgrown with grass and low brush, as seen in Photo 14. The leachate run off basin can be seen in Photo 15.

Photo 14 – Inactive Cells C and D, looking west.

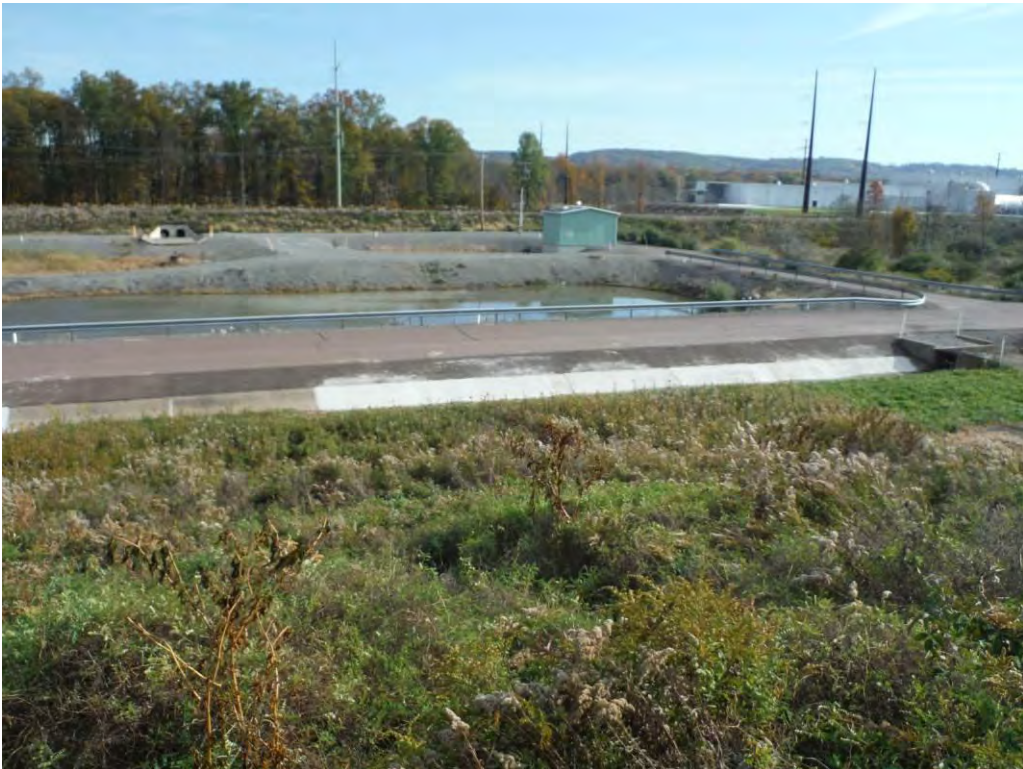
Photo 15 – Leachate runoff basin, looking south.

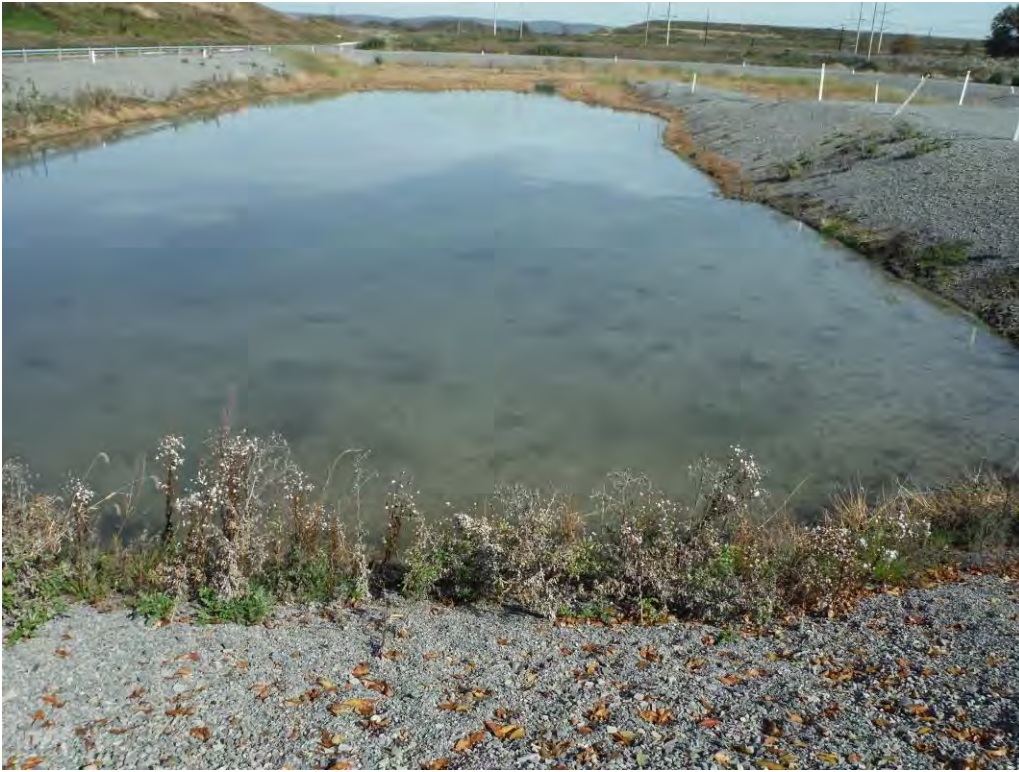
A number of small depressions were observed in the floor of the leachate run off basin, seen in Photo 16. The cause of these depressions and their impact on the leachate collection system should be assessed.

Photo 16 – Depressions in the clay liner of the leachate runoff basin.

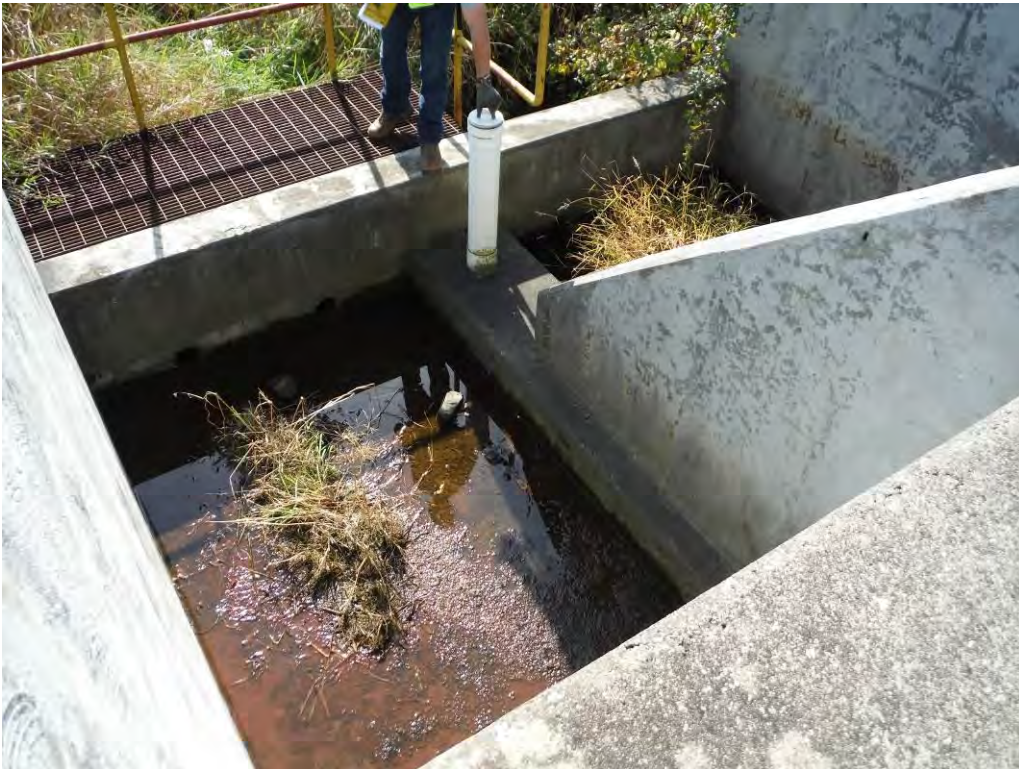
The leachate run off basin area has a number of manholes and hydraulic structures, some of which will remain inactive until the piping associated with activation of Cells C and D is installed. Labeling these structures and entrance and exit piping will simplify future inspections. The groundwater underdrain system is installed under the culvert diversion ditch, and the riser can be seen in Photo 17. The ditch was heavily overgrown so that the discharge to the groundwater drain could not be viewed. The stream diversion pipes had animal barriers on the downstream ends. These could catch trash flowing through the pipes and create a blockage. Alternate animal barriers should be provided, or breakaway barriers used to prevent accidental blockage of the channel.

Photo 17 – Groundwater underdrain riser pipe, visible from the stream diversion outfall structure.
