Corrective Measures Taken for Brunner Island LLC Ash Basin No. 6 per CFR §257.83(b)5
as identified in the Initial CCR Surface Impoundment Inspection Report dated December 11,
2015

Items Identified in the Initial CCR Surface Impoundment Inspection Report with corrective actions taken:

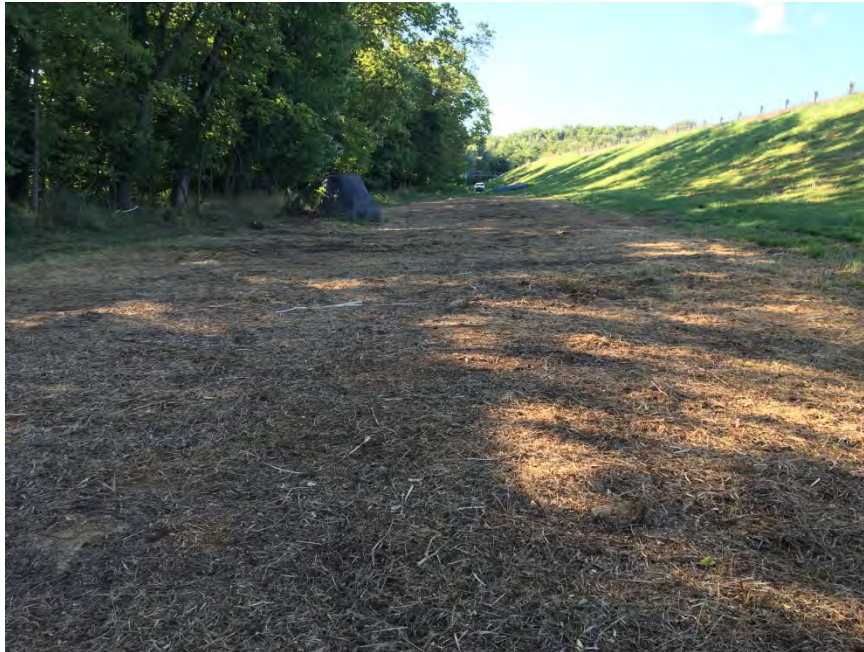
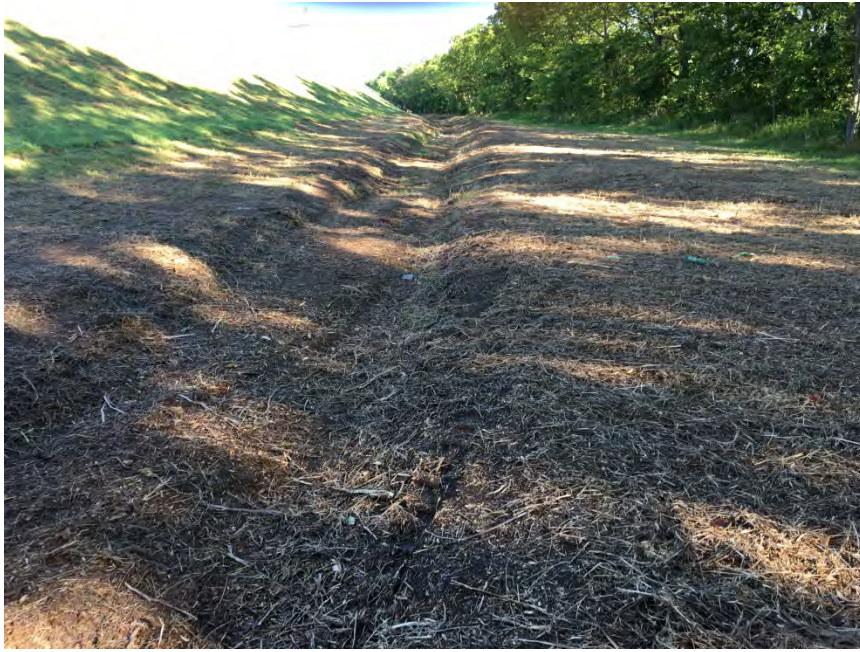
1. *East Embankment: "The ditch, which was constructed as part of erosion and sedimentation control measures during original construction and effectively part of the embankment, was cleared in 2013 but has since become heavily overgrown."*

Response: During the week of August 22, 2016 the vegetation within the ditch along the east embankment has been cut to less than 6" high. This work was completed by Liberty Excavators Inc. LLC under contact 645355. Photos of the completed vegetation clearing:

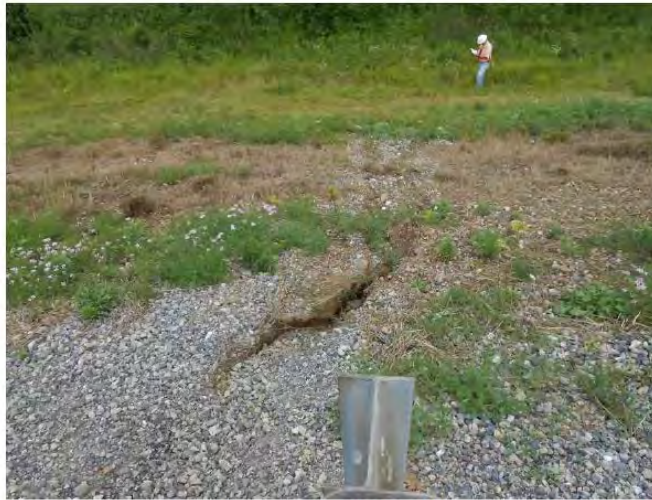
2. *East Embankment: "Minor erosion rills were observed along the downstream edge of the crest as seen in Photo 36. The condition of the roadway crest was consistent around the entire ash basin."*

Photo 36 – Typical erosion rills observed at the top of the east and south embankments, where the crest was recently raised. This erosion rill is approximately located at STA. 18+40 on the east embankment.

Response: Minor erosion rills were repaired along the downstream edge of the crest in March 2016.

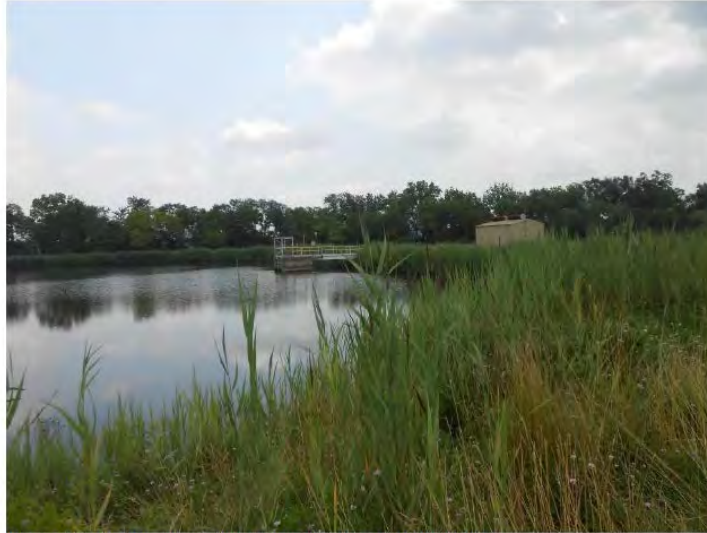
3. *"Vegetation along the upstream face of the west embankment, east embankment, and splitter dike has grown, as seen in Photo 29, and should be cut and removed or eliminated to prevent clogging of outlet structures."*

Photo 29 – Outlet structure between basin and polishing pond.

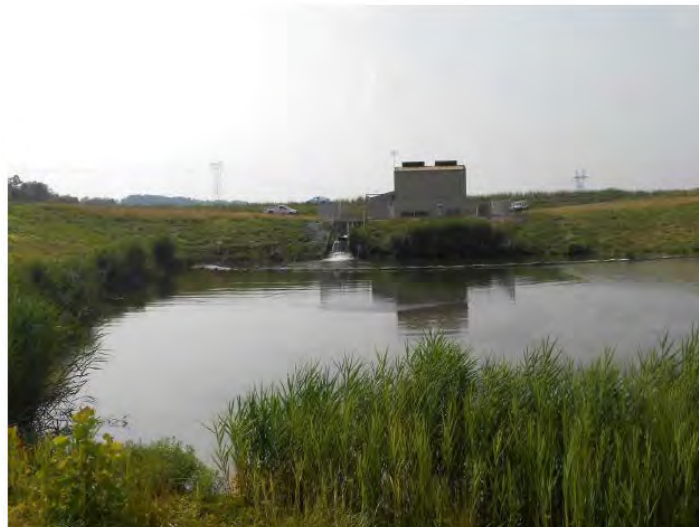
4. *Polishing Pond: “The upstream slope appeared to be in good condition, and the vegetation along the upstream slope had been trimmed recently, except along the waterline, as seen in Photos 15, 16, and 30.”*

Photo 30 – Median dike, metering station, and discharge structure to the polishing pond, looking north.

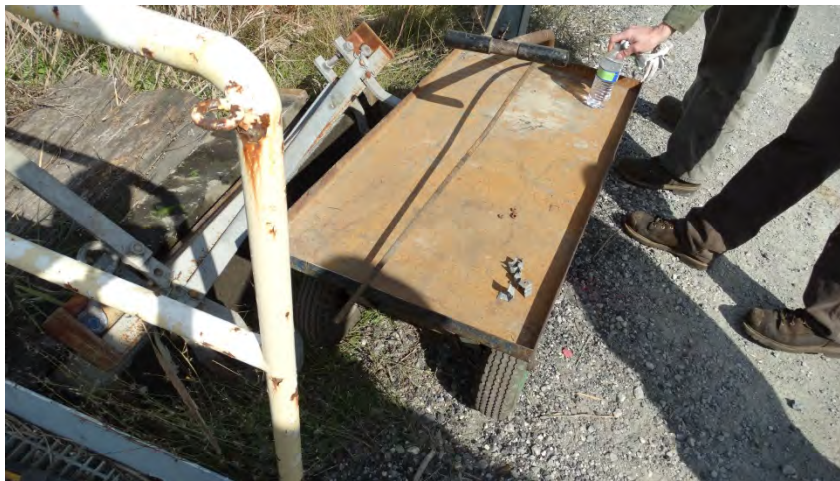
6. *Intake/Outlet Structures: "A stainless steel rod was observed resting against the low level outlet control gate, which was removed by the divers during the inspection."*

Response: The rod was removed on October 15, 2015 by a diver from Marion Hill Associates. Photo of the rod:

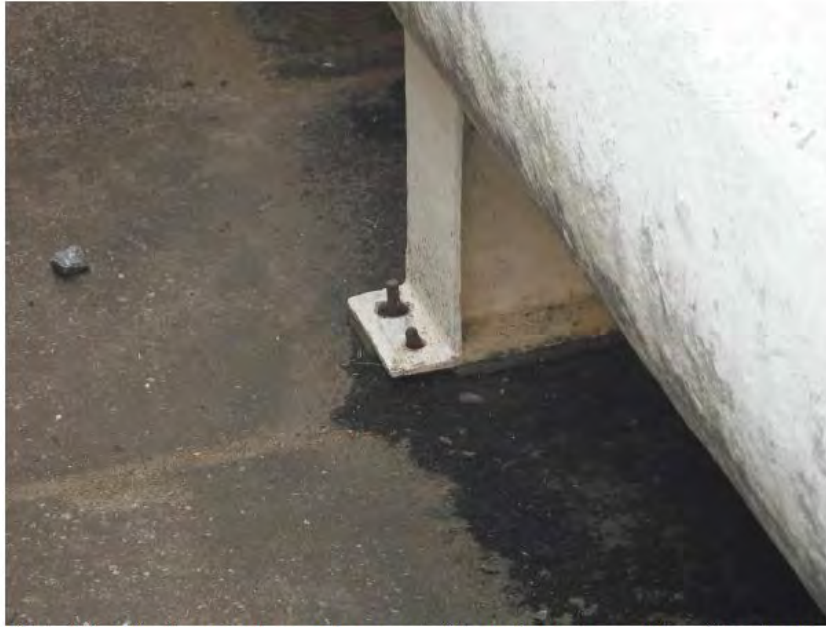
7. *"Missing nuts were observed on the bolts on the saddles of the discharge pipeline through the splitter dike, from the main basin to the polishing pond as seen in Photo 38. This is not typically a concern under normal or flood conditions but could result in movement or damage to the outlet pipe during earthquakes."*

Photo 38 – Missing nuts observed on most of the bolts on the saddles of the discharge pipeline to the polishing pond.

Response: On June 7, 2016 Brunner Island LLC employees tapped, chased studs, and installed new hardware.

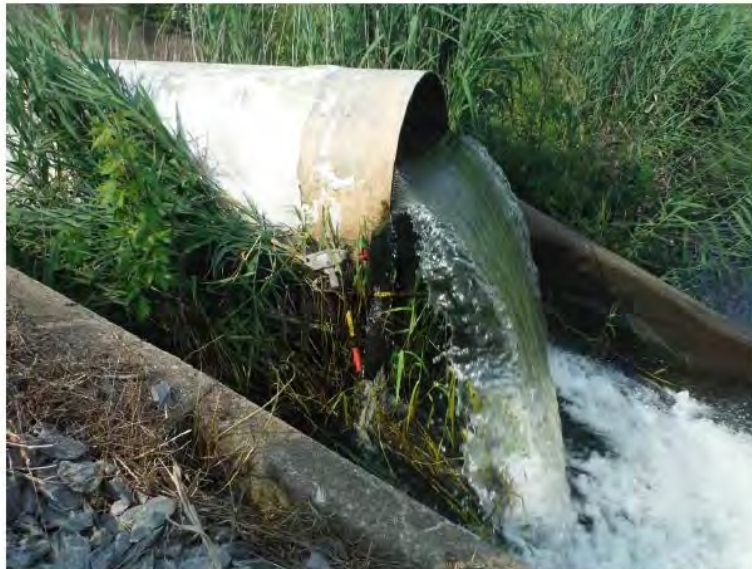
8. *“The discharge pipe through the splitter dike was observed to be 2/3 blocked with a timber exit weir ash shown in Photo 39. Brunner Island LLC reported that this weir is in place to raise the water level in the pipe to allow chemistry and water quality testing but that it can be removed in the event of a flood to achieve full capacity”.*

Photo 39 – Discharge pipe through the median dike observed to be 2/3 blocked with a timber exit weir. The spillway adequacy analysis assumed this discharge structure to be at full capacity. Maintenance staff were aware that the weir needs to be removed during a flood.

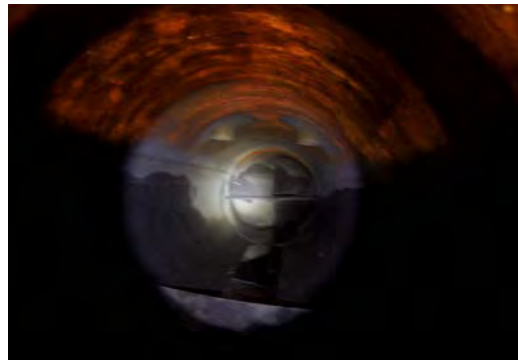
9. *“Brunner Island LLC is developing a plan to clear the trash and sediment in the mixing chamber and pipe and has verified that removal of the weir is included in the basin and polishing pond operating plan, but is still in the process of assessing the impact of the mixing chamber on discharge capability and hydraulic capability.”*

Response: Brunner Island LLC cleared the trash and sediment from within the pipe on 12/16/2015. Photo of the cleaned pipe looking at the mixing chamber:

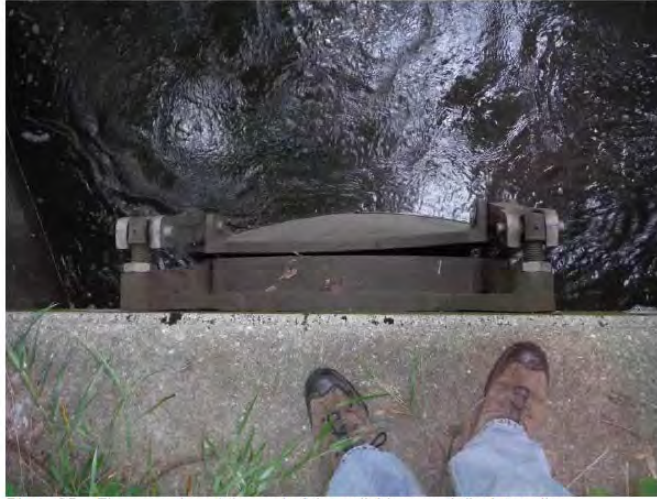
10. *“The flapper valve at the end of the discharge line, seen in Photo 35, appeared to have not been lubricated or exercised recently and was open on a skew.”*

Photo 35 – Flapper valve at the end of the polishing pond discharge line.

Response: On June 7, 2016 Brunner Island LLC employees rigged the flapper gate to a crane end exercised the gate through its full range of motion. The flapper gate was greased, the bottom of the pipe was cleaned, and completed the inspection.

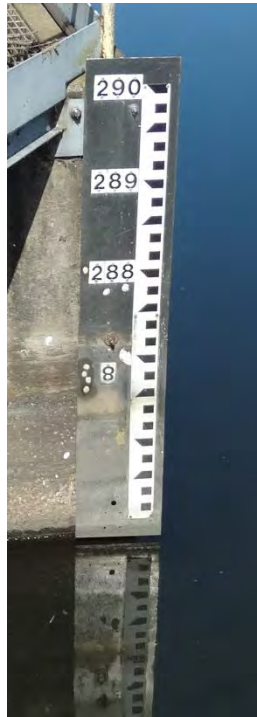
11. *“Since removal of the stoplogs at the outlet structure between the main basin and the polishing pond, the basin water level is now below the base of the staff gage as seen in Photo 37.”*
