2016 Initial Structural Stability Assessment Report

Brunner Island Ash Basin No. 6 CCR

Prepared for: Brunner Island, LLC

September 27, 2016

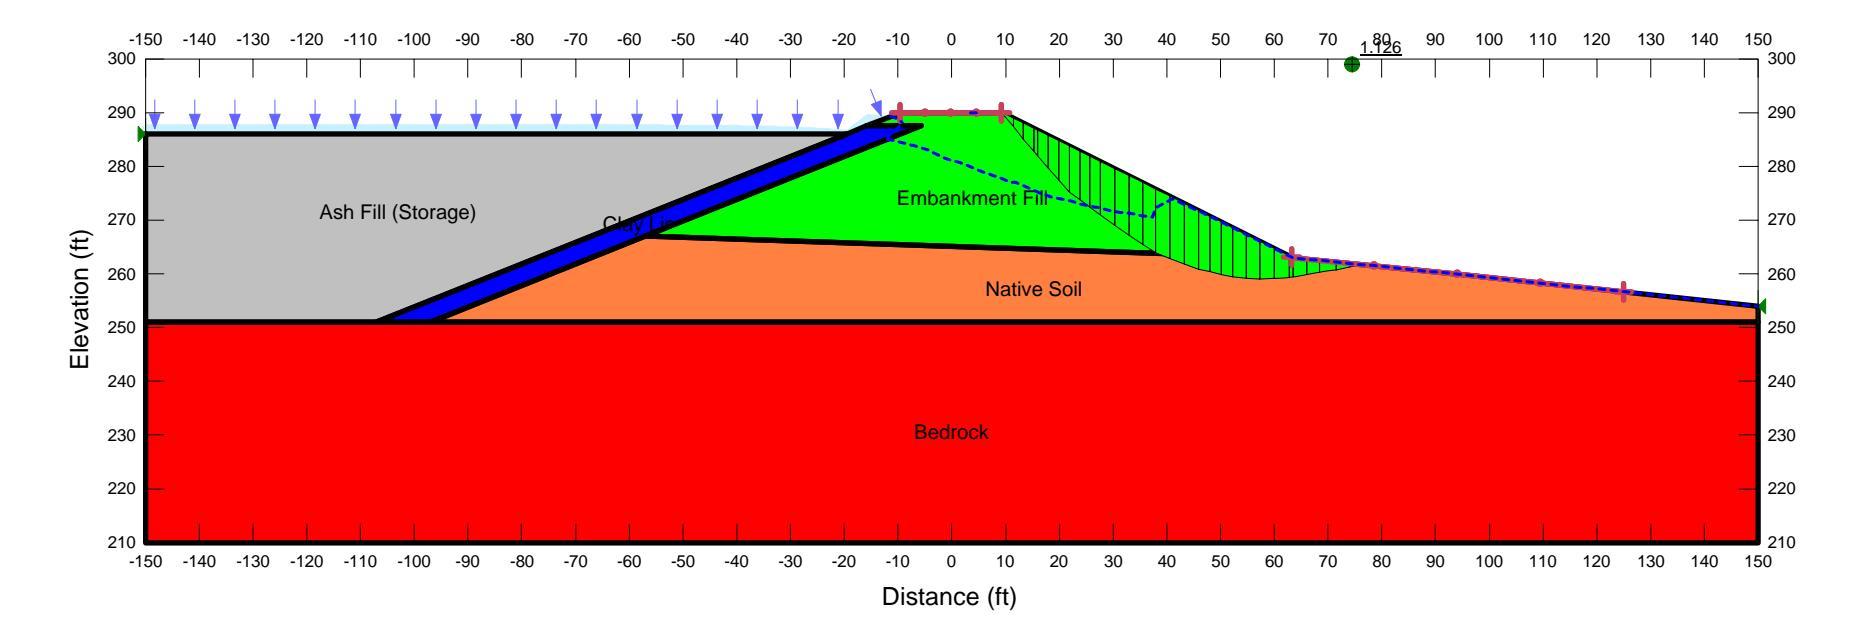
Material Input Properties

Name: Bedrock Model: Mohr-Coulomb Unit Weight: 160 pcf Cohesion: 2000 psf Phi: 45 ° Unit Weight: 130 pcf Cohesion: 0 psf Phi: 30 ° Model: Mohr-Coulomb Name: Native Soil Model: Mohr-Coulomb Unit Weight: 130 pcf Cohesion: 0 psf Phi: 30 ° Name: Clay Liner Name: Ash Fill (Storage) Model: Mohr-Coulomb Unit Weight: 90 pcf Cohesion: 0 psf Phi: 30 ° Name: Embankment Fill Model: Mohr-Coulomb Unit Weight: 135 pcf Unit Wt. Above Water Table: 125 pcf Cohesion: 0 psf Phi: 37 °

Brunner Island Ash Basin No. 6 Station 21+80 (Section 1-1) Manchester Township, Pennsylvania

CONDITION	Min. FOS (Plate #)			
Isotropic Hydraulic Conductivity				
Case 1: $K_v = K_h = 6.8*10^{-6}$ ft/sec (max sat hydr cond, isotropic)	1.13 (Attachment 1)			
Anisotropic Hydraulic Conductivity				
Case 6: $K_v = 0.13 * K_h = 2.8*10^{-6}$ ft/sec (avg sat hydr cond, anisotropy ratio = 8)	1.12 (Attachment 2)

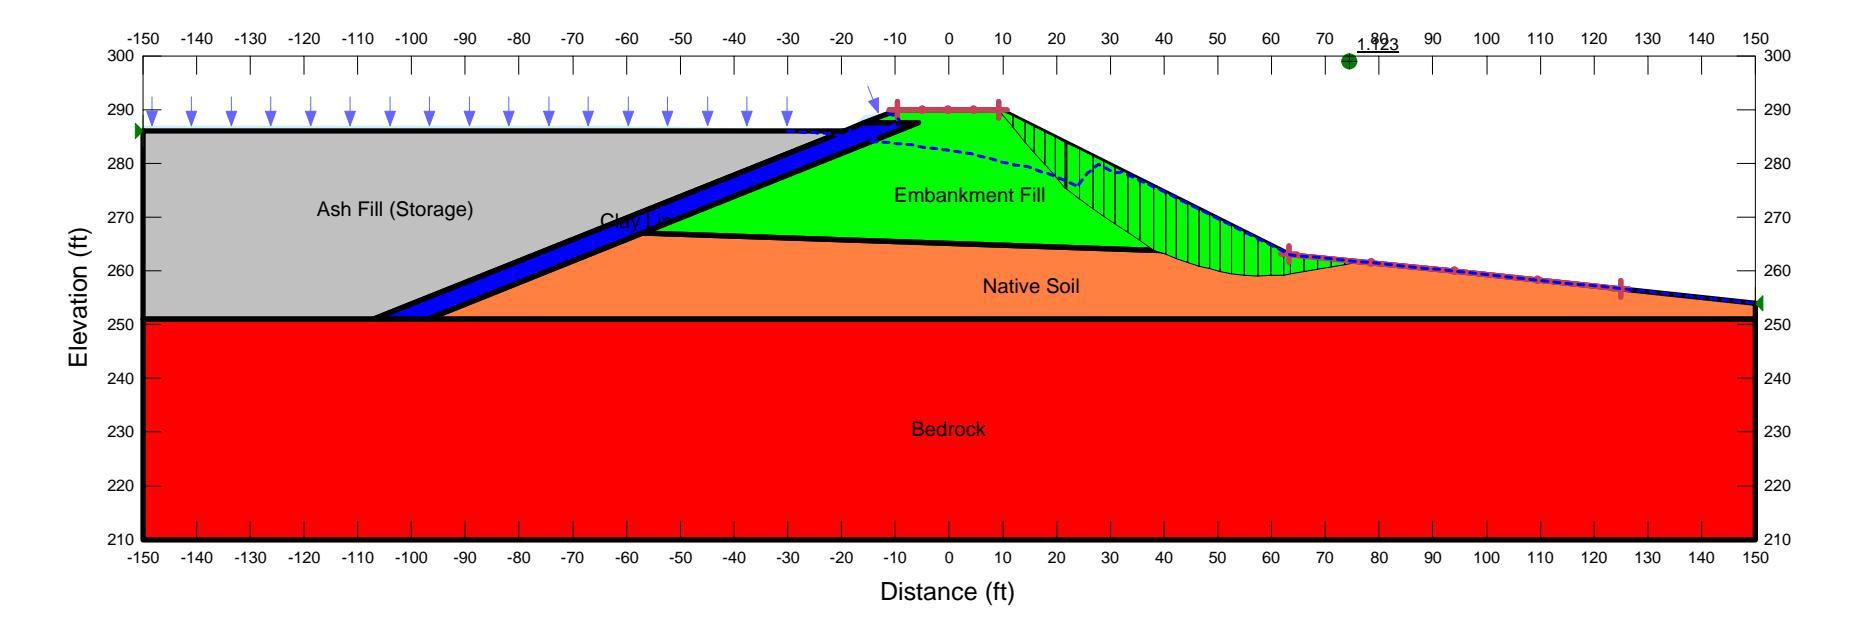
Material Input Properties

Name: Bedrock Model: Mohr-Coulomb Unit Weight: 160 pcf Cohesion: 2000 psf Phi: 45 ° Unit Weight: 130 pcf Cohesion: 0 psf Phi: 30 ° Name: Native Soil Model: Mohr-Coulomb Name: Clay Liner Unit Weight: 130 pcf Cohesion: 0 psf Phi: 30 ° Model: Mohr-Coulomb Name: Ash Fill (Storage) Model: Mohr-Coulomb Unit Weight: 90 pcf Cohesion: 0 psf Phi: 30 ° Name: Embankment Fill Model: Mohr-Coulomb Unit Weight: 135 pcf Unit Wt. Above Water Table: 125 pcf Cohesion: 0 psf Phi: 37 °

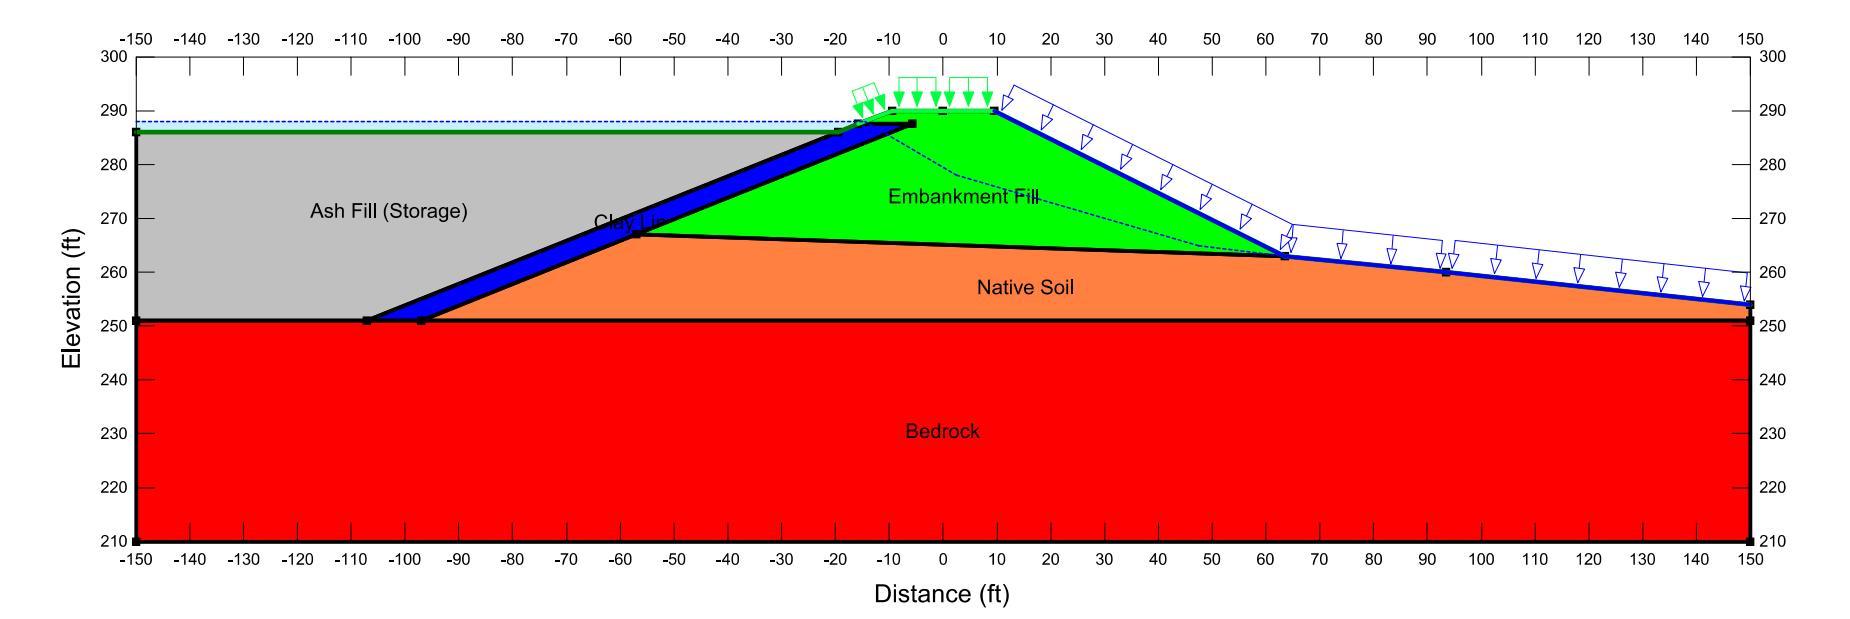
Plate D1 - Seepage Model

Name: Bedrock K-Sat: 1e-010 ft/sec Volumetric Water Content: 0 ft³/ft³ Mv: 0 /psf K-Ratio: 1 K-Direction: 0 ° Model: Saturated Only Name: Native Soil Model: Saturated Only K-Sat: 1e-008 ft/sec Volumetric Water Content: 0 ft³/ft³ Mv: 0 /psf K-Ratio: 1 K-Direction: 0 ° K-Sat: 1e-009 ft/sec Volumetric Water Content: 0 ft³/ft³ Mv: 0 /psf K-Ratio: 1 Name: Clay Liner Model: Saturated Only K-Direction: 0 ° Name: Ash Fill (Storage) Model: Saturated Only K-Sat: 1e-008 ft/sec Volumetric Water Content: 0 ft³/ft³ Mv: 0 /psf K-Ratio: 1 K-Direction: 0 ° Name: Embankment Fill Model: Saturated / Unsaturated K-Function: Embankment Fill Unsat K Vol. WC. Function: Embankment Fill - Vol. WC K-Ratio: 1 K-Direction: 0 °

Seepage was modeled using GeoStudio's SEEP/W (ver 7.14) computer program. SEEP/W is a twodimensional finite element computer program commonly used to model unconfined and confined seepage problems, including groundwater movement and pore water pressure distribution within porous materials, such as soil and rock. SEEP/W can be used to model seepage conditions and evaluate various parameters, including hydraulic head/pore water pressure distribution, hydraulic gradient, volume of flow, and many others. SEEP/W can be used to model both steady state and transient seepage conditions. Steady state conditions include situations in which model parameters (soil properties, boundary

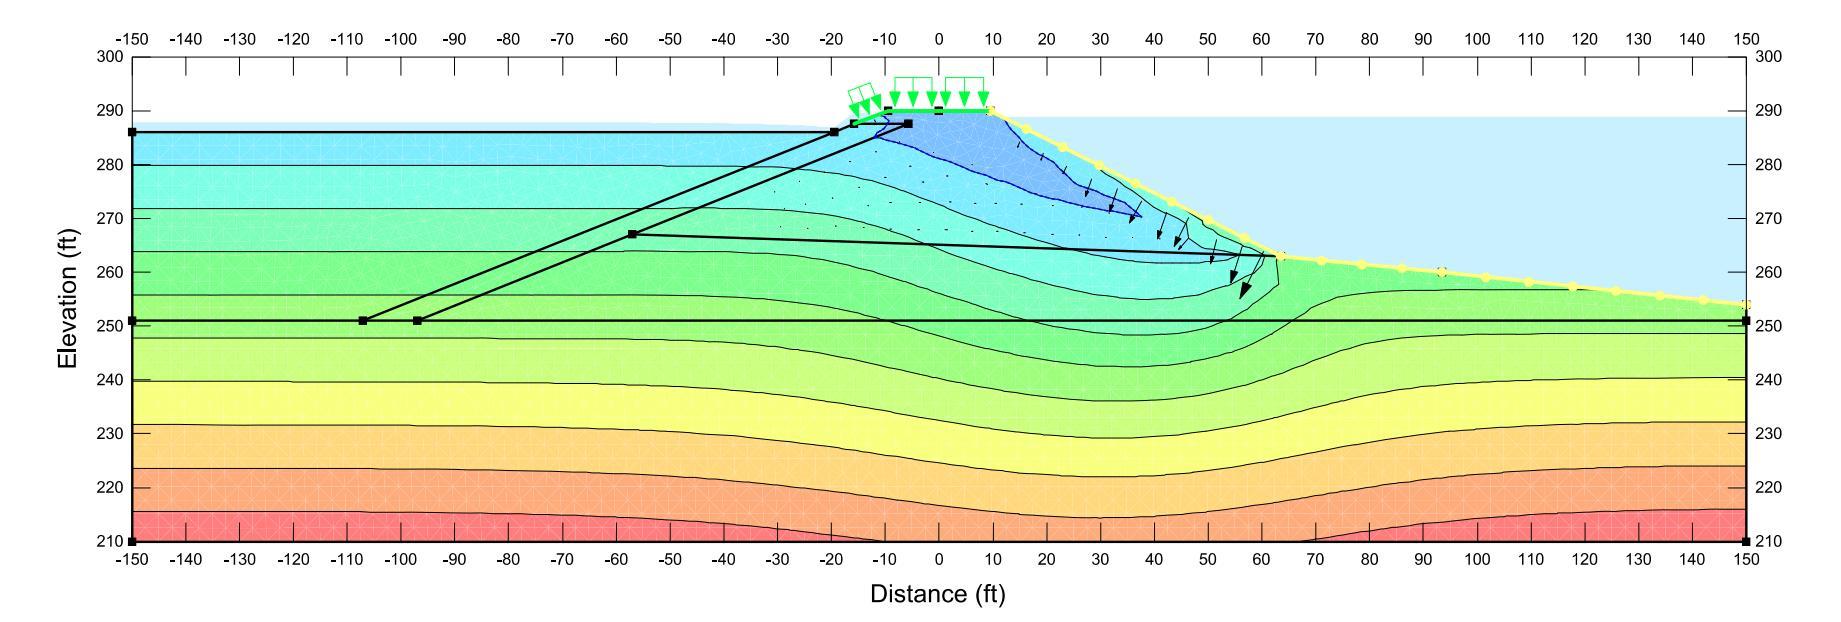
Plate D2a - River at 500-yr Flood Elevation (Case 1: Kv=Kh=6.8*10^-6 ft/sec)

Name: Bedrock K-Sat: 1e-010 ft/sec Volumetric Water Content: 0 ft3/ft3 Mv: 0 /psf K-Ratio: 1 K-Direction: 0 ° Model: Saturated Only Name: Native Soil Model: Saturated Only K-Sat: 1e-008 ft/sec Volumetric Water Content: 0 ft³/ft³ Mv: 0 /psf K-Ratio: 1 K-Direction: 0 ° K-Sat: 1e-009 ft/sec Volumetric Water Content: 0 ft³/ft³ Mv: 0 /psf K-Ratio: 1 Name: Clay Liner Model: Saturated Only K-Direction: 0 ° Model: Saturated Only K-Sat: 1e-008 ft/sec Volumetric Water Content: 0 ft³/ft³ Mv: 0 /psf K-Ratio: 1 Name: Ash Fill (Storage) K-Direction: 0 ° K-Direction: 0 ° Name: Embankment Fill Model: Saturated / Unsaturated K-Function: Embankment Fill Unsat K Vol. WC. Function: Embankment Fill - Vol. WC K-Ratio: 1

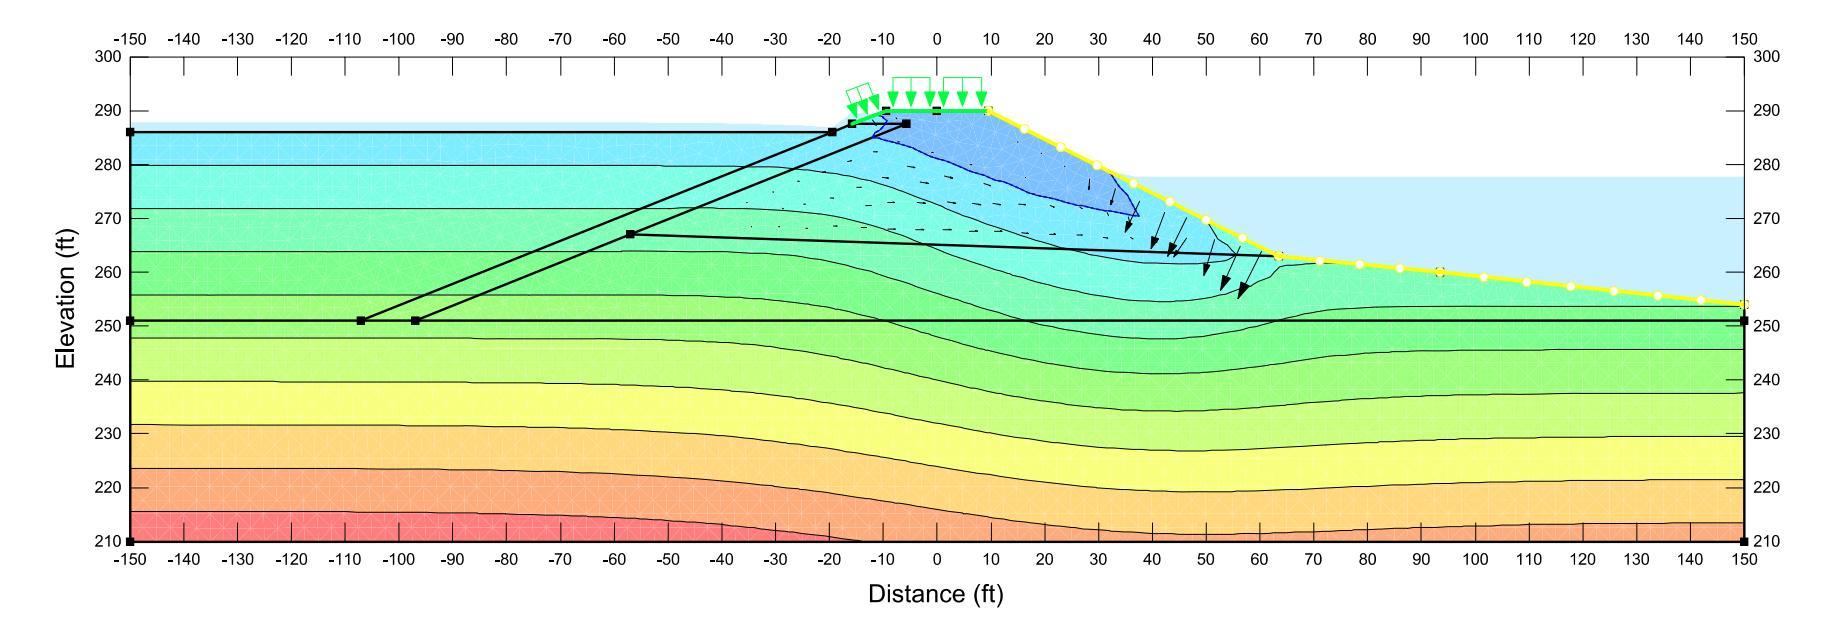
Plate D2b - River at Mid-Slope Elevation (Case 1: Kv=Kh=6.8*10^-6 ft/sec)

Name: Bedrock K-Sat: 1e-010 ft/sec Volumetric Water Content: 0 ft3/ft3 Mv: 0 /psf K-Ratio: 1 K-Direction: 0 ° Model: Saturated Only Name: Native Soil Model: Saturated Only K-Sat: 1e-008 ft/sec Volumetric Water Content: 0 ft³/ft³ Mv: 0 /psf K-Ratio: 1 K-Direction: 0 ° Model: Saturated Only K-Sat: 1e-009 ft/sec Volumetric Water Content: 0 ft³/ft³ Mv: 0 /psf K-Ratio: 1 Name: Clay Liner K-Direction: 0 ° Model: Saturated Only K-Sat: 1e-008 ft/sec Volumetric Water Content: 0 ft³/ft³ Mv: 0 /psf K-Ratio: 1 K-Direction: 0 ° Name: Ash Fill (Storage) Name: Embankment Fill Model: Saturated / Unsaturated K-Function: Embankment Fill Unsat K Vol. WC. Function: Embankment Fill - Vol. WC K-Ratio: 1 K-Direction: 0 °

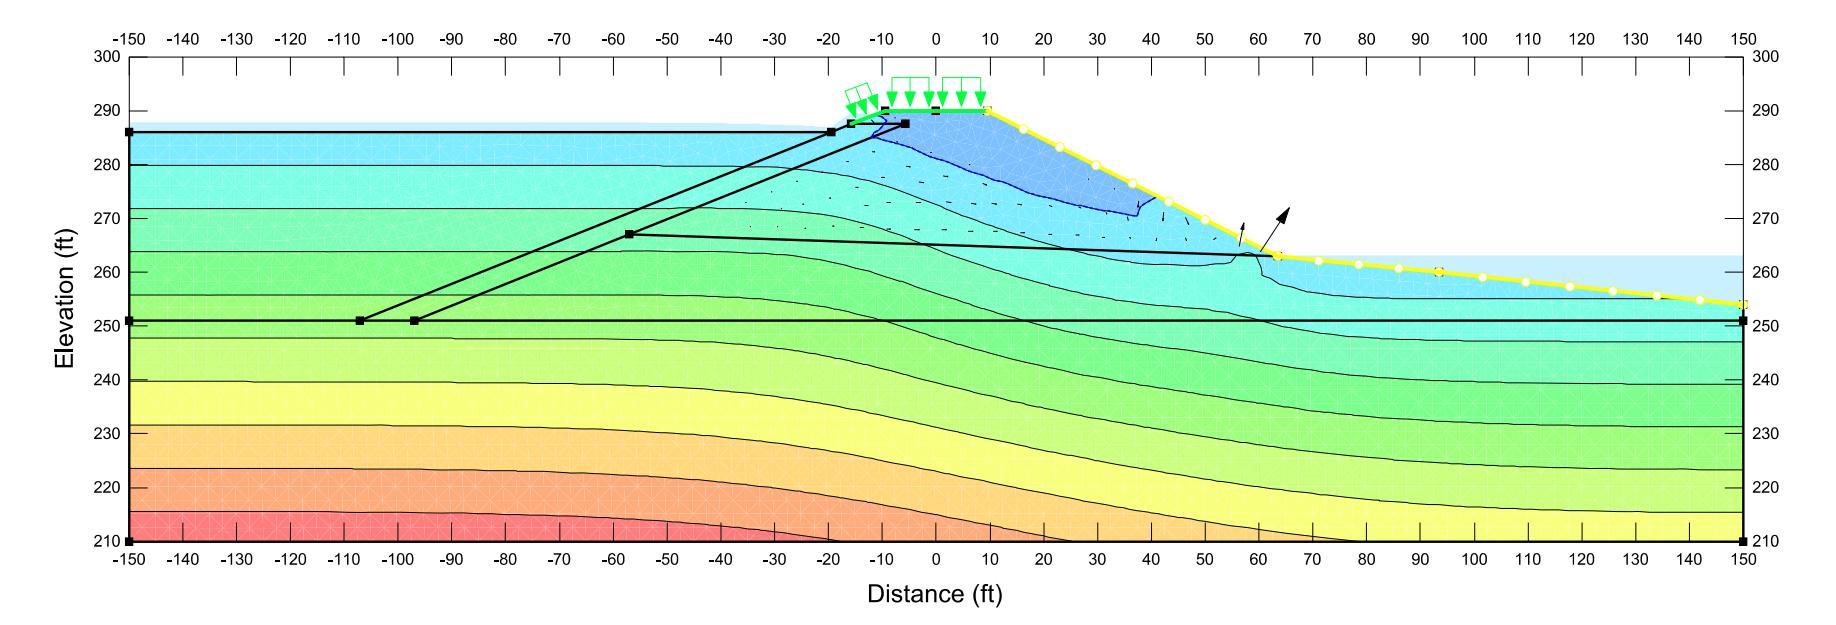
Plate D2c - River at Toe of Slope Elevation (Case 1: Kv=Kh=6.8*10^-6 ft/sec)

Name: Bedrock K-Sat: 1e-010 ft/sec Volumetric Water Content: 0 ft3/ft3 Mv: 0 /psf K-Ratio: 1 K-Direction: 0 ° Model: Saturated Only Name: Native Soil Model: Saturated Only K-Sat: 1e-008 ft/sec Volumetric Water Content: 0 ft³/ft³ Mv: 0 /psf K-Ratio: 1 K-Direction: 0 ° K-Sat: 1e-009 ft/sec Volumetric Water Content: 0 ft³/ft³ Mv: 0 /psf K-Ratio: 1 Name: Clay Liner Model: Saturated Only K-Direction: 0 ° Name: Ash Fill (Storage) Model: Saturated Only K-Sat: 1e-008 ft/sec Volumetric Water Content: 0 ft³/ft³ Mv: 0 /psf K-Ratio: 1 K-Direction: 0 ° K-Direction: 0 ° Name: Embankment Fill Model: Saturated / Unsaturated K-Function: Embankment Fill Unsat K Vol. WC. Function: Embankment Fill - Vol. WC K-Ratio: 1

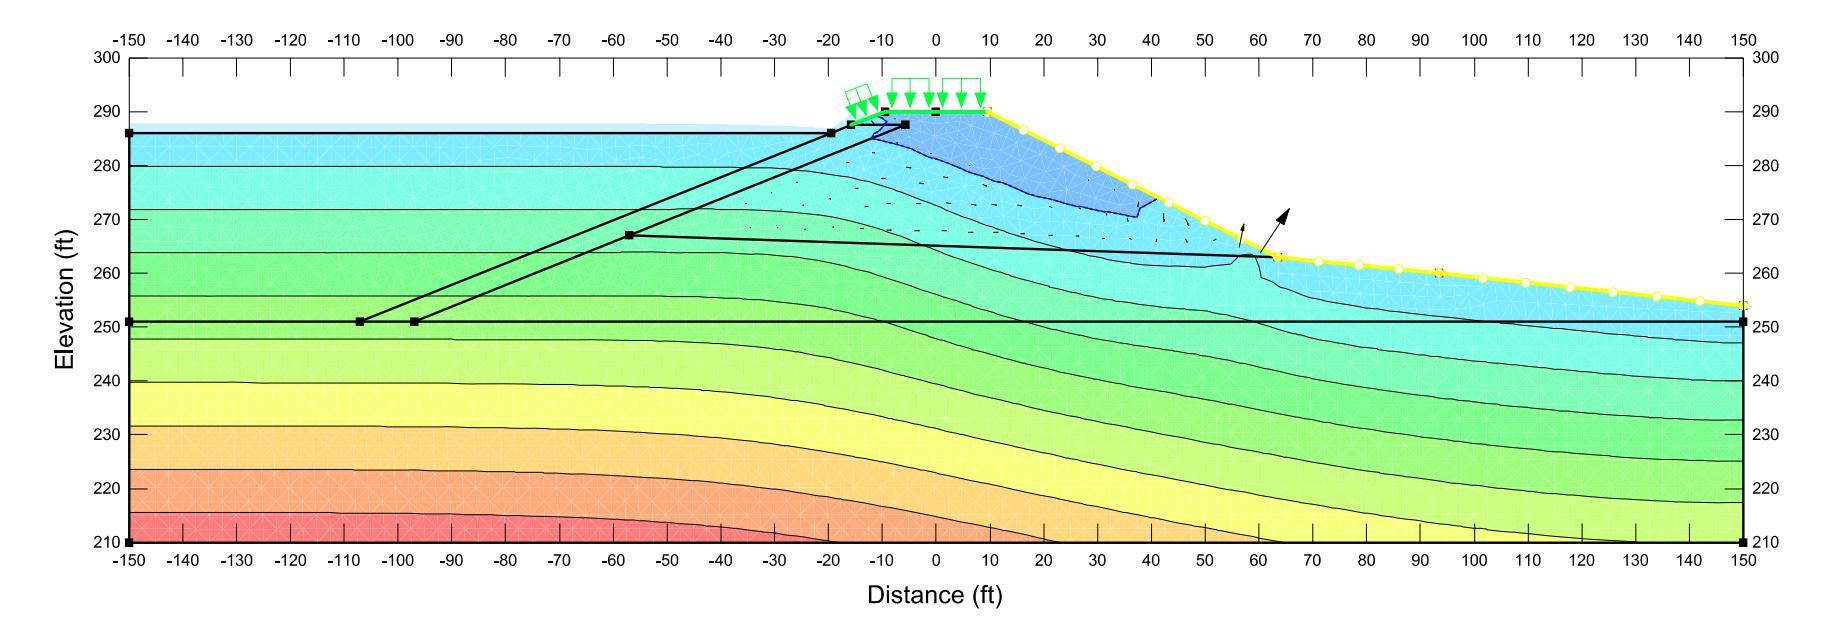
Plate D2d - River at Normal Water Level Elevation (Case 1: Kv=Kh=6.8*10^-6 ft/sec)

Name: Bedrock K-Sat: 1e-010 ft/sec Volumetric Water Content: 0 ft³/ft³ Mv: 0 /psf K-Ratio: 1 K-Direction: 0 ° Model: Saturated Only Name: Native Soil Model: Saturated Only K-Sat: 1e-008 ft/sec Volumetric Water Content: 0 ft³/ft³ Mv: 0 /psf K-Ratio: 1 K-Direction: 0 ° Model: Saturated Only K-Sat: 1e-009 ft/sec Volumetric Water Content: 0 ft³/ft³ Mv: 0 /psf K-Ratio: 1 Name: Clay Liner K-Direction: 0 ° Model: Saturated Only K-Sat: 1e-008 ft/sec Volumetric Water Content: 0 ft³/ft³ Mv: 0 /psf K-Ratio: 1 K-Direction: 0 ° Name: Ash Fill (Storage) Name: Embankment Fill Model: Saturated / Unsaturated K-Function: Embankment Fill Unsat K Vol. WC. Function: Embankment Fill - Vol. WC K-Ratio: 1 K-Direction: 0 °

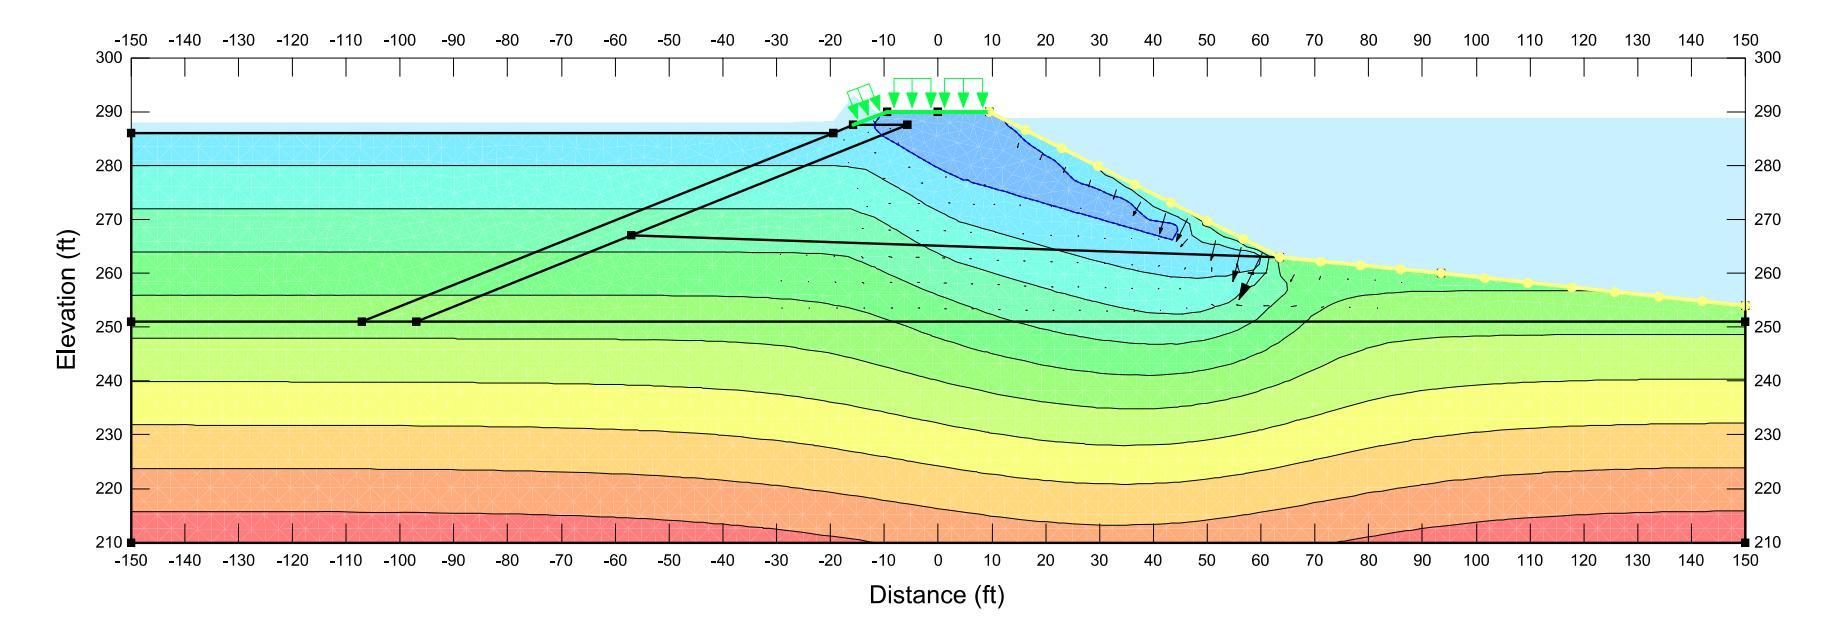
Plate D3a - River at 500-yr Flood Elevation (Case 3: Kv=Kh=6.8*10^-9 ft/sec)

Name: Bedrock K-Sat: 1e-010 ft/sec Volumetric Water Content: 0 ft3/ft3 Mv: 0 /psf K-Ratio: 1 K-Direction: 0 ° Model: Saturated Only Name: Native Soil Model: Saturated Only K-Sat: 1e-008 ft/sec Volumetric Water Content: 0 ft³/ft³ Mv: 0 /psf K-Ratio: 1 K-Direction: 0 ° K-Sat: 1e-009 ft/sec Volumetric Water Content: 0 ft³/ft³ Mv: 0 /psf K-Ratio: 1 Name: Clay Liner Model: Saturated Only K-Direction: 0 ° Model: Saturated Only K-Sat: 1e-008 ft/sec Volumetric Water Content: 0 ft³/ft³ Mv: 0 /psf K-Ratio: 1 Name: Ash Fill (Storage) K-Direction: 0 ° K-Direction: 0 ° Name: Embankment Fill Model: Saturated / Unsaturated K-Function: Embankment Fill Unsat K Vol. WC. Function: Embankment Fill - Vol. WC K-Ratio: 1

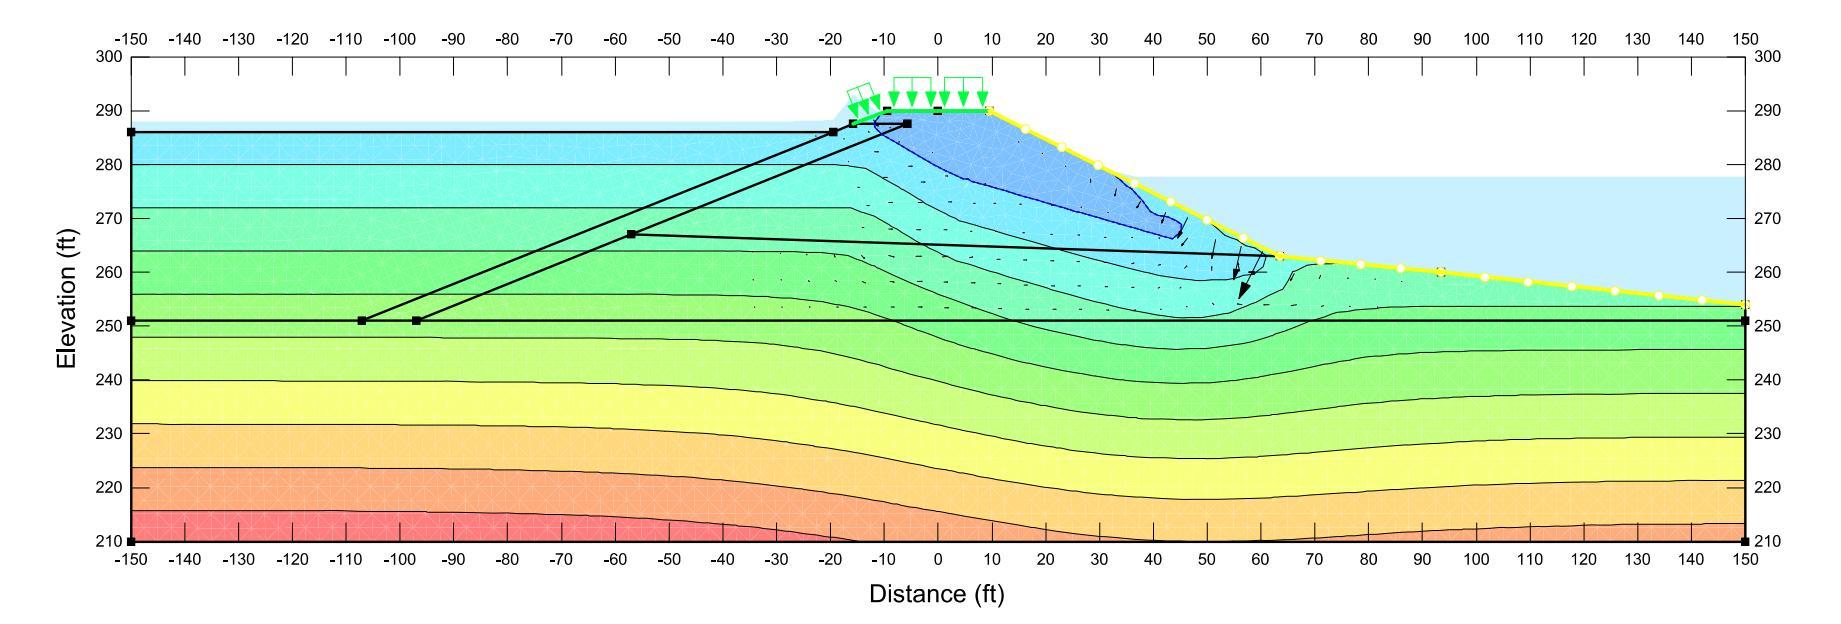
Plate D3b - River at Mid-Slope Elevation (Case 3: Kv=Kh=6.8*10^-9 ft/sec)

Name: Bedrock K-Sat: 1e-010 ft/sec Volumetric Water Content: 0 ft³/ft³ Mv: 0 /psf K-Ratio: 1 K-Direction: 0 ° Model: Saturated Only Name: Native Soil Model: Saturated Only K-Sat: 1e-008 ft/sec Volumetric Water Content: 0 ft³/ft³ Mv: 0 /psf K-Ratio: 1 K-Direction: 0 ° Model: Saturated Only K-Sat: 1e-009 ft/sec Volumetric Water Content: 0 ft³/ft³ Mv: 0 /psf K-Ratio: 1 Name: Clay Liner K-Direction: 0 ° Model: Saturated Only K-Sat: 1e-008 ft/sec Volumetric Water Content: 0 ft³/ft³ Mv: 0 /psf K-Ratio: 1 K-Direction: 0 ° Name: Ash Fill (Storage) K-Direction: 0 ° Name: Embankment Fill Model: Saturated / Unsaturated K-Function: Embankment Fill Unsat K Vol. WC. Function: Embankment Fill - Vol. WC K-Ratio: 1

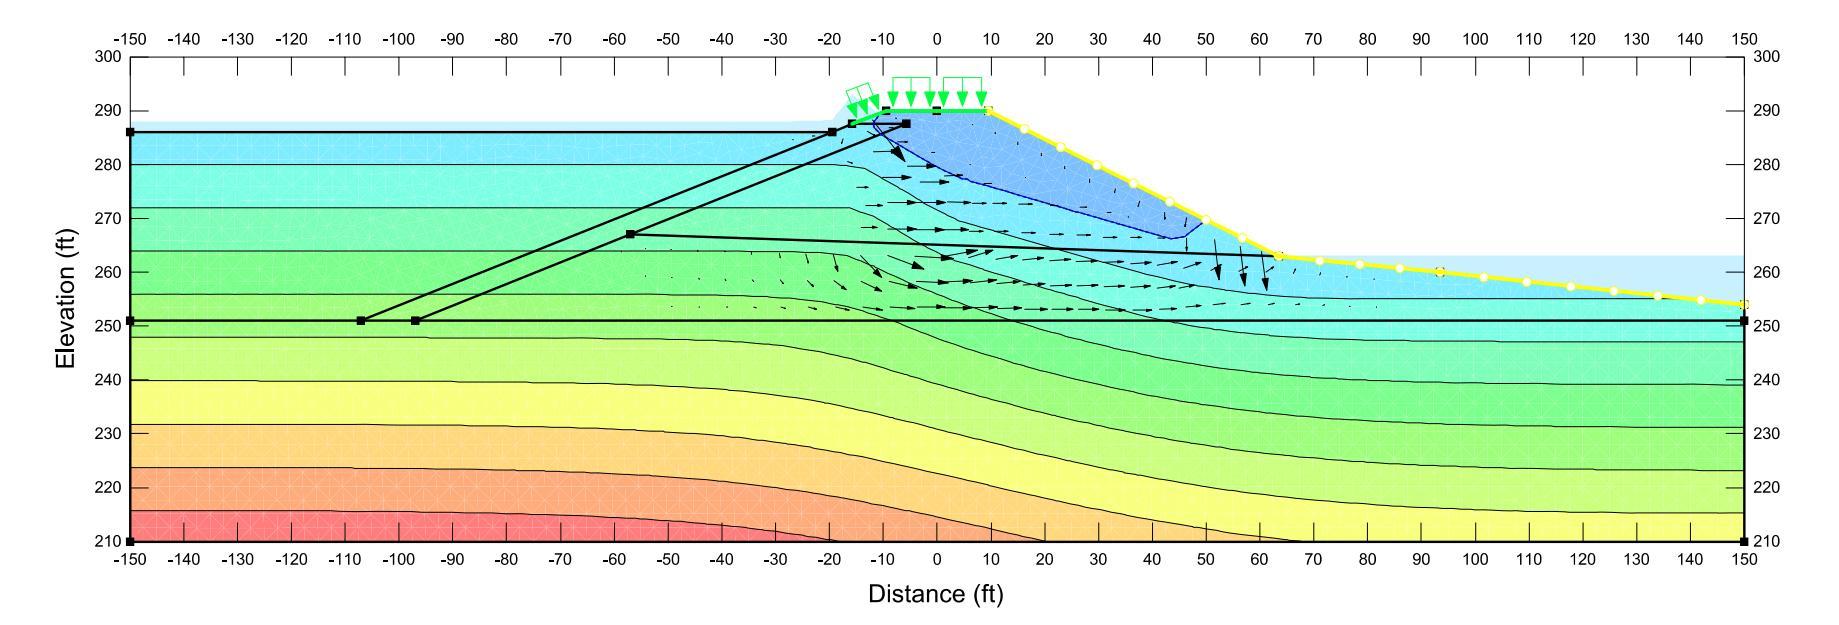
Plate D3c - River at Toe of Slope Elevation (Case 3: Kv=Kh=6.8*10^-9 ft/sec)

Name: Bedrock K-Sat: 1e-010 ft/sec Volumetric Water Content: 0 ft3/ft3 Mv: 0 /psf K-Ratio: 1 K-Direction: 0 ° Model: Saturated Only Name: Native Soil Model: Saturated Only K-Sat: 1e-008 ft/sec Volumetric Water Content: 0 ft³/ft³ Mv: 0 /psf K-Ratio: 1 K-Direction: 0 ° K-Sat: 1e-009 ft/sec Volumetric Water Content: 0 ft³/ft³ Mv: 0 /psf K-Ratio: 1 Name: Clay Liner Model: Saturated Only K-Direction: 0 ° Model: Saturated Only K-Sat: 1e-008 ft/sec Volumetric Water Content: 0 ft³/ft³ Mv: 0 /psf K-Ratio: 1 Name: Ash Fill (Storage) K-Direction: 0 ° K-Direction: 0 ° Name: Embankment Fill Model: Saturated / Unsaturated K-Function: Embankment Fill Unsat K Vol. WC. Function: Embankment Fill - Vol. WC K-Ratio: 1

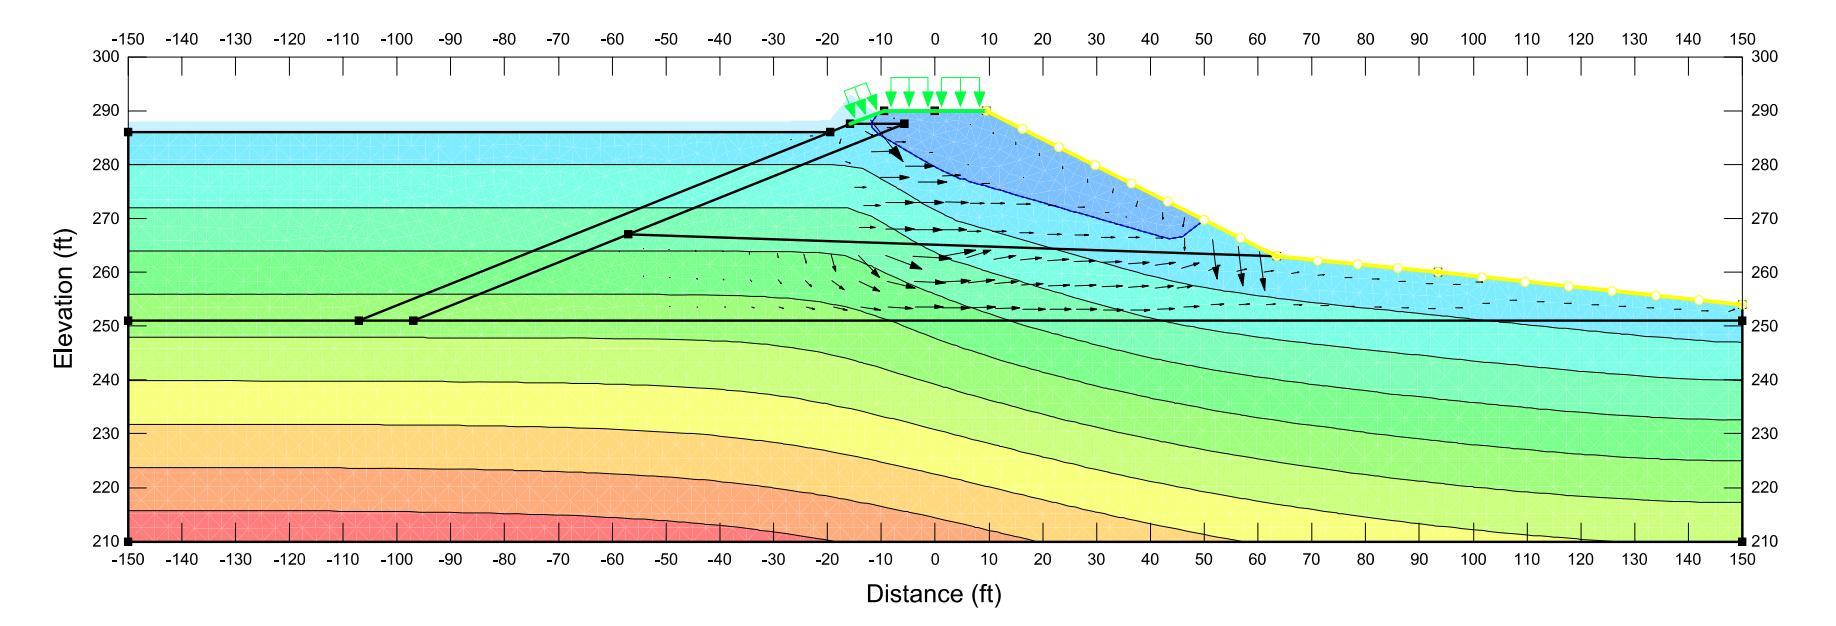
Plate D3d - River at Normal Water Level Elevation (Case 3: Kv=Kh=6.8*10^-9 ft/sec)

Name: Bedrock Model: Saturated Only K-Sat: 1e-010 ft/sec Volumetric Water Content: 0 ft3/ft3 Mv: 0 /psf K-Ratio: 1 K-Direction: 0 ° Name: Native Soil Model: Saturated Only K-Sat: 1e-008 ft/sec Volumetric Water Content: 0 ft³/ft³ Mv: 0 /psf K-Ratio: 1 K-Direction: 0 ° K-Sat: 1e-009 ft/sec Volumetric Water Content: 0 ft³/ft³ Mv: 0 /psf K-Ratio: 1 Name: Clay Liner Model: Saturated Only K-Direction: 0 ° Model: Saturated Only K-Sat: 1e-008 ft/sec Volumetric Water Content: 0 ft³/ft³ Mv: 0 /psf K-Ratio: 1 K-Direction: 0 ° Name: Ash Fill (Storage) Model: Saturated / Unsaturated K-Function: Embankment Fill Unsat K Vol. WC. Function: Embankment Fill - Vol. WC K-Direction: 0 ° Name: Embankment Fill K-Ratio: 1

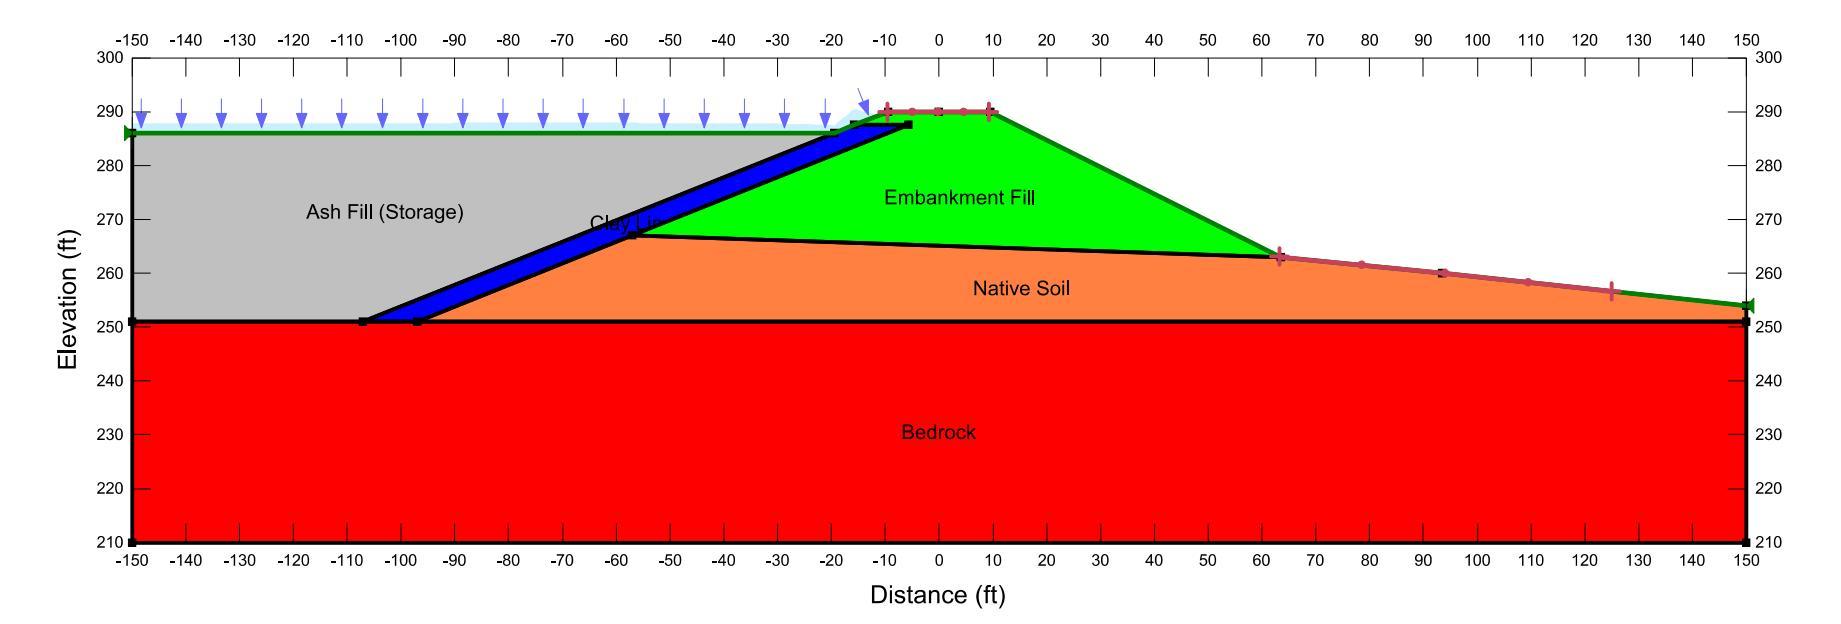
Plate E1 - Slope Model

Name: BedrockModel: Mohr-CoulombUnit Weight: 160 pcfCohesion: 2000 psfPhi: 45 °Name: Native SoilModel: Mohr-CoulombUnit Weight: 130 pcfCohesion: 0 psfPhi: 30 °Name: Clay LinerModel: Mohr-CoulombUnit Weight: 130 pcfCohesion: 0 psfPhi: 30 °Name: Ash Fill (Storage)Model: Mohr-CoulombUnit Weight: 90 pcfCohesion: 0 psfPhi: 30 °Name: Embankment FillModel: Mohr-CoulombUnit Weight: 135 pcfUnit Wt. Above Water Table: 125 pcfCohesion: 0 psfPhi: 37 °

Spencer's Method was used to evaluate global slope stability of the downstream slope using the pore water pressure distribution from SEEP/W. The minimum FOS resulting from the RDD from 1000-yr (EL 289.0) and slightly higher (EL 289.5) flood stage to normal water levels in the river was calculated at discrete time increments starting at flood stage, and ending when river levels return to the normal water level elevation. Only deep-seated potential failure planes were considered, which are failure planes that extend from the crest of the embankment beyond the downstream embankment toe.

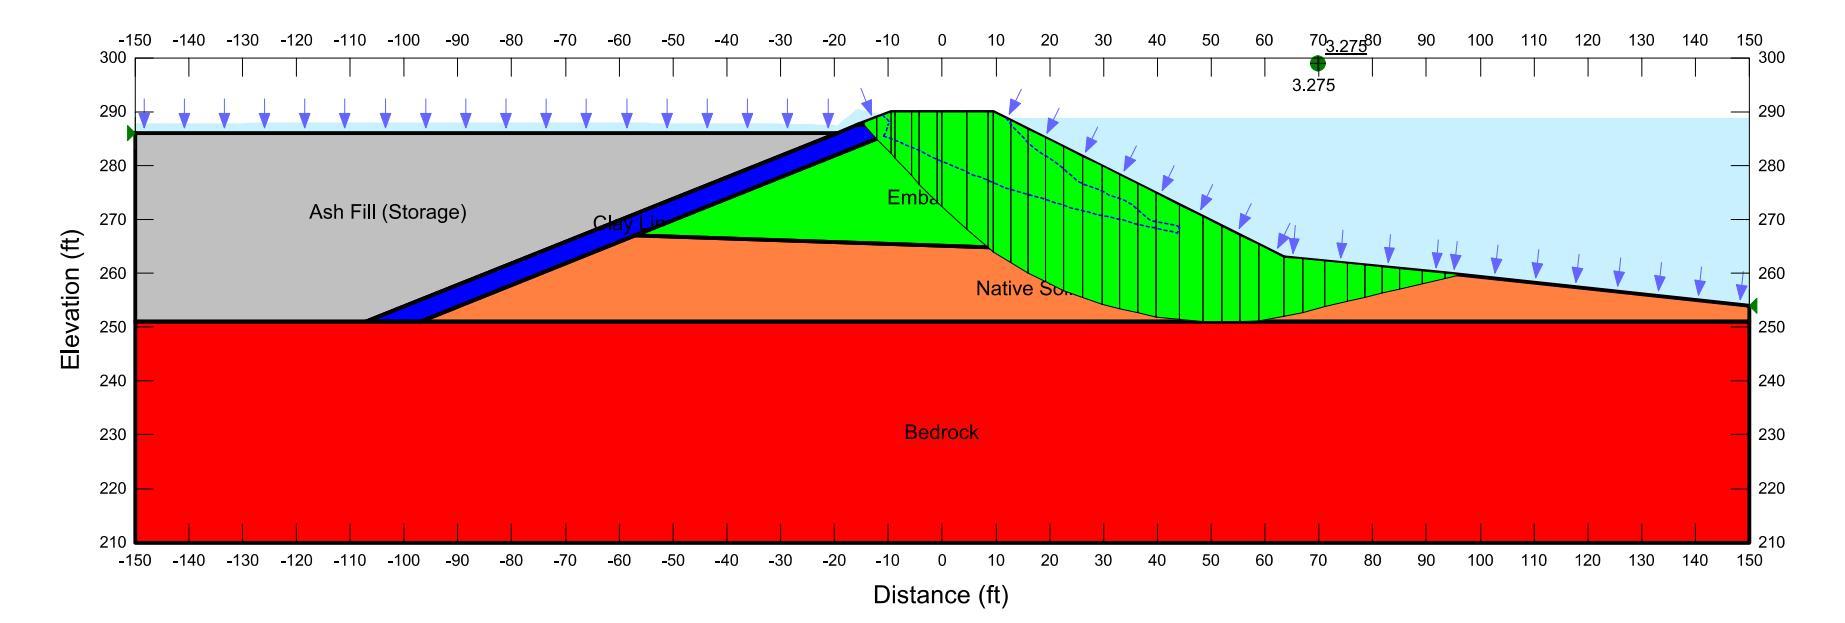
Plate E2a - River at 500-yr Flood Elevation (Case 2: Kv=Kh=2.8*10^-6 ft/sec)

Name: Bedrock Model: Mohr-Coulomb Unit Weight: 160 pcf Cohesion: 2000 psf Phi: 45 ° Name: Native Soil Model: Mohr-Coulomb Unit Weight: 130 pcf Cohesion: 0 psf Phi: 30 ° Name: Clay Liner Model: Mohr-Coulomb Unit Weight: 130 pcf Cohesion: 0 psf Phi: 30 ° Unit Weight: 90 pcf Cohesion: 0 psf Phi: 30 ° Name: Ash Fill (Storage) Model: Mohr-Coulomb Unit Weight: 135 pcf Unit Wt. Above Water Table: 125 pcf Cohesion: 0 psf Phi: 37 ° Name: Embankment Fill Model: Mohr-Coulomb

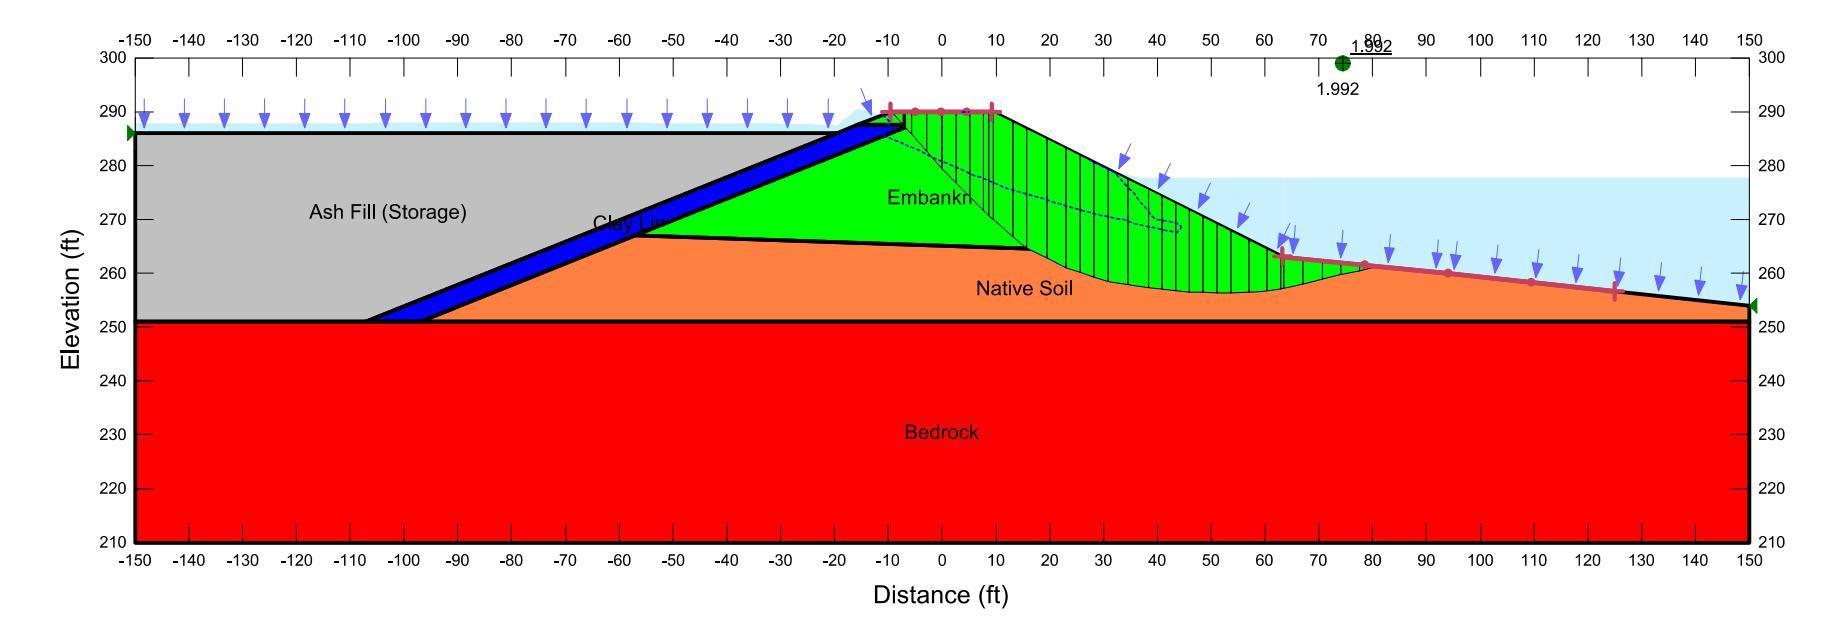
Plate E2b - River at Mid-Slope Elevation (Case 2: Kv=Kh=2.8*10^-6 ft/sec)

Name: Bedrock Model: Mohr-Coulomb Unit Weight: 160 pcf Cohesion: 2000 psf Phi: 45 ° Name: Native Soil Model: Mohr-Coulomb Unit Weight: 130 pcf Cohesion: 0 psf Phi: 30 ° Name: Clay Liner Model: Mohr-Coulomb Unit Weight: 130 pcf Cohesion: 0 psf Phi: 30 ° Unit Weight: 90 pcf Cohesion: 0 psf Phi: 30 ° Name: Ash Fill (Storage) Model: Mohr-Coulomb Name: Embankment Fill Unit Weight: 135 pcf Unit Wt. Above Water Table: 125 pcf Cohesion: 0 psf Phi: 37 ° Model: Mohr-Coulomb

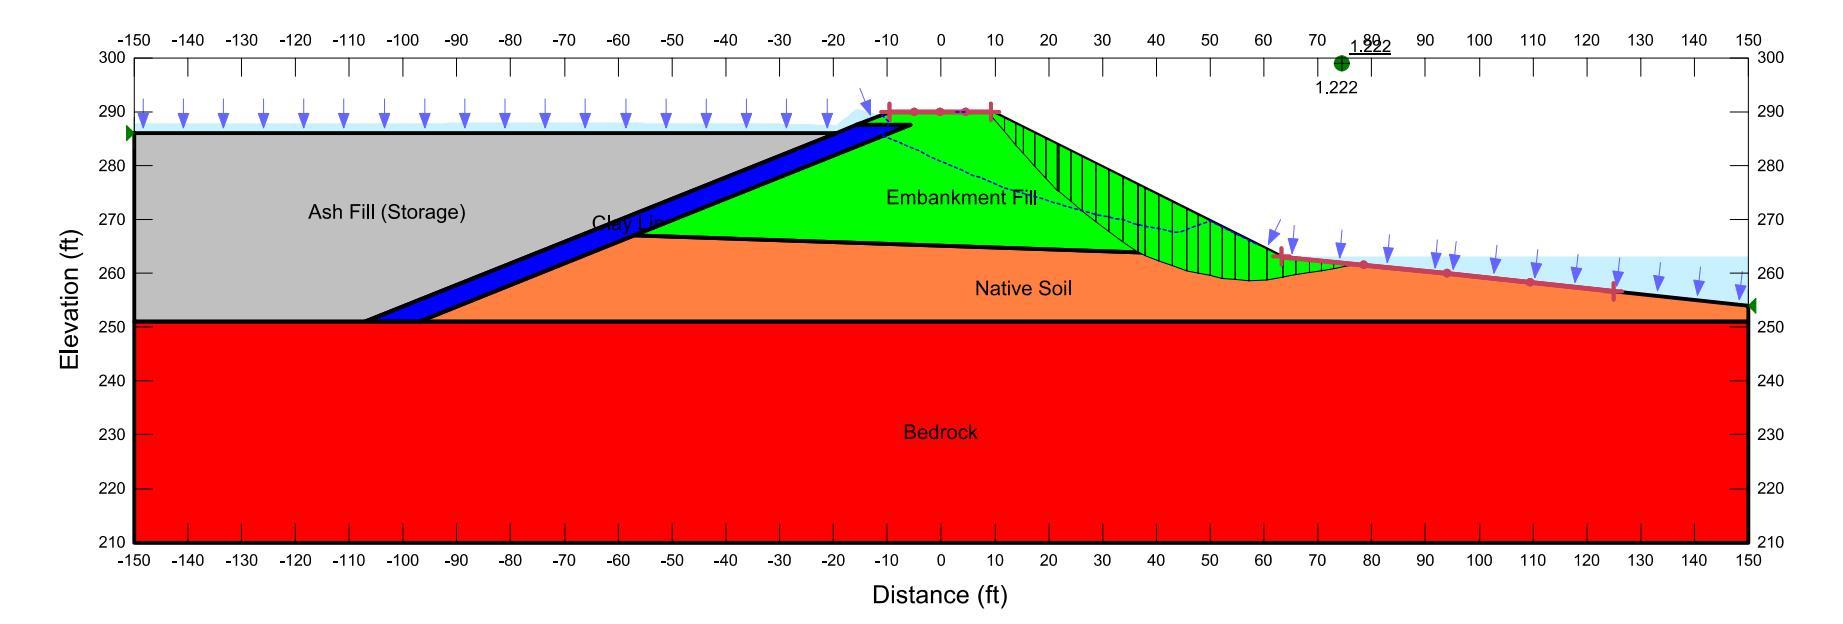
Plate E2c - River at Toe of Slope Elevation (Case 2: Kv=Kh=2.8*10^-6 ft/sec)

Name: Bedrock Model: Mohr-Coulomb Unit Weight: 160 pcf Cohesion: 2000 psf Phi: 45 ° Name: Native Soil Model: Mohr-Coulomb Unit Weight: 130 pcf Cohesion: 0 psf Phi: 30 ° Name: Clay Liner Model: Mohr-Coulomb Unit Weight: 130 pcf Cohesion: 0 psf Phi: 30 ° Unit Weight: 90 pcf Cohesion: 0 psf Phi: 30 ° Name: Ash Fill (Storage) Model: Mohr-Coulomb Unit Weight: 135 pcf Unit Wt. Above Water Table: 125 pcf Cohesion: 0 psf Phi: 37 ° Name: Embankment Fill Model: Mohr-Coulomb

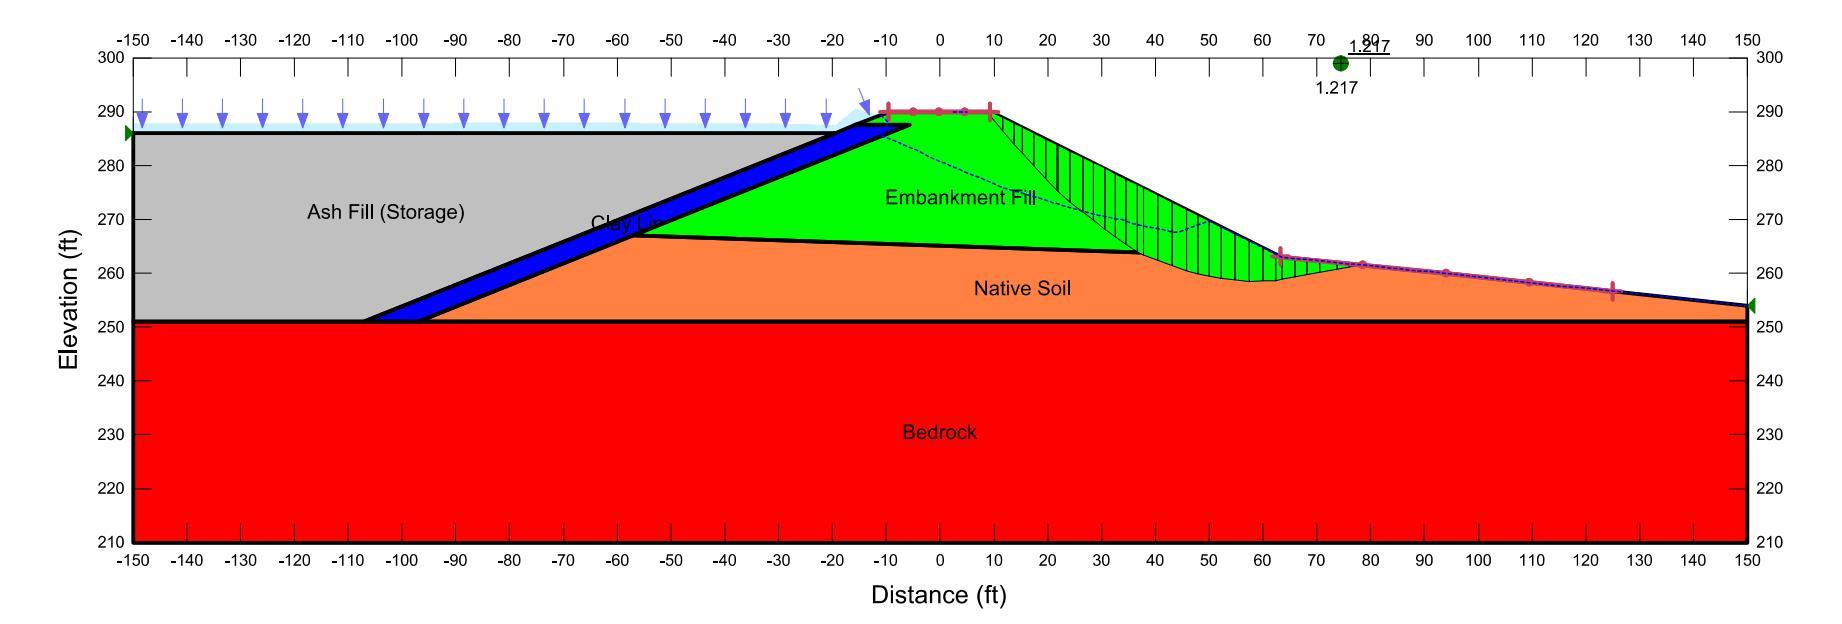
Plate E2d - River at Normal Water Level Elevation (Case 2: Kv=Kh=2.8*10^-6 ft/sec)

Name: BedrockModel: Mohr-CoulombUnit Weight: 160 pcfCohesion: 2000 psfPhi: 45 °Name: Native SoilModel: Mohr-CoulombUnit Weight: 130 pcfCohesion: 0 psfPhi: 30 °Name: Clay LinerModel: Mohr-CoulombUnit Weight: 130 pcfCohesion: 0 psfPhi: 30 °Name: Ash Fill (Storage)Model: Mohr-CoulombUnit Weight: 90 pcfCohesion: 0 psfPhi: 30 °Name: Embankment FillModel: Mohr-CoulombUnit Weight: 135 pcfUnit Wt. Above Water Table: 125 pcfCohesion: 0 psfPhi: 37 °
