2016 Initial Structural Stability Assessment Report

Brunner Island Ash Basin No. 6 CCR

Prepared for: Brunner Island, LLC

September 27, 2016

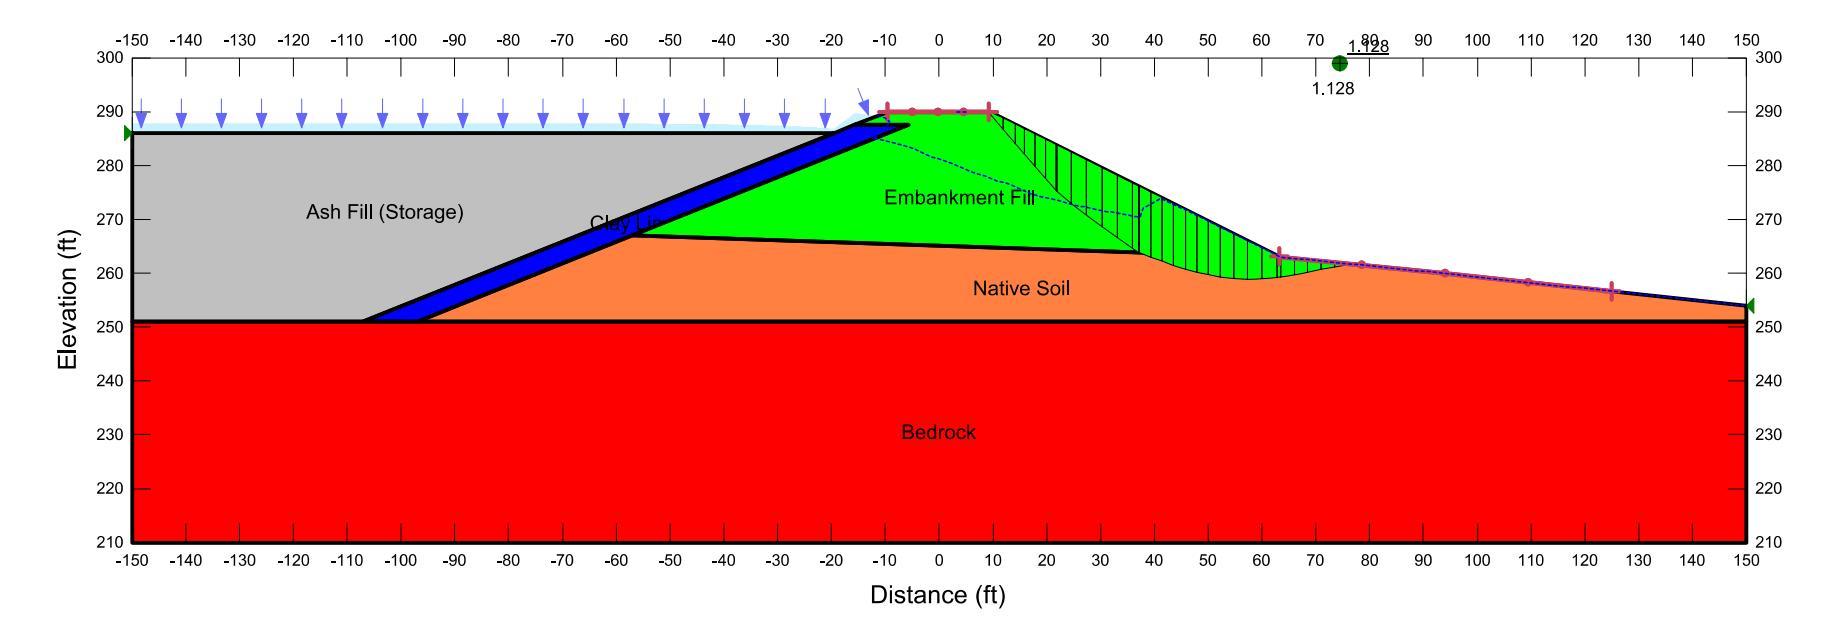
Plate E3a - River at Normal Water Level Elevation (Case 1: Kv=Kh=6.8*10^-6 ft/sec)

Name: Bedrock Model: Mohr-Coulomb Unit Weight: 160 pcf Cohesion: 2000 psf Phi: 45 ° Name: Native Soil Model: Mohr-Coulomb Unit Weight: 130 pcf Cohesion: 0 psf Phi: 30 ° Name: Clay Liner Model: Mohr-Coulomb Unit Weight: 130 pcf Cohesion: 0 psf Phi: 30 ° Unit Weight: 90 pcf Cohesion: 0 psf Phi: 30 ° Name: Ash Fill (Storage) Model: Mohr-Coulomb Name: Embankment Fill Unit Weight: 135 pcf Unit Wt. Above Water Table: 125 pcf Cohesion: 0 psf Phi: 37 ° Model: Mohr-Coulomb

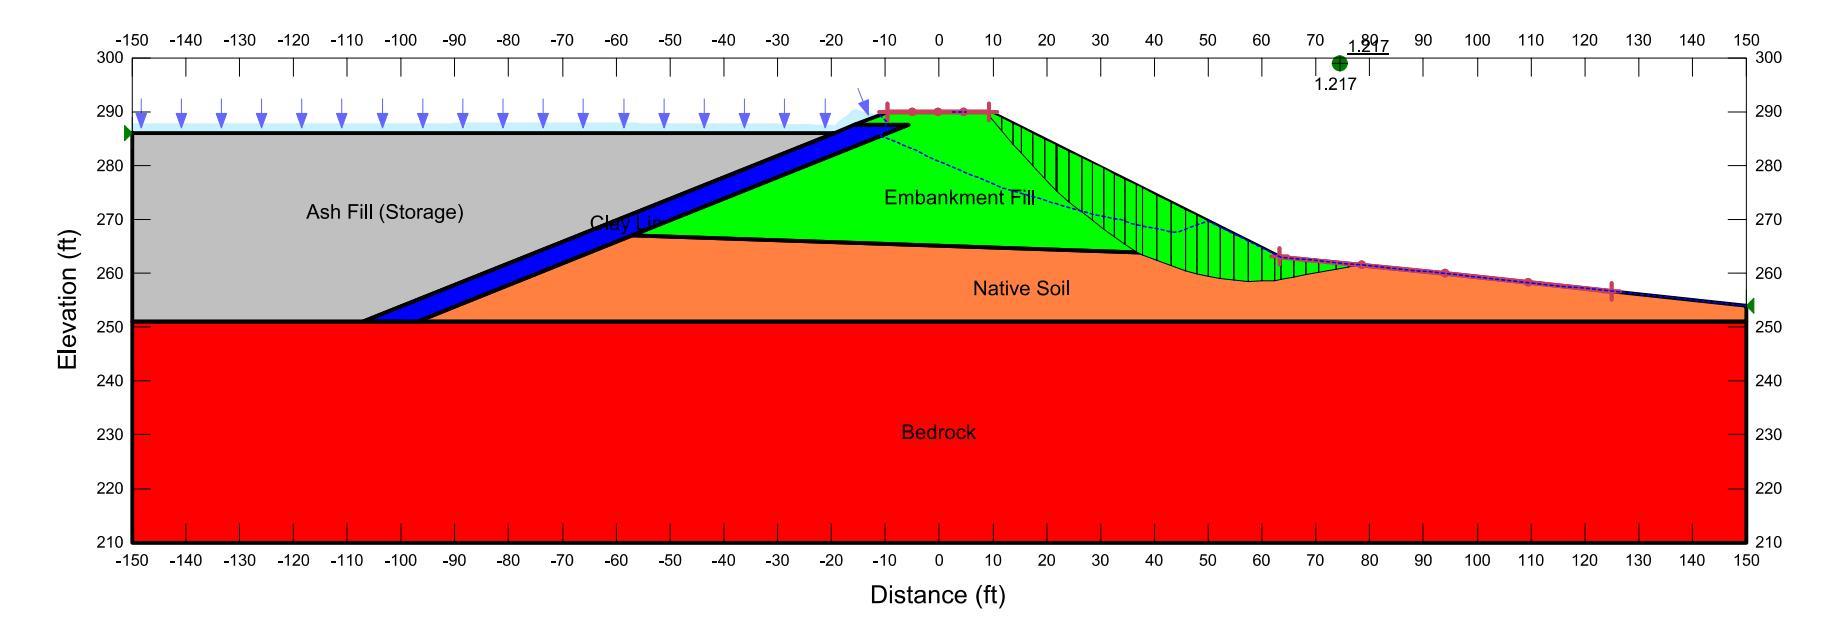
Plate E3b - River at Normal Water Level Elevation (Case 2: Kv=Kh=2.8*10^-6 ft/sec)

Name: BedrockModel: Mohr-CoulombUnit Weight: 160 pcfCohesion: 2000 psfPhi: 45 °Name: Native SoilModel: Mohr-CoulombUnit Weight: 130 pcfCohesion: 0 psfPhi: 30 °Name: Clay LinerModel: Mohr-CoulombUnit Weight: 130 pcfCohesion: 0 psfPhi: 30 °Name: Ash Fill (Storage)Model: Mohr-CoulombUnit Weight: 90 pcfCohesion: 0 psfPhi: 30 °Name: Embankment FillModel: Mohr-CoulombUnit Weight: 135 pcfUnit Wt. Above Water Table: 125 pcfCohesion: 0 psfPhi: 37 °

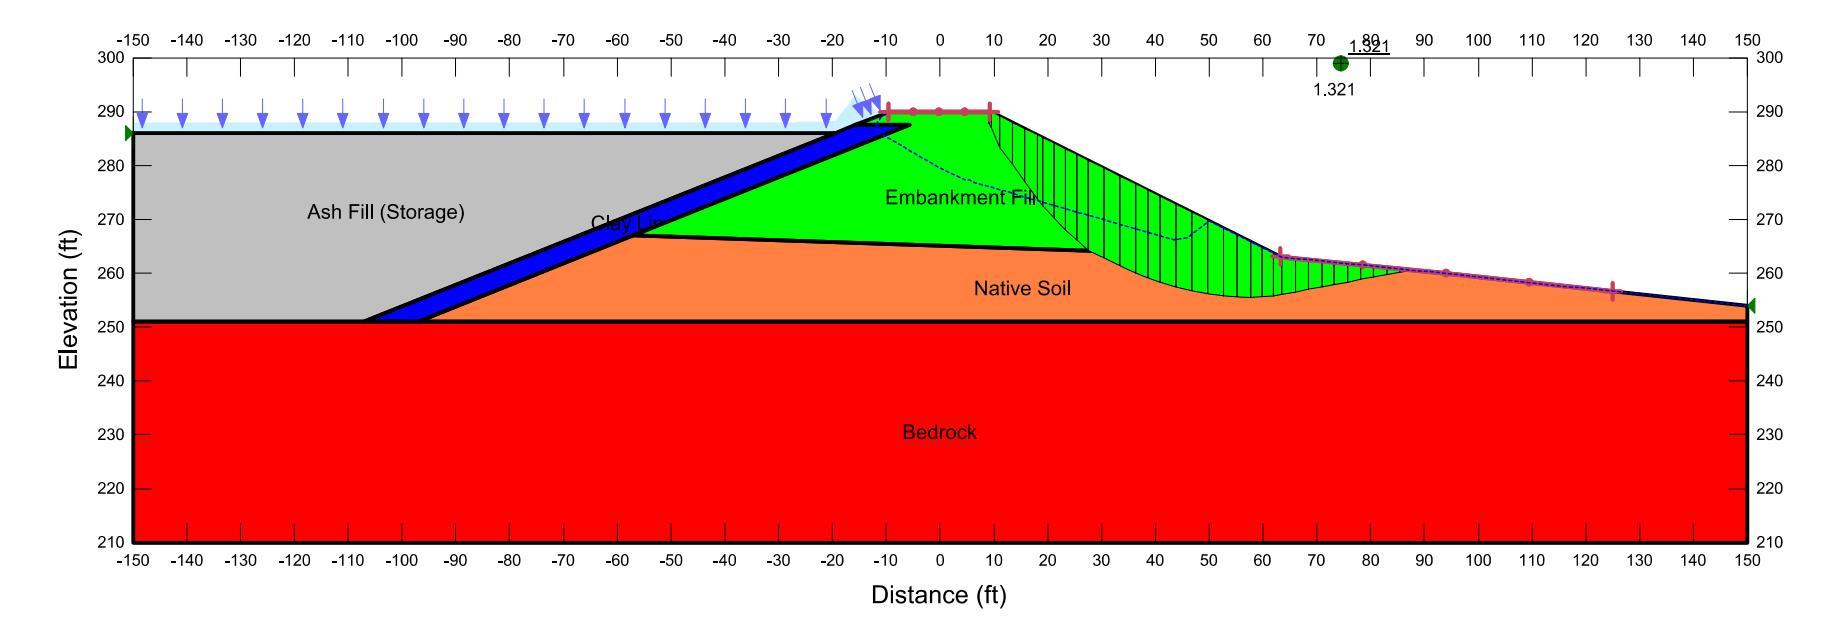
Plate E3c - River at Normal Water Level Elevation (Case 3: Kv=Kh=6.8*10^-9 ft/sec)

Name: BedrockModel: Mohr-CoulombUnit Weight: 160 pcfCohesion: 2000 psfPhi: 45 °Name: Native SoilModel: Mohr-CoulombUnit Weight: 130 pcfCohesion: 0 psfPhi: 30 °Name: Clay LinerModel: Mohr-CoulombUnit Weight: 130 pcfCohesion: 0 psfPhi: 30 °Name: Ash Fill (Storage)Model: Mohr-CoulombUnit Weight: 90 pcfCohesion: 0 psfPhi: 30 °Name: Embankment FillModel: Mohr-CoulombUnit Weight: 135 pcfUnit Wt. Above Water Table: 125 pcfCohesion: 0 psfPhi: 37 °

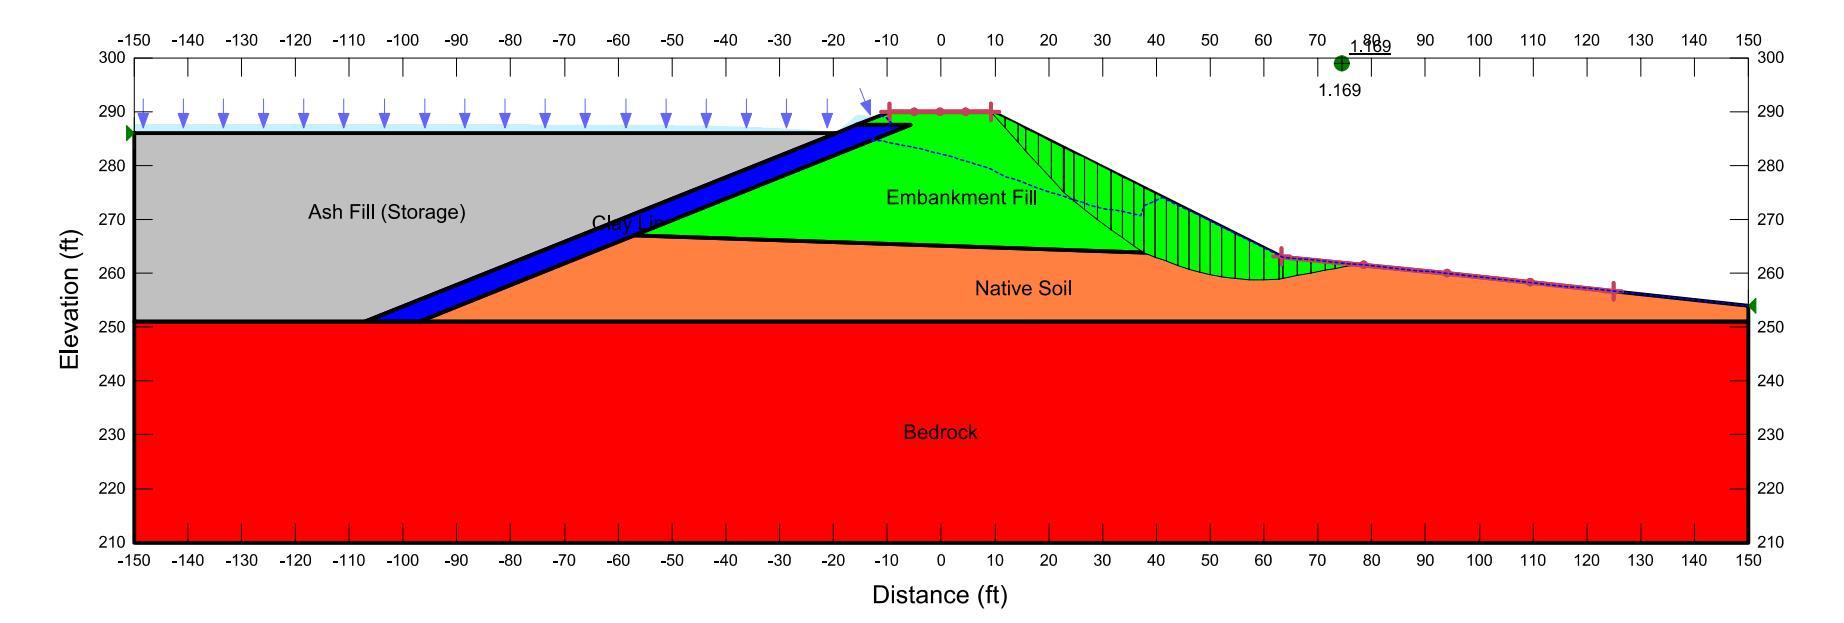
Plate E3e - River at Normal Water Level Elevation (Case 5: Kv=0.25*Kh=2.8*10^-6 ft/sec) Slope Stability (6) Brunner Island Ash Basin No. 6 Station 21+80 (Section 1-1) Manchester Township, Pennsylvania

Material Input Properties

Name: BedrockModel: Mohr-CoulombUnit Weight: 160 pcfCohesion: 2000 psfPhi: 45 °Name: Native SoilModel: Mohr-CoulombUnit Weight: 130 pcfCohesion: 0 psfPhi: 30 °Name: Clay LinerModel: Mohr-CoulombUnit Weight: 130 pcfCohesion: 0 psfPhi: 30 °Name: Ash Fill (Storage)Model: Mohr-CoulombUnit Weight: 90 pcfCohesion: 0 psfPhi: 30 °Name: Embankment FillModel: Mohr-CoulombUnit Weight: 135 pcfUnit Wt. Above Water Table: 125 pcfCohesion: 0 psfPhi: 37 °
